Facilities Assessment of School Buildings

City of Portland and Portland Public Schools

VOLUME 2
Detailed Existing Conditions Documentation
February 28, 2017

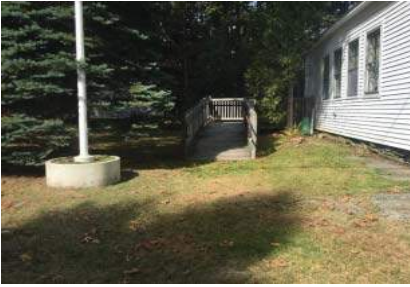
LEGEND					
Condition Level	Life Cycle (Age Factor)	Action Priority			
0 - Failed - Not Functional	N - New / Recent	I - Immediate (Year 0)			
1 - Poor - Failure Anticipated	ESL - w/In Expected Service Life	S - Short Term (Years 1-5)			
2 - Fair - Functions, Service Required	END - Nearing End of Service Life	L - Long Term (Years 6-20)			
3 - Good - Functional & Maintained	OB - Obsolete	N/A - Not Applicable			
4 - Excellent - New					
			SEE LEGEND		
CATEGORY	DESCRIPTION AND GENERAL COMMENTS	RECOMMENDED ACTION	COND. LEVEL	LIFE CYCLE	ACTION PRIORITY
Pedestrian Ramp Location & Materials	ADA ramp into school is good - wood with rail, rail needs minor repair.

Gravel/defined path from ramp to roadway needed. Repair handrail.

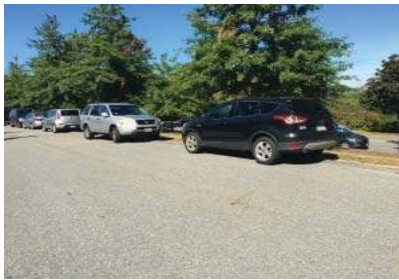
SITE					
Building Entrances					
Connection to accessible route and accessibility	Observed parent meeting child on playground.	Restrict playground access from the public.	2	ESL	I
Parking					
General Layout Description	Observed parking in non-parking areas.

Parking enforcement needed.

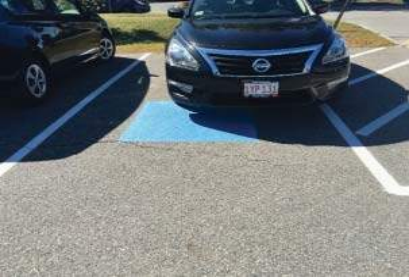
CATEGORY	DESCRIPTION AND GENERAL COMMENTS	RECOMMENDED ACTION	SEE LEGEND		
			COND. LEVEL	LIFE CYCLE	ACTION PRIORITY
Number of Spaces (Regular & ADA)	4 ADA on street, possibly 1 in staff lot (not painted). Faculty lot full, observed parking along fire lane.

Additional ADA space required. ADA spaces to be painted. Additional parking required.	0	OS	I
Size of Spaces	9' X 18'	No Action Required	3	ESL	N/A
Parking Striping Condition	Good - White	No Action Required	3	ESL	N/A
Accessible Parking Signage	Yes - at street. None at faculty lot.	Install ADA parking signs at staff lot.	0	OS	I
Vehicular Drop-Off & Pick-Up Areas					
Locations	Bus drop off in front loop.	No Action Required	3	ESL	N/A
Car & Bus Separations	Good	No Action Required	3	ESL	N/A
Vehicular & Pedestrian Circulation					
Observed Circulation Patterns	Good.	No Action Required	3	ESL	N/A

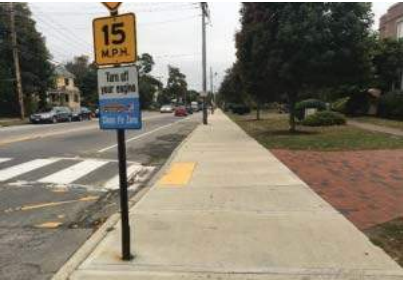
SEE LEGEND		
CATEGORY	DESCRIPTION AND GENERAL COMMENTS	RECOMMENDED ACTION	COND. LEVEL	LIFE CYCLE	ACTION PRIORITY
Accessible Parking Signage	Only 1 sign	Install additional signage, 1 per ADA space.	1	END	I
Vehicular Drop-Off & Pick-Up Areas					
Locations	Parent and Bus drop off in front of School on Stevens	No Action Required	3	ESL	N/A
Car & Bus Separations	None	No Action Required	3	ESL	N/A
Vehicular & Pedestrian Circulation					
Observed Circulation Patterns	Good	No Action Required	3	ESL	N/A
Traffic Markings & Traffic Signage	Good	No Action Required	3	ESL	N/A
Walkway Materials	Brick - Good	No Action Required	3	ESL	N/A
Curb Cuts & Detectable Warning Strips	Good	No Action Required	3	ESL	N/A
Pedestrian Ramp Location & Materials	Crosswalk/Speed Table at Stevens, concrete with comp. paver. Lip at base of Ramp. Food carts stored on ramp landing

Repair pavement at sidewalk transition to reduce lip to 1/4" or less. Install additional storage space for food carts if needed.	2	ESL	I

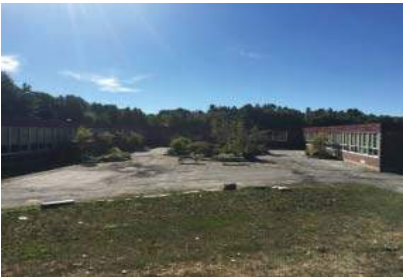
SEE LEGEND		
CATEGORY	DESCRIPTION AND GENERAL COMMENTS	RECOMMENDED ACTION	COND. LEVEL	LIFE CYCLE	ACTION PRIORITY
Paving Materials	Bituminous in rough shape, a lot of cracking and ruts <div>

</div>	Mill and repave. <div>

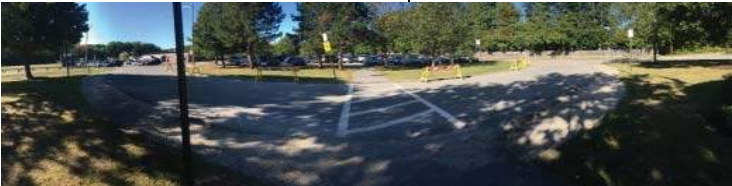
Car & Bus Separations	Separate at parking but not at access drive. Bus loop has wood guardrail. Parent loop has temporary barricades. Minimal drainage along drive aisles. <div>

</div>	Install sidewalk, curb and guardrail at parent drop off loop.	2	ESL	I
Vehicular & Pedestrian Circulation					
Observed Circulation Patterns					
Traffic Markings & Traffic Signage	Lacking	Need more stripping and signage	2	ESL	I

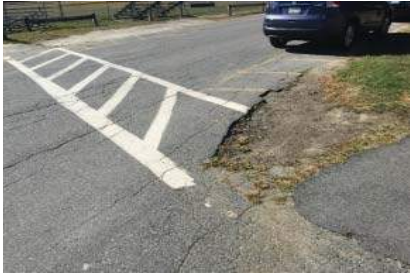
SEE LEGEND		
CATEGORY	DESCRIPTION AND GENERAL COMMENTS	RECOMMENDED ACTION	COND. LEVEL	LIFE CYCLE	ACTION PRIORITY
Walkway Materials	Bituminous. Breaks in guardrail sections.

Replace bituminous sidewalks. Replace missing guardrail sections.	2	ESL	I
Curb Cuts & Detectable Warning Strips	No panels observed	Install detectable warning panels at all crosswalks.	0	OS	I
Pedestrian Ramp Location & Materials	All bituminous.	Confirm ramp grade is compliant at front entrance.	2	ESL	I
DOT School Zone Markings/Signage at Street	Good	No Action Required	3	ESL	N/A
Fire Department Access					
Locations	Two - Not complete continuous loop, but accessible from two sides.	No Action Required	3	ESL	N/A
Extent of perimeter access (full, 1/2?)	Full	No Action Required	3	ESL	N/A
Service Area					
Paving Materials	Bituminous and Concrete	Replace pavement.	2	ESL	I
Loading Dock or Leveler	No leveler	No Action Required	3	ESL	N/A

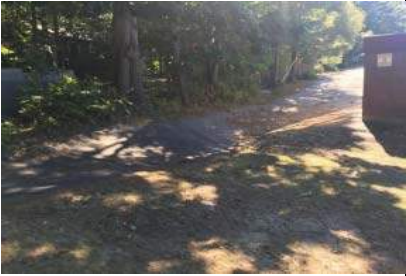
SEE LEGEND		
CATEGORY	DESCRIPTION AND GENERAL COMMENTS	RECOMMENDED ACTION	COND. LEVEL	LIFE CYCLE	ACTION PRIORITY
Characteristics	Generally flat with site stabilization

Need walls at rear where paved	1	END	I
Plantings, Trees and Shrubs					
Locations, Types and Densities	Sensory Garden - Winterberries designated as "Taste" - Toxic plants	Remove Winterberries.	0	OS	I
Courtyards & Exterior Gathering Spaces					
Locations, Materials and Characteristics	Playground and Athletic Field - Good	No Action Required	3	ESL	N/A
In-Site Renewable Energy Resources	Not Applicable				
Site Furniture & Accessories					
Types, Locations, Materials	Several Granite Benches, Remnants from wooden guardrail at edge of south parking lot

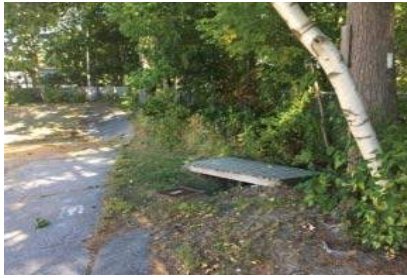
SEE LEGEND		
CATEGORY	DESCRIPTION AND GENERAL COMMENTS	RECOMMENDED ACTION	COND. LEVEL	LIFE CYCLE	ACTION PRIORITY
Ponding	Ponding within loop	Add catch basins to address ponding and erosion issues.	2	ESL	I
Catch Basins	None within landscaped area, minimal drainage along north side of site.

Adjust covers to grade where applicable.

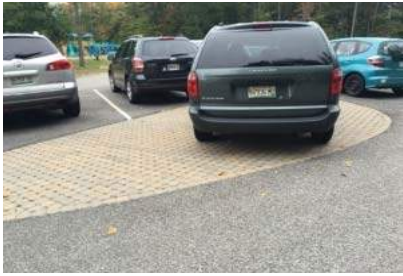
Number of Spaces (Regular & ADA)	5 ADA - good/compliant. Observed parking outside of designated spaces.

Reconfigure parking lot to allow for more spaces.

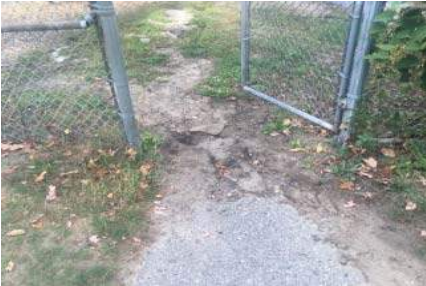
Remove fabric and riprap or other stabilization. Remove knot weed.	1	END	I
Catch Basins	None	No Action Required	-	-	-
Bio-Retention Area	None	No Action Required	-	-	-
Irrigation System	None	No Action Required	-	-	-
Other Observations	Erosion at gate near basketball court , runoff from Pleasant.

Check dam at gate to eliminate scour/erosion.	2	ESL	I
Exterior Building Signage					
Location and Materials	Sign on building.	No Action Required	3	ESL	N/A

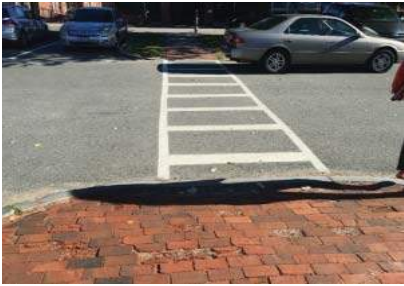
Pedestrian Ramp Location & Materials	Ramp at front in rough shape, not compliant, not structurally sound. The space underneath the ramp behind the planting bed provides a concern for hiding predators or an active shooter situation.

Ramp needs replacement.

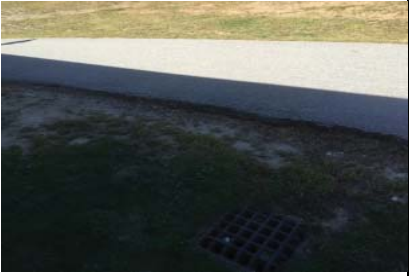
Overlay pavement. Repair signage.	2	ESL	I
Car & Bus Separations	Good Separation, Parent Drop-off area needs attention (Principal noted parental confrontations at pick up area)	Signage needed at parent drop off area. Consider reconfiguring. Parking enforcement needed.	2	ESL	I
Vehicular & Pedestrian Circulation					
Observed Circulation Patterns	Parking Enforcement necessary (Principal noted parked vehicles blocking emergency vehicle access)	Parking Enforcement necessary	1	END	I
Traffic Markings & Traffic Signage	Signs faded and tipping.	Replace faded signs. No parking signs needed along access driveway	2	ESL	I
Walkway Materials	Sloped curb at sidewalk, 7" drop off sidewalk at north of building.

Adjust grades at sidewalk around north side of building.	2	ESL	I

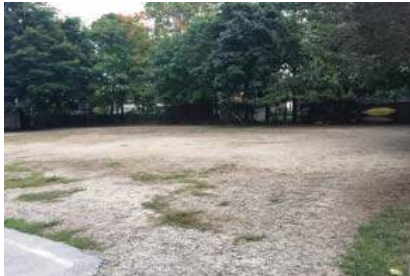
No Action Required	3	ESL	N/A
Trash & Recycling Containers (# & Size), Trash Compactor (size)	1- 8 yd solid, 1- 6 yd recycle. No screening.	Install screening.	2	ESL	S
Fencing					
Locations & Materials	Chain link around school. Corner fence/grade attenuation. Sections missing/sagging.	Needs repair.	2	ESL	I
Site Topography					
Characteristics	Poor grass cover in play area.

Reestablish green area.	2	ESL	S
Plantings, Trees and Shrubs					
Locations, Types and Densities	Good	No Action Required	3	ESL	N/A

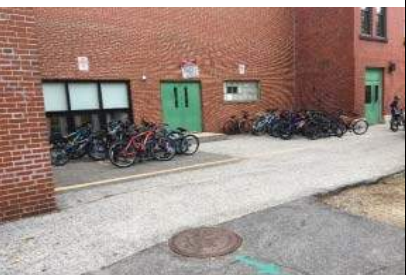
Recommend bollard(s) to restrict cars through fire lane.	2	ESL	S
Bicycle Racks	2 at rear (full)

Relocate racks out of fire lane. Install additional racks as they appear full.	2	ESL	I
Flagpoles	Front, good.		3	ESL	N/A
Site Drainage					
Ponding	Ponding/drainage needs attention at Dumpster area

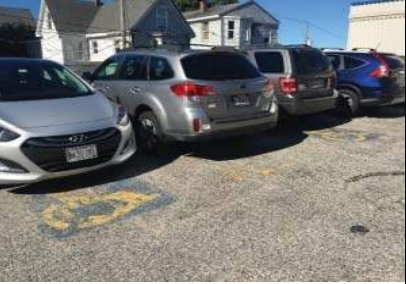
Wheel stops needed where wall ends.	2	ESL	S
Number of Spaces (Regular & ADA)	2 ADA with signs, faded markings. Observed 5 cars with ADA Placards.

Stripe Aisle to building. Repaint ADA spaces and aisles.
