Facilities Assessment of School Buildings

City of Portland and Portland Public Schools

VOLUME 1

February 28, 2017

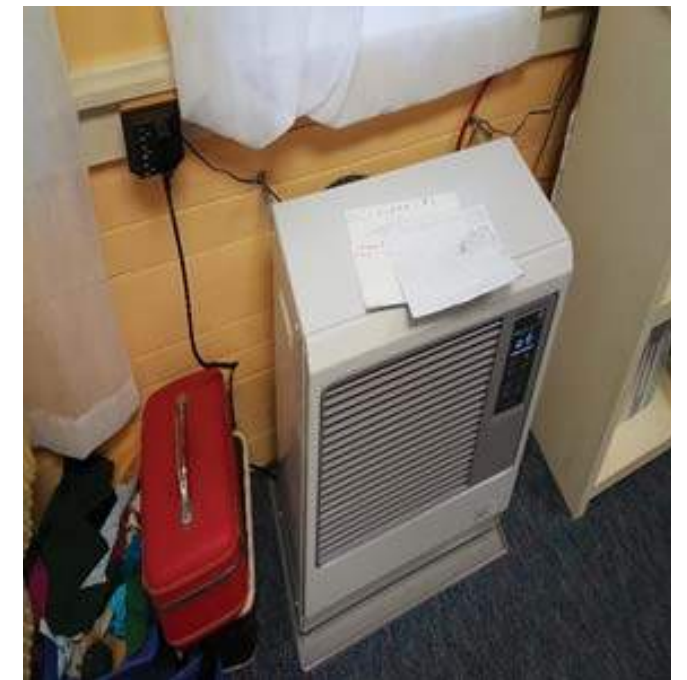
Although teachers at the school stated that the floor mounted Laser 730 heater is all that is used and heats the building comfortably it is recommended to install a central heating system, such as a condensing gas ducted furnace which also provides fresh air from a small energy recovery unit (ERU). The ERU will also provide exhaust air from both bathrooms.

Laser 730 Floor Fuel Fired Heater

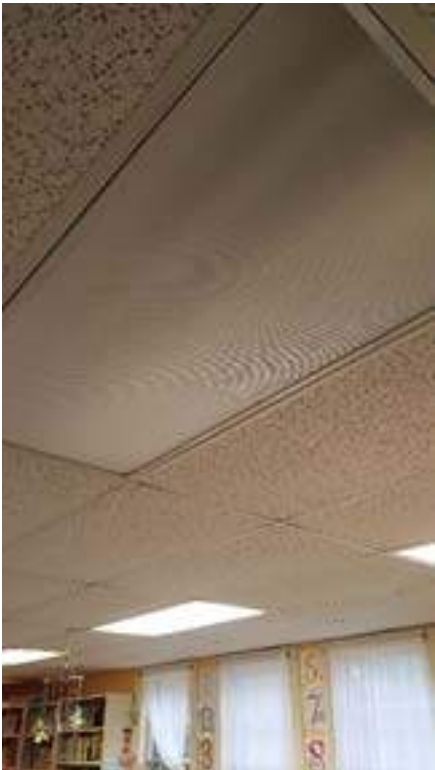
Recessed fluorescent lens troffers utilizing T12 lamps are installed in all interior areas. T12 fluorescent lamps are obsolete and the fixtures are at the end of their anticipated useful lives. We recommend updating the interior lighting to LED fixtures with high performance optics as part of any planned facility renovations.

Typical interior lighting

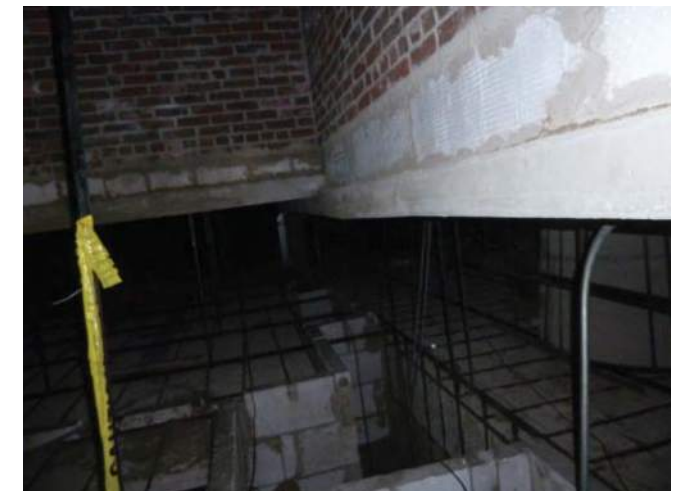
Central Roof Beam Cover

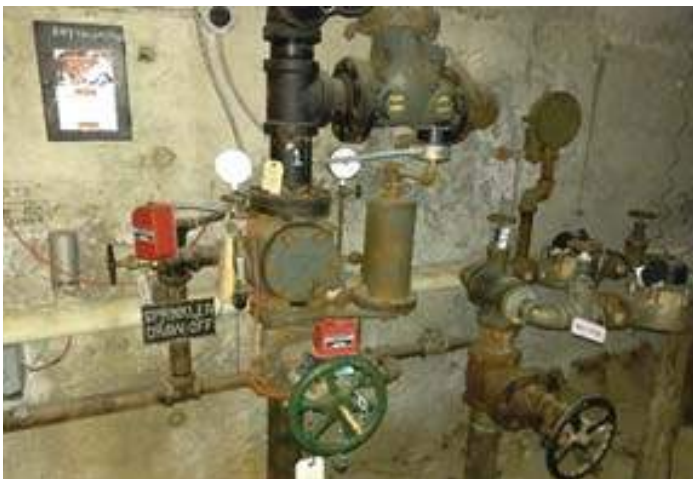
The 4" sprinkler entrance is supplied by municipal water and does not have a backflow preventer. The sprinkler system cover the hallways only and the stage with an automatic wet system from a single 4" riser; there may be a dry system serving the second floor per documentation at the sprinkler entrance. There is a 4" fire department connection. The piping system appears in good condition however it is an aged system (exact year not known but assuming at least 40 years). Recommend that a new, 100% coverage NFPA 13 sprinkler system be installed.

Sprinkler Entrance

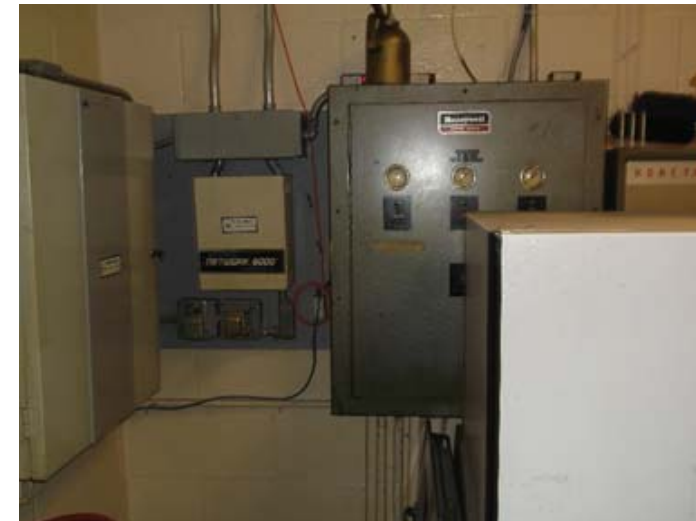
Existing temperature controls are pneumatic and beyond their expected service life. There is some newer DDC electric but it is nearing 20 years old. The existing HVAC systems are simple, comprised mostly of unit ventilators which are generally in fair operating condition given their age. How and when to replace the equipment depends on whether there are planned building renovations or replace systems as a major HVAC upgrade. The best recommendation is to convert the original building to heating hot water and eliminate the aged steam equipment and steam / condensate piping. Install a hot water heating plant dedicated to Lyseth. All heating and ventilating equipment would need to be replaced/upgraded with new systems at the time of the steam to HW conversion. Also, coordinate the temperature controls DDC electric upgrade at the time of conversion. Basically, there are no intermediate steps with upgrading the HVAC at Lyseth without replacing all HVAC systems.

Temperature Controls

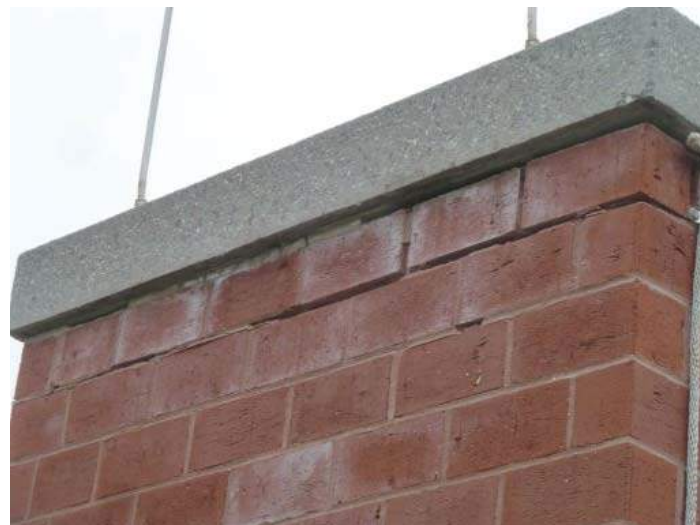
- Mortar at top of chimney

Mortar at top of chimney

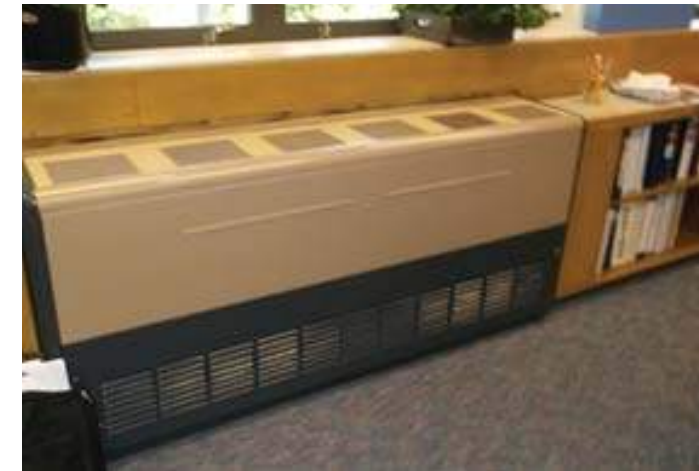
The existing HVAC equipment, other than boiler plant are beyond their useful service life and should be replaced. Although the steam boiler is new it is recommended to replace the steam boiler with a hot water boiler to simplify the boiler plant (no HX or condensate pump) for the given size of the building. The building heating would be fin tube radiation throughout with CUHs at vestibules. Building ventilation would be (1 or 2) ERUs to supply fresh air to occupied space and exhaust toilet rooms and other odor producing spaces. The temperature controls should be upgraded at the time of steam to HW conversion, in lieu of its own upgrade project. Heating system conversion can be performed without major building renovations.

Typical Classroom Unit Ventilator

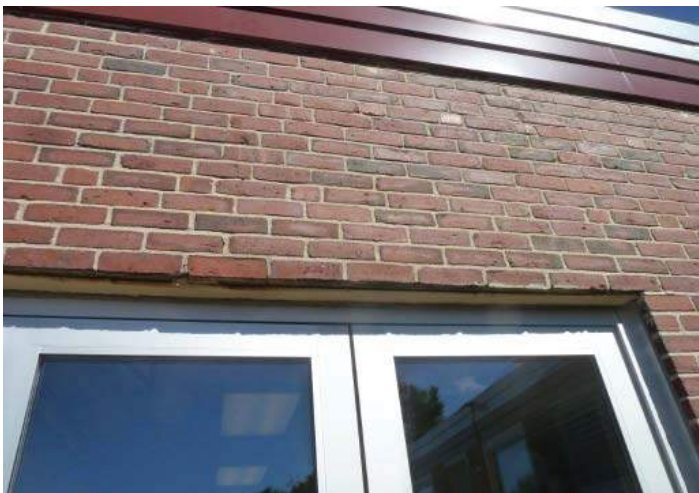
Lintel condition

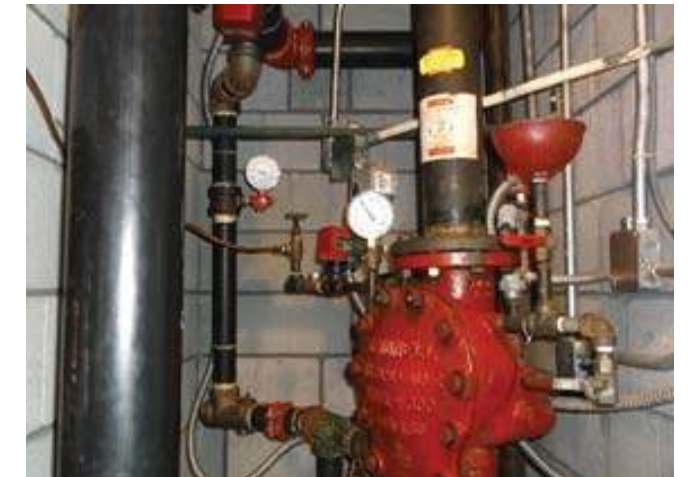
The sprinkler entrance is supplied by municipal water and does not have a testable backflow preventer. The sprinkler system is a partial automatic wet & dry system with (2) 4" risers. Original portions of this sprinkler system maybe 40 years old and would require sprinkler head replacement at a minimum. Typical expected service life of sprinkler heads is 25 years. It is recommended to extend the automatic sprinkler system to provide complete coverage for the entire building; a licensed sprinkler contractor will have to determine if the existing sprinkler entrance has adequate capacity to extend the system.

Current Sprinkler Entrance

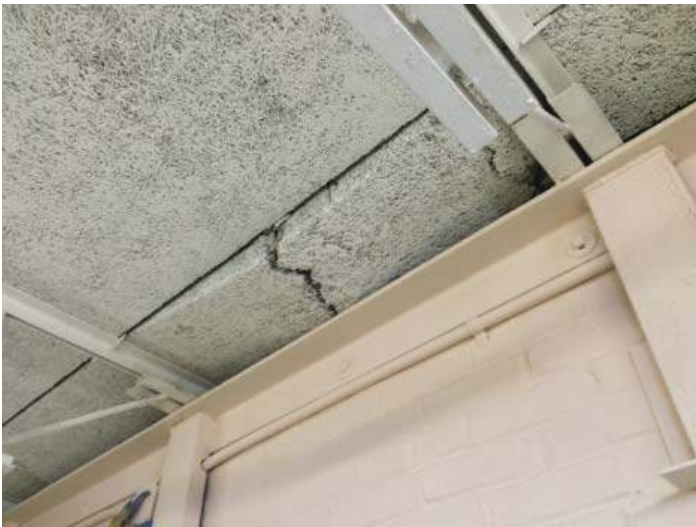
Broken tectum planks

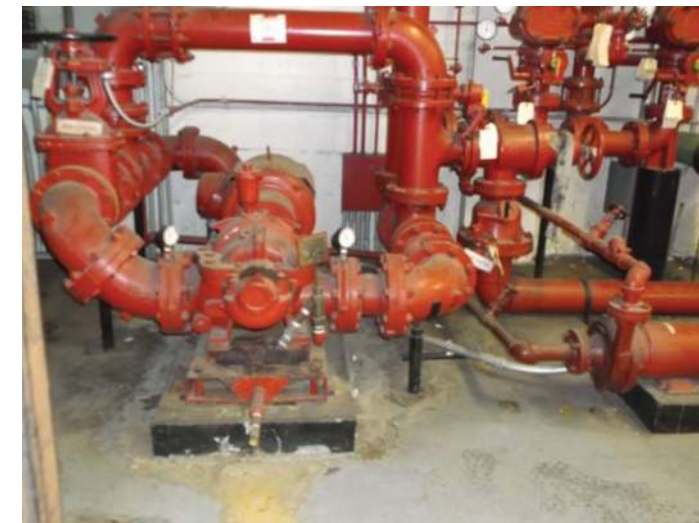
It is recommended to provide an allowance to hire a Fire Sprinkler Consultant/Designer to perform an in depth analysis of the existing system. Given the that the system is beyond the useful service life, especially the service entrance and fire pump, and that Hazard occupancies may have change thru renovations, it could require a complete redesign and a complete new NFPA 13 automatic sprinkler system installation.

Fire Sprinkler Entrance With Pump

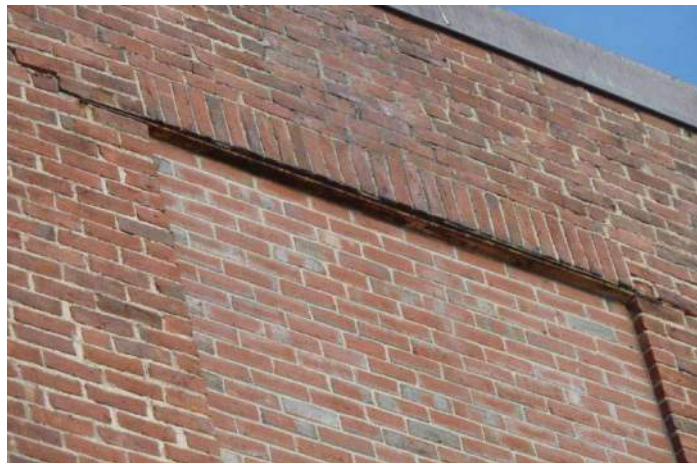
Lintel condition

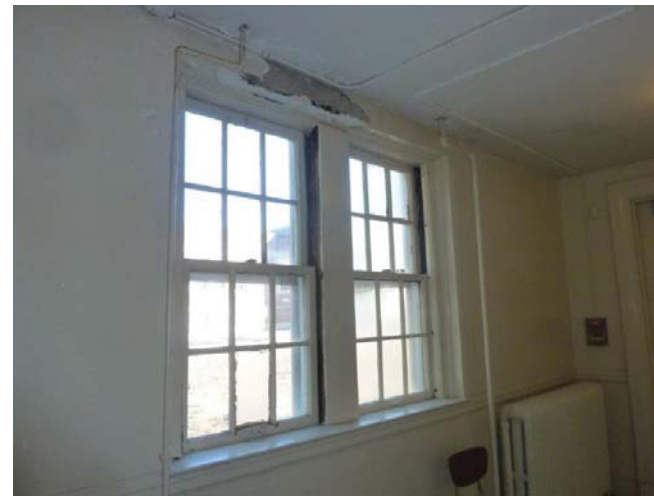
Water damage

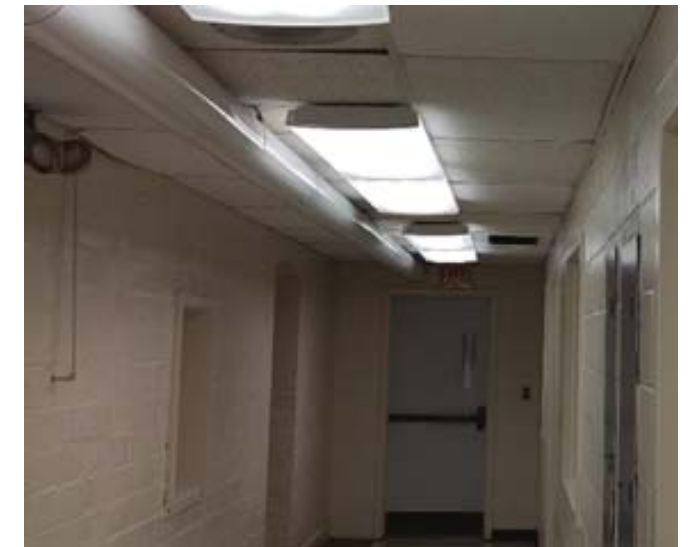
LED illuminated exit signs with integral battery backup are located appropriately for most exits, although some exits have signs that are not illuminated in the lower level fitness area. We recommend adding LED illuminated exits with integral battery backup in lower level fitness area.

*Incandescent emergency light heads and non-illuminated exit sign*

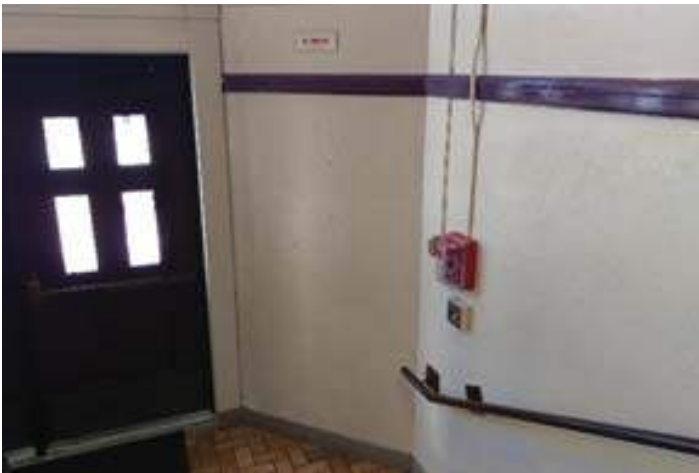
Pull station located too far from exit – a common condition in this building.

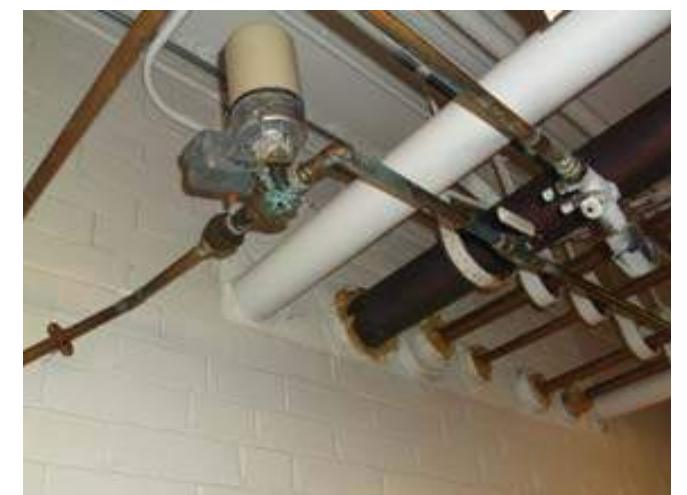
Leaking Actuator and Corroding Solder Joints

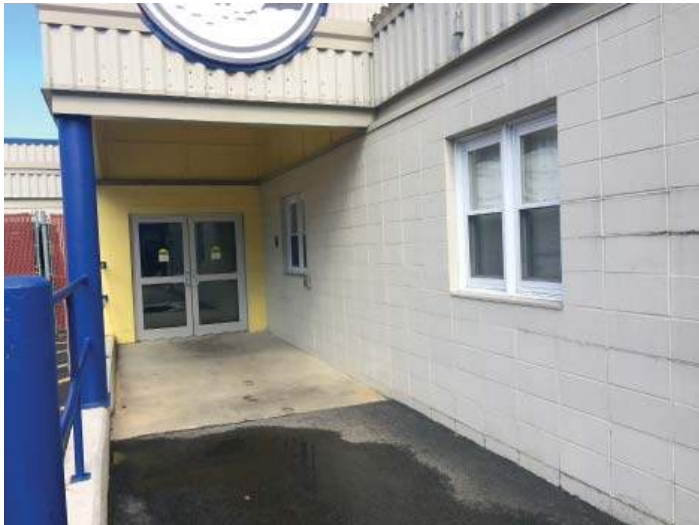
CMU joints

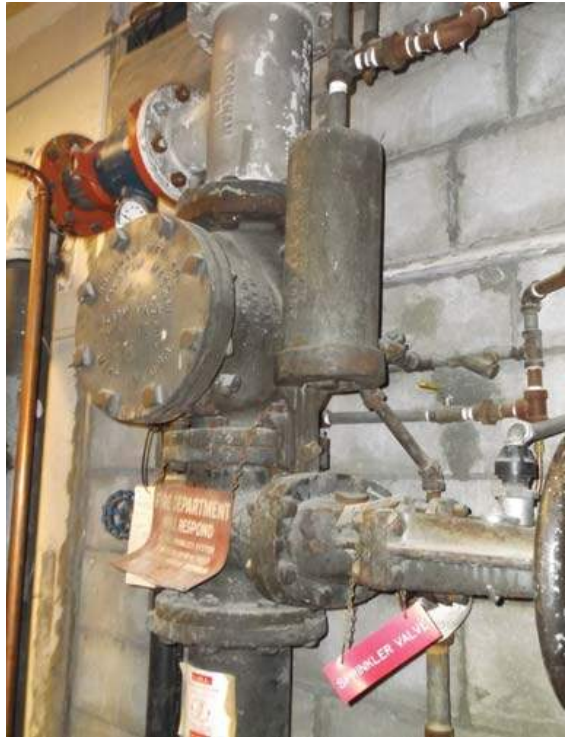
The 4" sprinkler entrance is supplied by municipal water and does not have a backflow preventer. The sprinkler system is a complete coverage automatic wet system, single 4" riser, with a 4" fire department siamese connection. The piping system appears in good condition with black steel piping serving all floors of the building. The third floor had the sprinkler heads replaced and relocated in 2013 as directed by AHJ. There is a sprinkler cabinet with wrench and spare heads.

Sprinkler Entrance

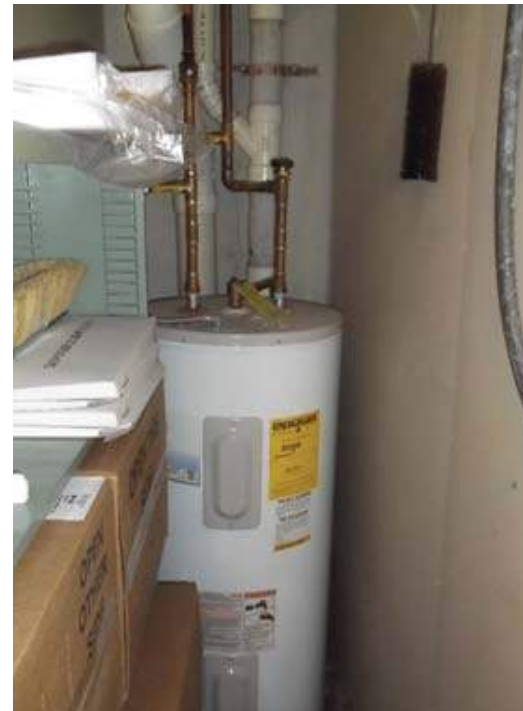
The current installed plumbing systems are mostly in good operating condition and maintained. Electric water heaters have piping in the immediate locations without insulation, this piping should be insulated to current code requirements.

Missing pipe insulation at water heater
