Facilities Assessment of School Buildings

City of Portland and Portland Public Schools

VOLUME 2
Detailed Existing Conditions Documentation
February 28, 2017

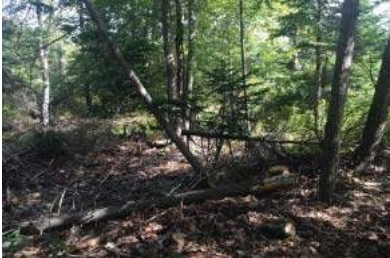
CATEGORY	DESCRIPTION AND GENERAL COMMENTS	RECOMMENDED ACTION	SEE LEGEND		
			COND. LEVEL	LIFE CYCLE	ACTION PRIORITY
Locations, Types and Densities	Number of damaged/failing trees in close proximity to building. Piles of lumber/debris. <div>

</div>	Tree removal needed. <div>

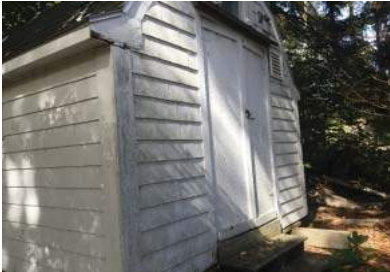
</div>	0	END	I
In-Site Renewable Energy Resources	Not Applicable				
Site Furniture & Accessories					
Types, Locations, Materials	Teacher informed that the storage shed is infested. Oil tank located at rear of building, no screening. <div>

</div>	Eradicate infestation in storage shed and repair/improve security. Add screening around oil tank. <div>

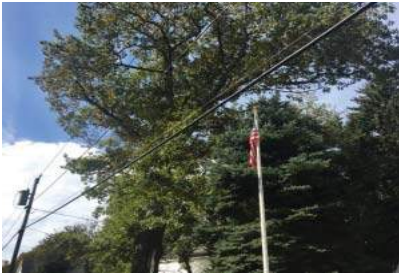
CATEGORY	DESCRIPTION AND GENERAL COMMENTS	RECOMMENDED ACTION	SEE LEGEND		
			COND. LEVEL	LIFE CYCLE	ACTION PRIORITY
Flagpoles	Proximity to OHE. <div>

</div>	Relocate flagpole away from OHE.	1	END	S
Site Drainage					
Ponding	Plugged culvert. <div>

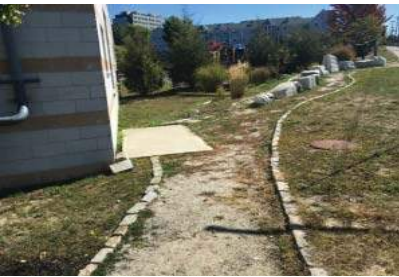
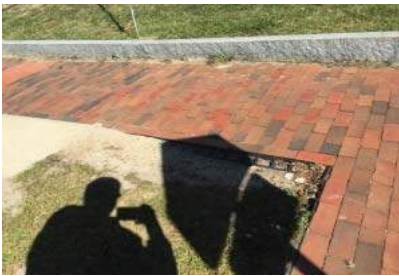
CATEGORY	DESCRIPTION AND GENERAL COMMENTS	RECOMMENDED ACTION	SEE LEGEND		
			COND. LEVEL	LIFE CYCLE	ACTION PRIORITY
Walkway Materials	Brick, Concrete, Bituminous, Gravel	Brick to be adjusted where heaved from frost. Loam and seed around visible edging (brick) and where large drop (bit.).	2	ESL	S

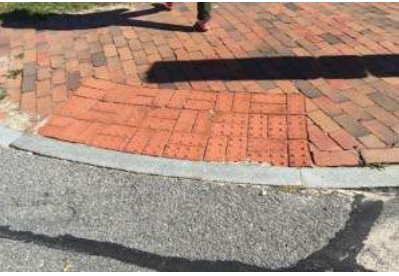
Curb Cuts & Detectable Warning Strips	Curb cut with panels at front entrance in bus loop.	Brick panels to be replaced.	1	END	I

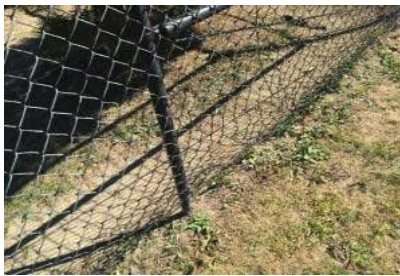
CATEGORY	DESCRIPTION AND GENERAL COMMENTS	RECOMMENDED ACTION	SEE LEGEND		
			COND. LEVEL	LIFE CYCLE	ACTION PRIORITY
Fire Department Access					
Locations	Full access around building via Streets and fire lane.	No Action Required	3	ESL	N/A
Extent of perimeter access (full, 1/2?)	Full - Gated	No Action Required	3	ESL	N/A
Service Area					
Paving Materials	Bituminous - Good	No Action Required	3	ESL	N/A
Loading Dock or Leveler	Concrete, no leveler	No Action Required	3	ESL	N/A
Trash & Recycling Containers (# & Size), Trash Compactor (size)	1- 8 yd solid, no front screen	No Action Required	3	ESL	N/A
Fencing					
Locations & Materials	Chain link, some damage

Repair damaged sections	2	ESL	I
Site Topography					
Characteristics	Rolling	No Action Required	3	ESL	N/A
Plantings, Trees and Shrubs					
Locations, Types and Densities	Good.	No Action Required	3	ESL	N/A
Courtyards & Exterior Gathering Spaces					
Locations, Materials and Characteristics	Good.	No Action Required	3	ESL	N/A

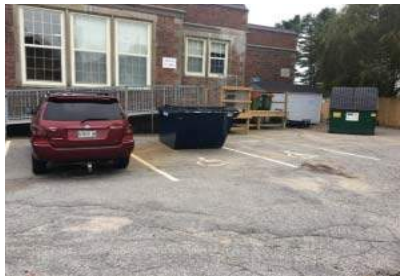
SITE							
<u>Building Entrances</u>							
Connection to accessible route and accessibility		Concrete Sidewalks on Stevens		No Action Required	3	ESL	N/A
<u>Parking</u>							
General Layout Description		The faculty parking lot is accessible via Concord Street West with one-way circulation through the lot.		No Action Required	3	ESL	N/A
Paving Materials		Bituminous Pavement in Parking Lot in Poor condition		Recommend pavement overlay.	2	END	S
Curbing Materials & Wheel Stops		None Internal		Install wheel stops where parking is adjacent to ADA ramp.	0	OB	I
Number of Spaces (Regular & ADA)		6 ADA spaces, only 2 compliant, 1 space has a dumpster in it.		Relocate dumpster. Repaint to include parking aisle(s).	2	ESL	I

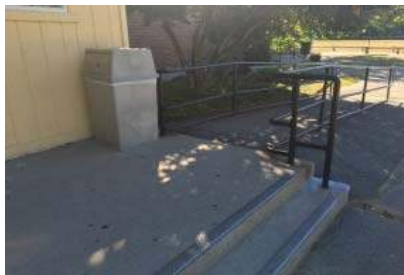
SITE					
Building Entrances					
Connection to accessible route and accessibility	Patched ADA ramp at entrance (check grades), only 1 ADA entrance. Unsecured - people using multiple entry/exit, service door propped open. <div>

</div>	Confirm ADA ramp grades at front entry. Secure entrances. <div>

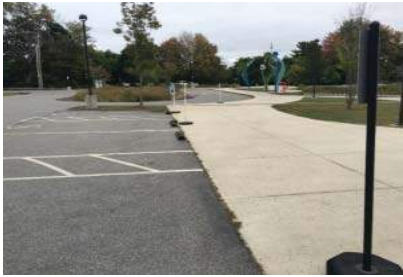
SITE					
Building Entrances					
Connection to accessible route and accessibility	Parent drop off accessible via Ocean Avenue. Bus drop off accessible via Walton Street. Through connection via mountable curb.	No Action Required	3	ESL	N/A
Parking					
General Layout Description	Observed parking in non-parking space indicating a shortage of availability.	Reconfigure parking lot to allow for more spaces.	2	ESL	I
Paving Materials	Bituminous - Good	No Action Required	3	ESL	I
Curbing Materials & Wheel Stops	1 wheel stop missing at parking, 1 needed

Replace missing wheel stop and install one additional

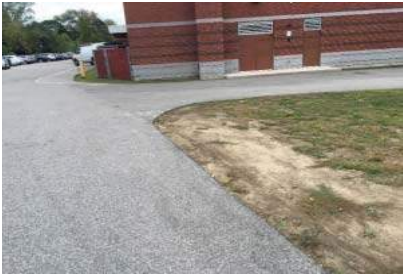
2	ESL	I
Size of Spaces	9' X 18'	No Action Required	3	ESL	N/A
Parking Striping Condition	Good	No Action Required	3	ESL	N/A
Accessible Parking Signage	Good - portable.	No Action Required	3	ESL	N/A
Vehicular Drop-Off & Pick-Up Areas					
Locations	Parent drop off loop off Ocean Ave. Bus loop off Walton Street.	No Action Required	3	ESL	N/A
Car & Bus Separations	Good	No Action Required	3	ESL	N/A
Vehicular & Pedestrian Circulation					
Traffic Markings & Traffic Signage	Good	No Action Required	3	ESL	N/A
Walkway Materials	Observed erosion due to pavement run off.

Recommend curb around entrance to playground to remediate erosion.

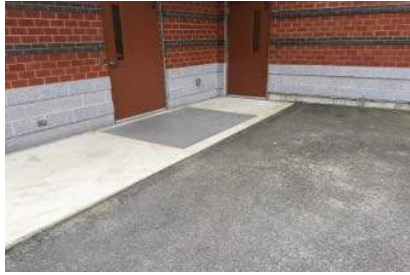
CATEGORY	DESCRIPTION AND GENERAL COMMENTS	RECOMMENDED ACTION	SEE LEGEND		
			COND. LEVEL	LIFE CYCLE	ACTION PRIORITY
Pedestrian Ramp Location & Materials	Good - lip at side entry could be better. <div>

</div>	Adjust grade of pavement/sidewalk for ramp to be flush.	2	ESL	S
DOT School Zone Markings/Signage at Street	Good	No Action Required	3	ESL	N/A
Fire Department Access					
Locations	Access to front and sides but not rear.	No Action Required	3	ESL	N/A
Extent of perimeter access (full, 1/2?)	3/4	No Action Required	3	ESL	N/A
Service Area					
Paving Materials	Bituminous - Good	No Action Required	3	ESL	N/A
Loading Dock or Leveler	None	No Action Required	0	OB	N/A
Trash & Recycling Containers (# & Size), Trash Compactor (size)	1 - 10 yd solid with screening	No Action Required	3	ESL	N/A
Fencing					
Locations & Materials	Chain link around playground - good	No Action Required	3	ESL	N/A
Site Topography

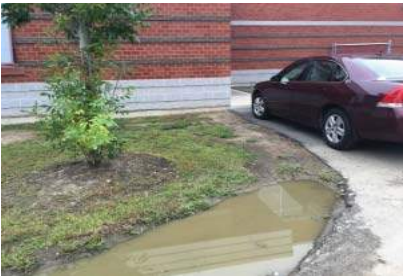
CATEGORY	DESCRIPTION AND GENERAL COMMENTS	RECOMMENDED ACTION	SEE LEGEND		
			COND. LEVEL	LIFE CYCLE	ACTION PRIORITY
Site Drainage					
Ponding	At corner of parking lot <div>

</div>	Install curbing and catch basin to mitigate ponding. <div>

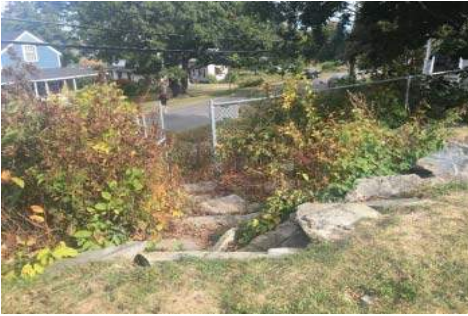
CATEGORY	DESCRIPTION AND GENERAL COMMENTS	RECOMMENDED ACTION	SEE LEGEND		
			COND. LEVEL	LIFE CYCLE	ACTION PRIORITY
Observed Circulation Patterns	Rock steps to gate with worn path.

Rail/Handrail needed. Adjust grades/provide steps.

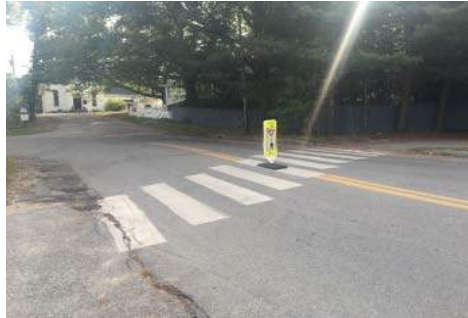
2	ESL	I
Traffic Markings & Traffic Signage	None within school grounds.	No Action Required	3	ESL	N/A
Walkway Materials	None around building.	No Action Required	3	ESL	N/A
Curb Cuts & Detectable Warning Strips	No Panels

Install panels at crosswalk.	2	ESL	I
Pedestrian Ramp Location & Materials	None - Main Entry flush entrance.	No Action Required	3	ESL	N/A
DOT School Zone Markings/Signage at Street	Limited School Zone Signs	Install additional signage.	2	ESL	I
Fire Department Access					
Locations	Full	No Action Required	3	ESL	N/A
Extent of perimeter access (full, 1/2?)	Bituminous on right to ?. Grass open area at rear. Dead tree at fire egress. Fire egress/escape onto steep/shelved grade.	Install switch back at rear for emergency ADA exit.

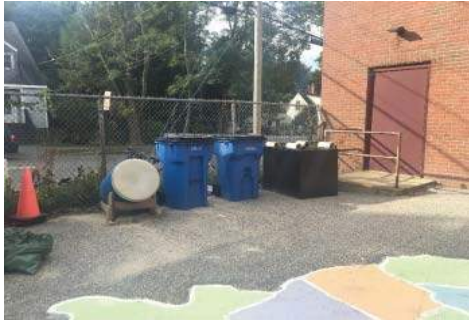
CATEGORY	DESCRIPTION AND GENERAL COMMENTS	RECOMMENDED ACTION	SEE LEGEND		
			COND. LEVEL	LIFE CYCLE	ACTION PRIORITY
Trash & Recycling Containers (# & Size), Trash Compactor (size)	Small roller recycle bins.

No Action Required	3	ESL	N/A
Fencing					
Locations & Materials	Chain link - Good	No Action Required	3	ESL	N/A
Site Topography					
Characteristics	Rocky, steep	No Action Required	3	ESL	N/A
Plantings, Trees and Shrubs					
Locations, Types and Densities	Good	No Action Required	3	ESL	N/A
Courtyards & Exterior Gathering Spaces					
Locations, Materials and Characteristics	Good	No Action Required	3	ESL	N/A
In-Site Renewable Energy Resources	Not Applicable				
Site Furniture & Accessories					
Types, Locations, Materials	No trash bin in play area (not a lot of littler).

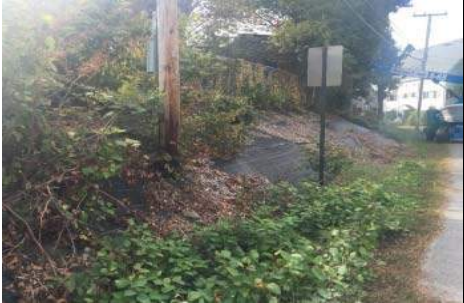
CATEGORY	DESCRIPTION AND GENERAL COMMENTS	RECOMMENDED ACTION	SEE LEGEND		
			COND. LEVEL	LIFE CYCLE	ACTION PRIORITY
Ponding	On Island Avenue - Mulch side slope with woven fabric.

Remove fabric and riprap or other stabilization. Remove knot weed.	1	END	I
Catch Basins	None	No Action Required	-	-	-
Bio-Retention Area	None	No Action Required	-	-	-
Irrigation System	None	No Action Required	-	-	-
Other Observations	Erosion at gate near basketball court , runoff from Pleasant.

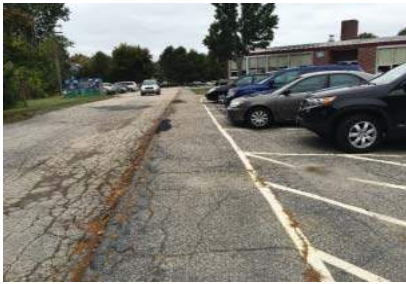
SITE					
Building Entrances					
Connection to accessible route and accessibility	Sidewalk along Presumpscot and Sherwood with internal connections.	Surfaces to be repaved and crosswalks	2	ESL	S
Parking					
General Layout Description	Pavement poor	Recommend rerouting parking and bus drop off. All pavement and sidewalks to be repaved.	1	END	S
Paving Materials	Bituminous - Poor

1	END	S
Curbing Materials & Wheel Stops	Bituminous Curb - Poor	To be replaced	1	END	S

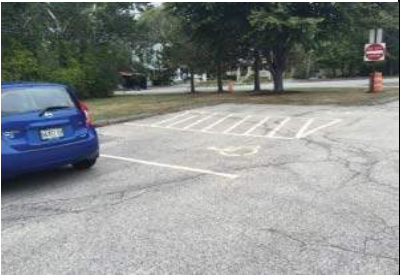
Number of Spaces (Regular & ADA)	2 ADA - adequate for number of spaces

Shift existing catch basin out of ADA stall, see catch basin notes.	3	ESL	N/A
Size of Spaces	9' X 18'	No Action Required	3	ESL	-
Parking Striping Condition	Poor	To be painted w/ pavement replacement.	1	END	S
Accessible Parking Signage	No Signage	Install Signs	0	OB	I
Vehicular Drop-Off & Pick-Up Areas					
Locations	Parent loop in front, bus loop on side. Children have to cross in front of buses to get to school.	Bus loop could be reconfigured drop and pick up closer to the front entrance.	2	ESL	S
Car & Bus Separations	Adequate Separation	No Action Required	2	ESL	-
Vehicular & Pedestrian Circulation					
Observed Circulation Patterns	Observed, pedestrian walking dog on school ground.	Install school zone & limited public access signage.	0	OS	I
Traffic Markings & Traffic Signage	Lacking one way signage and delineation of parent/bus parking.	Install signage.	0	OS	I

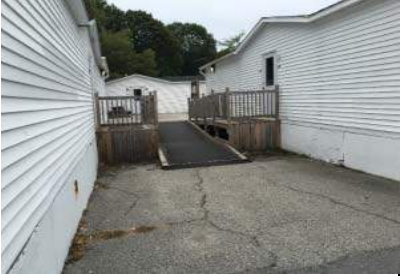
Walkway Materials	Bituminous - Poor	To be replaced	1	END	I
Curb Cuts & Detectable Warning Strips	No Panels	Install panels.	1	OS	I
Pedestrian Ramp Location & Materials	Front ramp at parent drop off, not ADA compliant, no panel. Shared ADA ramp for 3 modular in back - good.

Front ramp at parent drop off to be replaced. Additional ramps to be installed at front entrance loop.

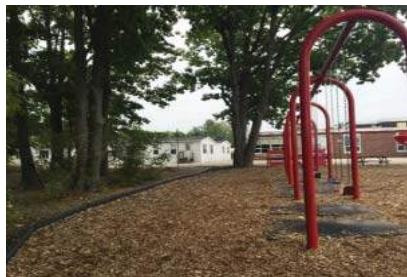
CATEGORY	DESCRIPTION AND GENERAL COMMENTS	RECOMMENDED ACTION	SEE LEGEND			
			COND. LEVEL	LIFE CYCLE	ACTION PRIORITY	
	DOT School Zone Markings/Signage at Street	Flashing School Zone Signage.	Signage needed.	3	ESL	S
Fire Department Access						
Locations	Could be full 100% if open curb on left side "exit".	Add curb cut and fire lane on north side of school and shift modulars.	3	ESL		L
Extent of perimeter access (full, 1/2?)	3/4	No Action Required	-	-		-
Service Area						
Paving Materials	Bituminous - Poor	To be replaced.	1	END		I
Loading Dock or Leveler	None	No Action Required	-	-		-
Trash & Recycling Containers (# & Size), Trash Compactor (size)	1- 10 yd. solid, no screening	Add screening.	2	ESL		S
Fencing						
Locations & Materials	North face, chain link, solid but dated/rusty, gap at north side	Repair damaged sections	2	ESL		S
Site Topography						
Characteristics	Mulch barrier introduces trip hazard.

1	END		I

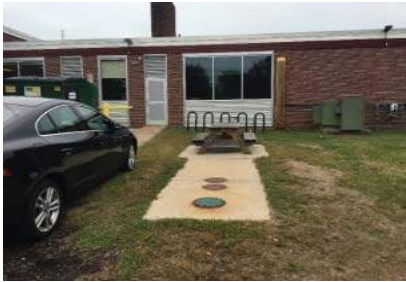
CATEGORY	DESCRIPTION AND GENERAL COMMENTS	RECOMMENDED ACTION	SEE LEGEND		
			COND. LEVEL	LIFE CYCLE	ACTION PRIORITY
Bicycle Racks	2- 1 at south side at loading area, 1 at north side.

Recommend relocation of bike racks.

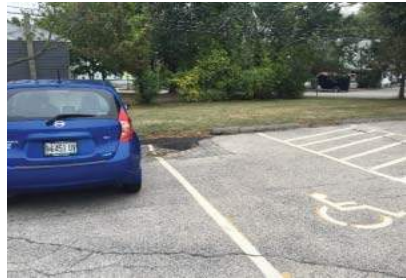
2	ESL	S
Flagpoles	1 at front - Good	No Action Required	3	ESL	-
Site Drainage					
Ponding	None Observed	No Action Required	-	-	-
Catch Basins	Catch basin located in ADA space.

Move catch basin out of ADA stall.	2	ESL	S
Bio-Retention Area	None	No Action Required	-	-	-
Irrigation System	None	No Action Required	-	-	-
Exterior Building Signage					
Location and Materials	Yes	No Action Required	3	ESL	-

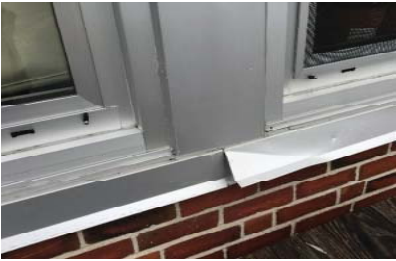
BUILDING EXTERIOR					
Exterior Wall Cladding					
Materials	Clay brick veneer, painted metal siding above windows	No Action Required	3	ESL	-
Spalling, Staining, Efflorescence	Non observed	No Action Required	-	-	-
Weeps	None installed in a building of this vintage	No Action Required	-	-	-
Windows					
Frame Materials	Thermally broken aluminum storefront windows appear to have been recently replaced	No Action Required	3	ESL	-
Glazing Type and Color	Clear, insulated glass units	No Action Required	3	ESL	-
Operable Sash Type and Sash Hardware	Inward folding awning type	No Action Required	3	ESL	-
Storm Windows and Insect Screens	Yes - insect screens	No Action Required	3	ESL	-
Sills	Aluminum flashing as part of storefront systems; some splice joints have separated posing a safety hazard	Repair flashing splice joints with mechanical fasteners	2	ESL	I

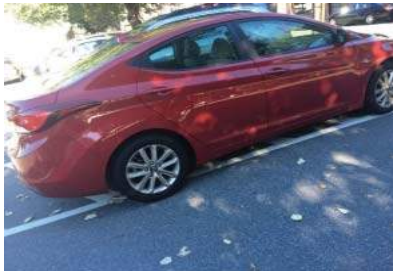
SITE					
Building Entrances					
Connection to accessible route and accessibility	Observed staff proposing open loading door and smoking in vehicle on school premises. Steep grades sloping towards school entrance, not ADA compliant.	Grading adjustment needed at front entrance.	2	ESL	I
Parking					
General Layout Description	Vehicle parked in striped space not for parking. Vehicles parked in loading zone.

Parking enforcement needed.	2	ESL	I
Paving Materials	Bituminous - Good	No Action Required	3	ESL	N/A
Curbing Materials & Wheel Stops	Granite - Good	No Action Required	3	ESL	N/A

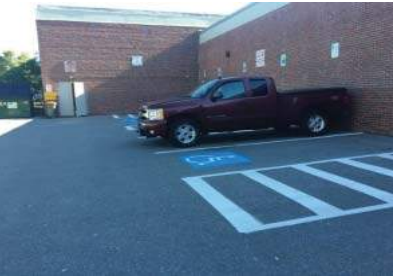
SEE LEGEND		
CATEGORY	DESCRIPTION AND GENERAL COMMENTS	RECOMMENDED ACTION	COND. LEVEL	LIFE CYCLE	ACTION PRIORITY
Number of Spaces (Regular & ADA)	No ADA parking in Brackett Street lot. 4 ADA in community/pool lot.

At least one ADA space is needed in the faculty parking lot.	2	ESL	I
Size of Spaces	9' X 18' Good	No Action Required	3	ESL	N/A
Parking Striping Condition	Good	No Action Required	3	ESL	N/A
Accessible Parking Signage	Good - 1 per space.	No Action Required	3	ESL	N/A
Vehicular Drop-Off & Pick-Up Areas					
Locations	Parents drop off on street, no designation. Bus drop off in loop.

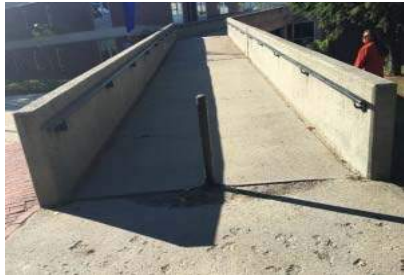
Pedestrian Ramp Location & Materials	Ramp at front in rough shape, not compliant, not structurally sound. The space underneath the ramp behind the planting bed provides a concern for hiding predators or an active shooter situation.

Ramp needs replacement.

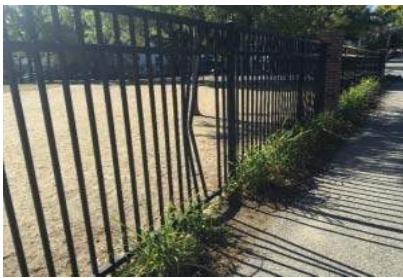
3	ESL	N/A
Trash & Recycling Containers (# & Size), Trash Compactor (size)	1 - 10 yd solid, Screened.	No Action Required	3	ESL	N/A
Fencing					
Locations & Materials	Decorative fence around site, some repairs needed.

Repair fence as needed.	2	ESL	I
Site Topography					
Characteristics	Relatively Flat	No Action Required	3	ESL	N/A
Plantings, Trees and Shrubs					
Locations, Types and Densities	Mulch barrier introduces trip hazard.

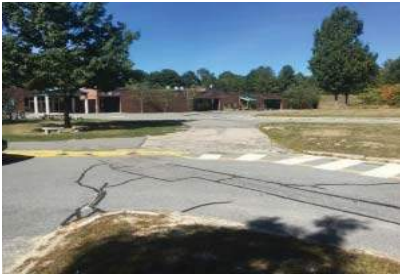
SITE					
Building Entrances					
Connection to accessible route and accessibility	Signalized Entrance/Exit, ADA at Building OK, Doors At-Grade, Speed Table dumps into bus access loop	Relocate speed table further back from access loop entrance.	2	ESL	S
Parking					
General Layout Description	Public Library/Community Center Attached	No Action Required	3	ESL	N/A
Paving Materials	Bituminous - Poor	Overlay needed.	2	ESL	S

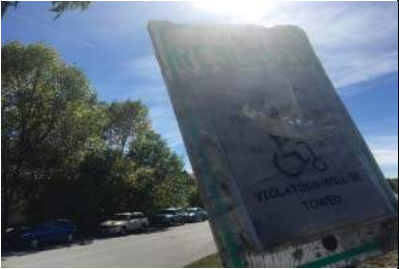
Accessible Parking Signage	Not compliant (only 2 signs), one in poor condition.

Install/replace signs such that each ADA space is signed.	0	OB	I
Vehicular Drop-Off & Pick-Up Areas					
Locations	Bus loop ok, surface needs attention, poor signage

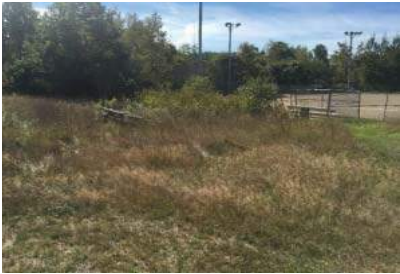
Trash & Recycling Containers (# & Size), Trash Compactor (size)	2-10 yd solid, 1-6yd recycle, no screening	Install screening.	2	ESL	I
Fencing					
Locations & Materials	Chain link fencing at baseball diamond adjacent to tennis courts failing (dilapidated bleachers in this area to be removed)

Replace fencing at rear baseball diamond. Remove bleachers.	2	ESL	S
Site Topography					
Characteristics	Play areas level, landscaping hills throughout (possible security issue, recommended 2-ft max height)	The landscape hills should be reduced to a maximum height of 2' as the provide cover for an active shooter.	2	ESL	I
Plantings, Trees and Shrubs					
Locations, Types and Densities	Good	No Action Required	3	ESL	N/A

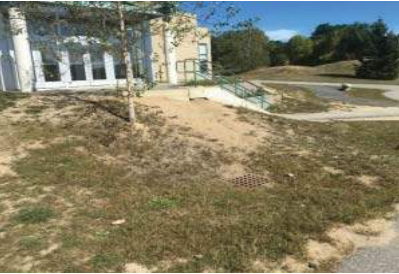
CATEGORY	DESCRIPTION AND GENERAL COMMENTS	RECOMMENDED ACTION	SEE LEGEND		
			COND. LEVEL	LIFE CYCLE	ACTION PRIORITY
Courtyards & Exterior Gathering Spaces					
Locations, Materials and Characteristics	Cracking with grass observed at tennis courts. Direct wear path at stairs at Community Center.

Repair cracking at tennis courts. Recommend continuation of retaining wall	2	ESL	I
In-Site Renewable Energy Resources	Not Applicable				
Site Furniture & Accessories					
Types, Locations, Materials	Front of school: granite benches good, no trash cans Community Center: granite benches good (1 tipped backwards), wood benches at rear in need of repair, 1 trash/recycle

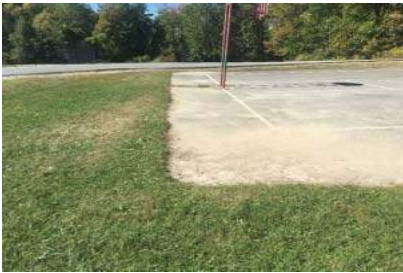
CATEGORY	DESCRIPTION AND GENERAL COMMENTS	RECOMMENDED ACTION	SEE LEGEND		
			COND. LEVEL	LIFE CYCLE	ACTION PRIORITY
Ponding	Ponding in corner of basketball court

Install catch basin or regrade to eliminate ponding.	2	ESL	I
Catch Basins	Basin at drop off loop has filter fabric.

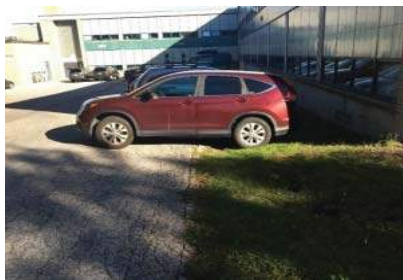
Zoning Designation:	R5 Residential/ROS Recreational Open Space/B2 Business Community				
SITE					
Building Entrances					
Connection to accessible route and accessibility	Brick sidewalk on Deering with ADA panels (one missing).	Install detectible warning panel.	2	ESL	I
Parking					
General Layout Description	Observed parking in non-parking areas

Additional parking needed.	2	ESL	S
Paving Materials	Bituminous - faculty lot poor

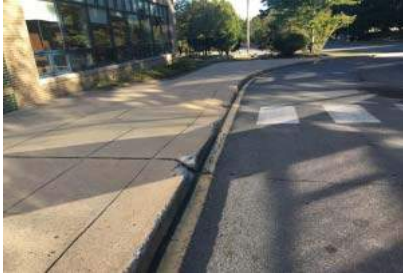
Needs repair.	2	ESL	I

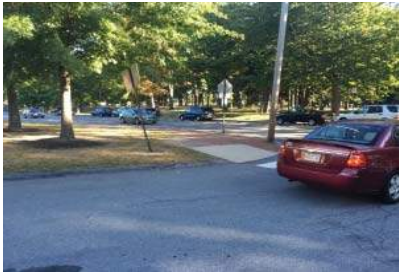
SEE LEGEND		
CATEGORY	DESCRIPTION AND GENERAL COMMENTS	RECOMMENDED ACTION	COND. LEVEL	LIFE CYCLE	ACTION PRIORITY
Curb Cuts & Detectable Warning Strips	No panels at bus loop, panels needed where missing along street sidewalks.	Need panel and crossing at park aisle. Panel needed at crossing to Deering Oaks.	2	ESL	I

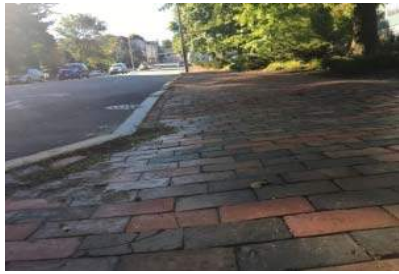
Pedestrian Ramp Location & Materials	Concrete ramp at bus loop - poor condition. Brick ramp in need of repair.	Concrete in need of repair at bus loop ramp. Brick sidewalk repair at brick ramp. Need panel and crossing at park aisle. Panel needed at crossing to Deering Oaks.	2	END	I

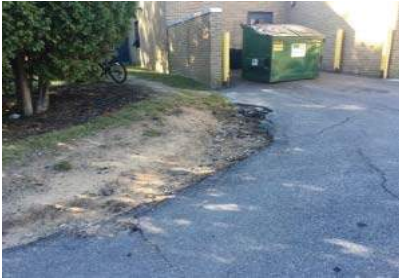
SEE LEGEND		
CATEGORY	DESCRIPTION AND GENERAL COMMENTS	RECOMMENDED ACTION	COND. LEVEL	LIFE CYCLE	ACTION PRIORITY
Courtyards & Exterior Gathering Spaces					
Locations, Materials and Characteristics	Good	No Action Required	3	ESL	N/A
In-Site Renewable Energy Resources	Not Applicable				
Site Furniture & Accessories					
Types, Locations, Materials	Stone benches at front	Pedestrian trash bins needed.	3	ESL	S
Bicycle Racks	4 - not maxed at entrance.	No Action Required	3	ESL	N/A
Flagpoles	Front - Good	No Action Required	3	ESL	N/A
Site Drainage					
Ponding	Erosion	Add curbing at dumpster - erosive flows.	2	ESL	S

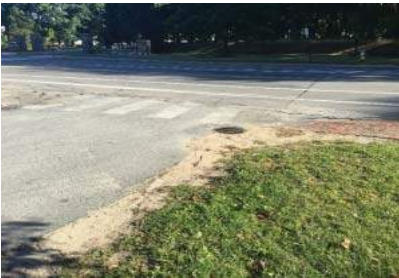
Catch Basins	Observed debris.	Add field inlet at front seating. Clean field inlet basin at (Fitz?)/Deering. Recommend beehive cover in grass.	2	ESL	I

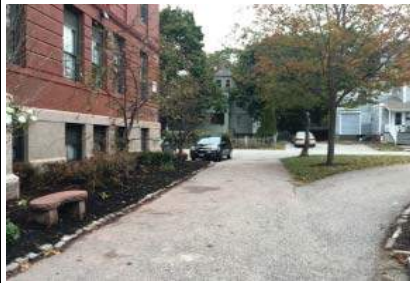
SITE					
Building Entrances					
Connection to accessible route and accessibility	Sidewalks all around. 9" Granite Steps at front entrance.	No Action Required	3	ESL	N/A
Parking					
General Layout Description					
Paving Materials	Bituminous - Fair	No Action Required	2	ESL	L
Curbing Materials & Wheel Stops	No wheel stops	Wheel stop/Pedestrian guard needed.	2	ESL	I

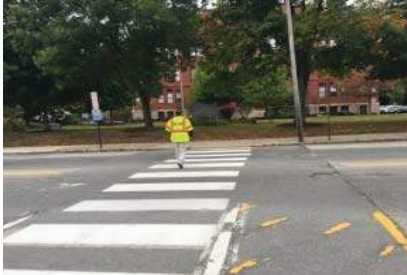
SEE LEGEND		
CATEGORY	DESCRIPTION AND GENERAL COMMENTS	RECOMMENDED ACTION	COND. LEVEL	LIFE CYCLE	ACTION PRIORITY
Size of Spaces	9' X 17', 8'8" X 17'	No Action Required	3	ESL	N/A
Parking Striping Condition	Good, minimal cracks	No Action Required	3	ESL	N/A
Accessible Parking Signage					
Vehicular Drop-Off & Pick-Up Areas					
Locations	Parents - Front. Buses - Rear	No Action Required	3	ESL	N/A
Car & Bus Separations	Good	No Action Required	3	ESL	N/A
Vehicular & Pedestrian Circulation					
Observed Circulation Patterns					
Traffic Markings & Traffic Signage	No Fire Lane Signs	Install fire lane/no parking signs	0	OS	I
Walkway Materials	Bituminous - Fair	No Action Required	2	ESL	L
Curb Cuts & Detectable Warning Strips	No panels

Install panels at crosswalk.	0	OS	I
Pedestrian Ramp Location & Materials	2 ADA access (none at front), flush entrance at rear and at side

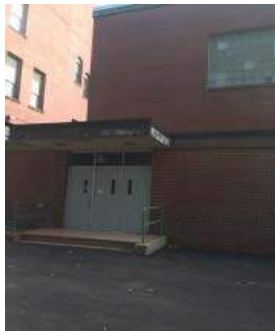
SEE LEGEND		
CATEGORY	DESCRIPTION AND GENERAL COMMENTS	RECOMMENDED ACTION	COND. LEVEL	LIFE CYCLE	ACTION PRIORITY
Exterior Wall Construction	F. North entry: large canopy shows damage on the underside.

Verify damage is not structural. Repair

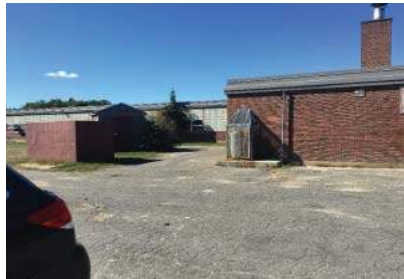
Total Site Area (Acres):	25.1178 (Lyseth & Moore same parcel)				
Zoning Designation:	R2 Residential/ROS Recreation Open Space				
SITE					
Building Entrances					
Connection to accessible route and accessibility	Signalized Entrance. 5' bituminous sidewalk around building	No Action Required	3	ESL	N/A
Parking					
Paving Materials	Bituminous - pavement at parking in front of building good. Pavement along primary route and parking lot side of building- Poor

Mill and repave primary route and parking lot at side of building.

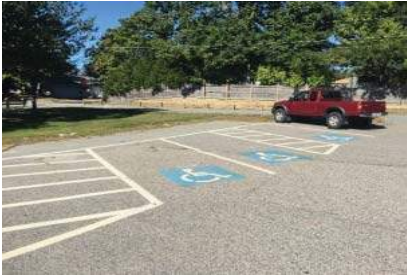
SEE LEGEND		
CATEGORY	DESCRIPTION AND GENERAL COMMENTS	RECOMMENDED ACTION	COND. LEVEL	LIFE CYCLE	ACTION PRIORITY
Number of Spaces (Regular & ADA)	4 ADA, only 1 sign, non compliant grades, no van accessible parking

Adjust parking grades to be less than 2% within ADA parking. Repaint to include van accessible aisle.	1	END	I
Size of Spaces	9' X 18'	No Action Required	3	ESL	N/A
Parking Striping Condition	Good, White/ Faint Arrows	Repaint arrows around access loop.	2	ESL	I
Accessible Parking Signage	Only 1 sign	Install 1 ADA sign per space.	2	ESL	I
Vehicular Drop-Off & Pick-Up Areas					
Locations	No separation	Further investigate and study: Paint and/or install curbing and signage to better define and separate bus and parent drop off locations.	2	ESL	I
Car & Bus Separations	No strong delineation from cars and buses, only 1 sign				
Vehicular & Pedestrian Circulation					
Observed Circulation Patterns	Wood guardrail along sidewalk to delineate drop off and pedestrian walk.	No Action Required	3	ESL	N/A

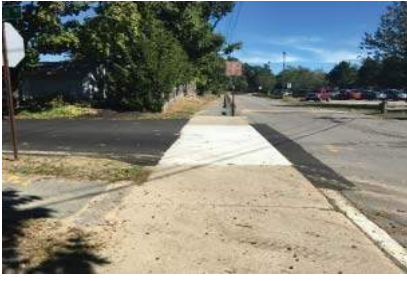
Traffic Markings & Traffic Signage	Need better signage for no parking spaces	Install no parking signs	2	ESL	I
Walkway Materials	Bituminous, walk along east side in poor condition	Replace walkway on east side of building.	2	ESL	I
Curb Cuts & Detectable Warning Strips	No panels on site

Install detectible warning panels at crosswalks.	0	OS	I

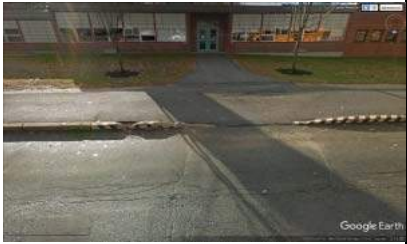
CATEGORY	DESCRIPTION AND GENERAL COMMENTS	RECOMMENDED ACTION	SEE LEGEND		
			COND. LEVEL	LIFE CYCLE	ACTION PRIORITY
Pedestrian Ramp Location & Materials	Bituminous and concrete - Fair

Adjust transitions to 1/4" or less where applicable.	2	ESL	I
DOT School Zone Markings/Signage at Street	Good	No Action Required	3	ESL	N/A
Fire Department Access					
Locations	Front and Rear only, no side (near Brook Road)	No Action Required	3	ESL	N/A
Extent of perimeter access (full, 1/2?)	1/2 (front) Double gate at Brook Road	No Action Required	3	ESL	N/A
Service Area					
Paving Materials	Bituminous with concrete dock.

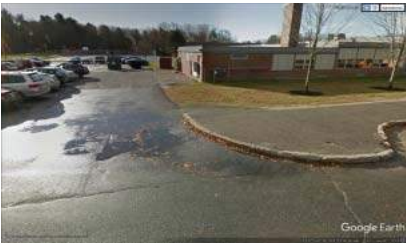
CATEGORY	DESCRIPTION AND GENERAL COMMENTS	RECOMMENDED ACTION	SEE LEGEND		
			COND. LEVEL	LIFE CYCLE	ACTION PRIORITY
Locations, Materials and Characteristics	Wood seating with granite backs at loading near pond.	No Action Required	3	ESL	N/A
In-Site Renewable Energy Resources	Not Applicable				
Site Furniture & Accessories					
Types, Locations, Materials	Propane @ loading	Make fence more secure	2	ESL	I
Bicycle Racks	2 - 1 front, 1 back	No Action Required	3	ESL	N/A
Flagpoles	1 - by pond - Good	No Action Required	3	ESL	N/A
Site Drainage					
Ponding	Evidence of ponding at side parking lot.

Install catch basin or adjust grade to drain.	2	ESL	S
Catch Basins	Limited	No Action Required	3	ESL	N/A
Bio-Retention Area	Gravel wetland with black chain link fence

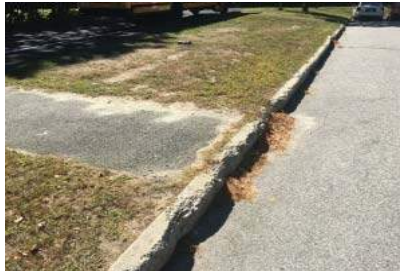
SITE					
Parking					
General Layout Description	Observed a need for pedestrian safe passage in lot. Observed students parking in limited parking. ADA spaces don't have passage. Observed low lying OHE along East side of site. Observed parents parking in bus drop-off. No lighting.	Paint crosswalks and install signs in parking lot. Relocate/raise OHE. Install lighting in parking lot.	2	ESL	I
Paving Materials	Bituminous Asphalt - Poor in parking areas, at loading docks and along east access roadway.	Mill and overlay bituminous in poor condition.	2	END	I
Curbing Materials & Wheel Stops	Concrete curb poor condition at parking lot, no wheel stops at door to school maintenance,

Replace/repair curb where needed. Install wheel stops at parking adjacent to building near maintenance entrance.	2	ESL	S

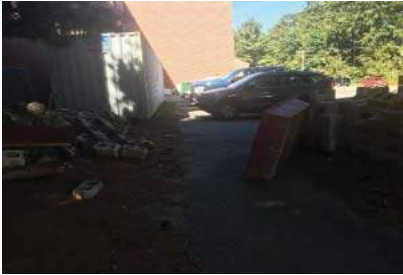
CATEGORY	DESCRIPTION AND GENERAL COMMENTS	RECOMMENDED ACTION	SEE LEGEND		
			COND. LEVEL	LIFE CYCLE	ACTION PRIORITY
Number of Spaces (Regular & ADA)	2 front - 9' aisle, paint & stop 2 front signed, no paint 1 signed& paint	Paint ADA spaces as needed. Maintenance area could use defined parking area.	2	ESL	I
Size of Spaces	9' X 18'	No Action Required	3	ESL	N/A
Parking Striping Condition	Good, White	No Action Required	3	ESL	N/A
Accessible Parking Signage	Sign on each	No Action Required	3	ESL	N/A
Vehicular Drop-Off & Pick-Up Areas					
Locations	Front	No Action Required	3	ESL	N/A
Car & Bus Separations	Good, bus only loop, ADA ramp not compliant	No Action Required	3	ESL	N/A
Vehicular & Pedestrian Circulation					
Observed Circulation Patterns	Good - observed students entering parking lot fast. Observed material storage intruding walkway.

Recommend defined material storage with screening.	0	OB	I
Traffic Markings & Traffic Signage	Good	No Action Required	3	ESL	N/A

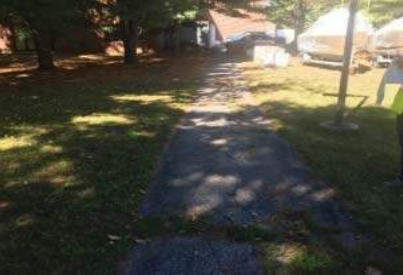
Walkway Materials	Concrete - Good, Bituminous - poor at front

Overlay walks around front of school.	2	ESL	S

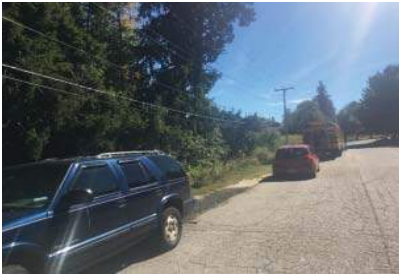
Pedestrian Ramp Location & Materials	Ramp at bus loop not ADA compliant.	Adjust grades to allowable ADA slopes.	2	ESL	I
DOT School Zone Markings/Signage at Street	No School Zone signs on Allen Avenue.	Install School Zone signs on Allen Avenue	0	OB	I
Fire Department Access					
Locations	Access around sides and back. No front access.	No Action Required	3	ESL	N/A
Extent of perimeter access (full, 1/2?)	3/4	No Action Required	3	ESL	N/A
Service Area					
Paving Materials	Poor pavement at drive to maintenance/loading area. Curb and Drainage recommended	Replace pavement drive to maintenance area. Install curbing and catch basins.	2	ESL	I

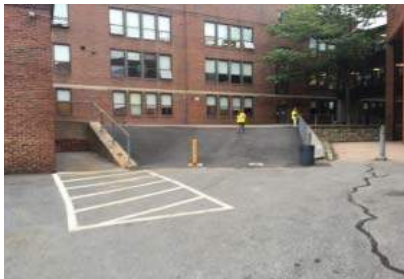
SITE					
Building Entrances					
Connection to accessible route and accessibility	No primary access for ADA. Unsecured doors/entry				
Parking					
General Layout Description	Observed parking enforcement walking lot. Linear at back. Bollards to be replaced. Observed parking in fire lane

Replace bollards.

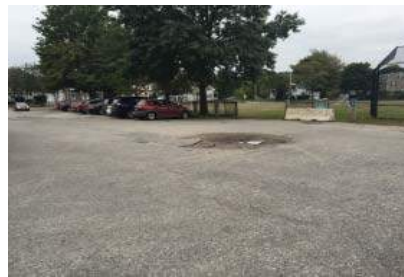
1	END	I
Paving Materials	Bituminous. Parking lot of Ludlow Street, Poor. Permit parking signs outside of paved lot.

Mill and repave parking lot off Ludlow Street. Pave permit parking spaces.

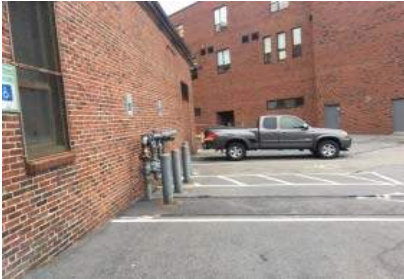
SEE LEGEND		
CATEGORY	DESCRIPTION AND GENERAL COMMENTS	RECOMMENDED ACTION	COND. LEVEL	LIFE CYCLE	ACTION PRIORITY
Curbing Materials & Wheel Stops	None

Install wheel stops in staff lot at building and along grassed/sidewalk at faculty/student parking in rear.

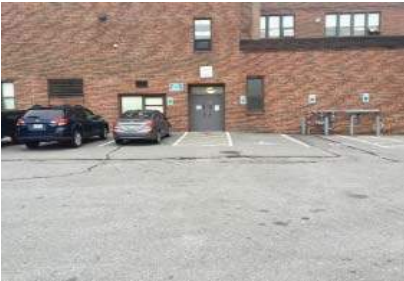
0	OS	S
Number of Spaces (Regular & ADA)	5 at faculty parking, not compliant 1 at Ludlow Street lot no aisle, not compliant

Update grade, signage, striping, accessible route, etc. to bring spaces into compliance.

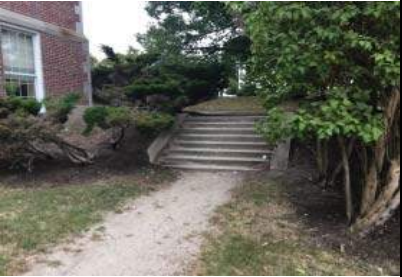
CATEGORY	DESCRIPTION AND GENERAL COMMENTS	RECOMMENDED ACTION	SEE LEGEND		
			COND. LEVEL	LIFE CYCLE	ACTION PRIORITY
Observed Circulation Patterns	Worn path along south side of building.

Consider installing sidewalk.

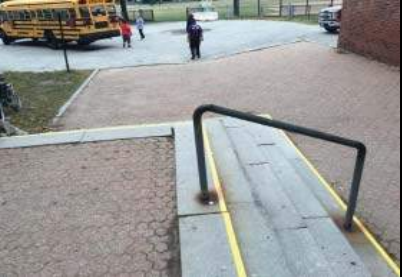
2	END	S
Traffic Markings & Traffic Signage					
Walkway Materials	Brick, Pavers, Concrete as noted on plans. Faculty/Student parking does not have connectors to sidewalk. Observed Peds using drive aisle as opposed to sidewalk. Brick sidewalk in front of school, south of the circle in poor condition.

Handrails needed at stairwell nearest the Ludlow Street parking. Brick sidewalk in front of school, south of the circle needs replacement.

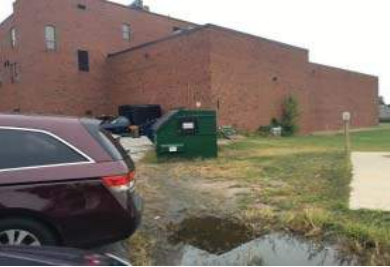
CATEGORY	DESCRIPTION AND GENERAL COMMENTS	RECOMMENDED ACTION	SEE LEGEND		
			COND. LEVEL	LIFE CYCLE	ACTION PRIORITY
Trash & Recycling Containers (# & Size), Trash Compactor (size)	2- 10 yd solid. 1- 6 yd recycle. No screening.

Screening needed. Recommend swapping dumpster and recycle area with facility maintenance vehicle parking.	3	ESL	S
Fencing					
Locations & Materials	Black chain link fence around athletic fields, Good.	No Action Required.	3	ESL	N/A
Site Topography					
Characteristics	Relatively flat.	No Action Required.	3	ESL	N/A
Plantings, Trees and Shrubs					
Locations, Types and Densities	Good	No Action Required.	3	ESL	N/A
Courtyards & Exterior Gathering Spaces					
Locations, Materials and Characteristics	Bare area between Deering HS and Longfellow ES.

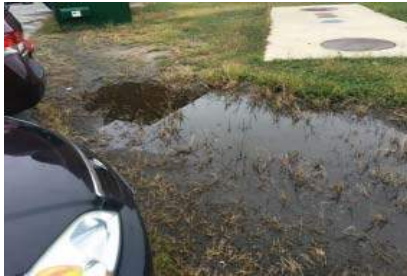
SEE LEGEND		
CATEGORY	DESCRIPTION AND GENERAL COMMENTS	RECOMMENDED ACTION	COND. LEVEL	LIFE CYCLE	ACTION PRIORITY
Ponding	Various, Ponding at dumpsters

Install catch basin and connect to existing drainage.	1	OB	S
Catch Basins	Sags at basins within parking.

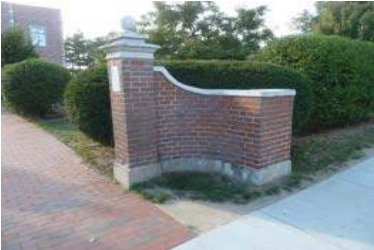
CATEGORY	DESCRIPTION AND GENERAL COMMENTS	RECOMMENDED ACTION	SEE LEGEND		
			COND. LEVEL	LIFE CYCLE	ACTION PRIORITY
	Site Feature: Entry features at street (brick walls on concrete foundations spalls, crack and effervescent observed in the brick).

Repair brick	2	END	S
	Site Feature: Concrete site walls and stairs: cracks and spalls observed in discrete locations, some exposing reinforcement. Additional spoils noted at base of post	Coat reinforcement with protective coating and path concrete	2	END	S

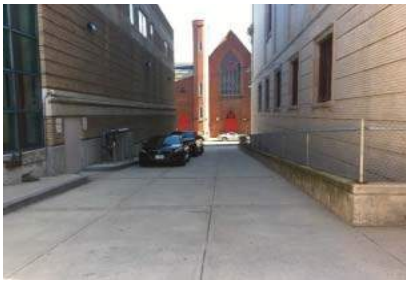
SITE					
Building Entrances					
Connection to accessible route and accessibility	Main entrance is not accessible due to monumental stair case	Provide elevator addition at main entry of the building	-	-	S
Parking					
General Layout Description	Staff parking in garage. Pedestrian circulation conflict behind the Church with vehicular parking.

Delineate pedestrian walk and parking along alley.			
Paving Materials	No on site parking	No Action Required	3	ESL	N/A
Curbing Materials & Wheel Stops	Granite - Good, Concrete - Poor

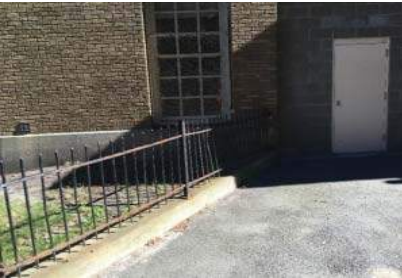
CATEGORY	DESCRIPTION AND GENERAL COMMENTS	RECOMMENDED ACTION	SEE LEGEND		
			COND. LEVEL	LIFE CYCLE	ACTION PRIORITY
Locations & Materials	Metal - Poor/damaged

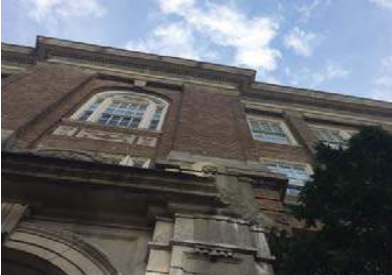
SEE LEGEND		
CATEGORY	DESCRIPTION AND GENERAL COMMENTS	RECOMMENDED ACTION	COND. LEVEL	LIFE CYCLE	ACTION PRIORITY
Foundations / Drainage	D. Entry cast stone spalled and effloresced.

Replace cast stone elements and provide appropriate flashing.	2	OB	I
Foundations / Drainage	E. Elevated pediment at newer south entry constructed of cast stone' stones appear to be separating.

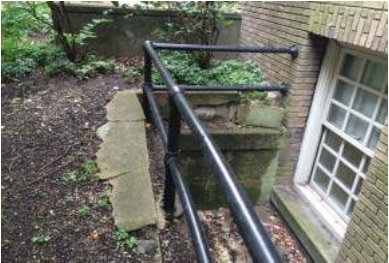
SEE LEGEND		
CATEGORY	DESCRIPTION AND GENERAL COMMENTS	RECOMMENDED ACTION	COND. LEVEL	LIFE CYCLE	ACTION PRIORITY
Foundations / Drainage	H. Areaway at connector in poor condition with displaced stone surround.

Replace with new anchored stones or concrete	2	END	I
First Floor Construction	Presumed terra cotta floors with steel or iron beams; perhaps wood frame at central spine; not accessible for review because of plaster ceiling. Extensive terrazzo cracking previously repaired. Not believed to be a structural issue	No Action Required	3	ESL	-
Second Floor Construction	Presumed terra cotta floors with steel or iron beams; perhaps wood frame at central spine; not accessible for review because of plaster ceiling. Extensive terrazzo cracking previously repaired. Not believed to be a structural issue	No Action Required	3	ESL	-
Roof Construction	Terracotta flat arch floors spanning to steel or iron beams. Riveted steel or iron trusses noted in some locations in attic. At center spine, steel or iron girders with timber filler beams & wood decking. Evidence of prior fire. Repaired roof decking locations at wood roof area. Steel reinforcing noted in attic likely from 80's/90/s renovation Overall condition good. Specific conditions identified below	No Action Required	3	ESL	-

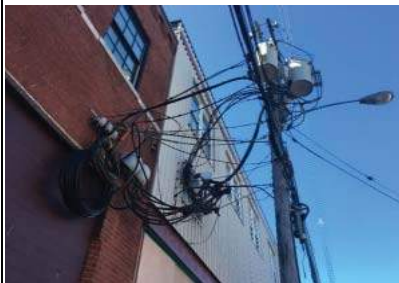
SITE					
Building Entrances					
Connection to accessible route and accessibility	Sidewalks. Thresholds at Community Center do not meet tolerances. Utility pole hazard

Adjust ramp and/or threshold transition to meet ADA tolerances. Remove any unnecessary wiring/move/add protection at utility pole.	1	ESL	I
Parking					
General Layout Description	Parking lot at District Office/on street parking/parking garage.	No Action Required	3	ESL	N/A
Paving Materials	Bituminous - Fair	No Action Required	3	ESL	N/A

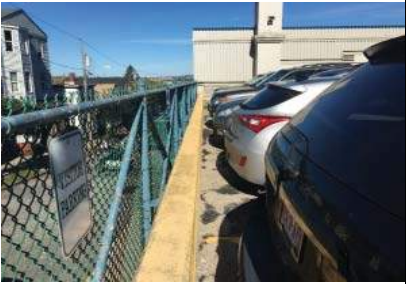
CATEGORY	DESCRIPTION AND GENERAL COMMENTS	RECOMMENDED ACTION	SEE LEGEND		
			COND. LEVEL	LIFE CYCLE	ACTION PRIORITY
Curbing Materials & Wheel Stops

Wheel stops needed where wall ends.	2	ESL	S
Number of Spaces (Regular & ADA)	2 ADA with signs, faded markings. Observed 5 cars with ADA Placards.

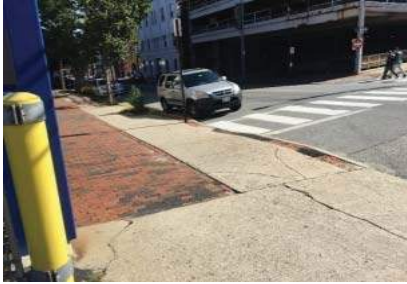
CATEGORY	DESCRIPTION AND GENERAL COMMENTS	RECOMMENDED ACTION	SEE LEGEND		
			COND. LEVEL	LIFE CYCLE	ACTION PRIORITY
Walkway Materials	Brick. Cumberland crosswalk/sidewalk rough condition. Guy connection at Alder & Portland creates paving hazard.

Some Repair Needed.

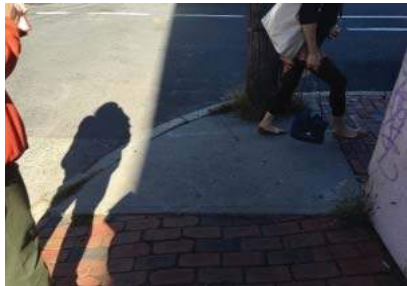
2	ESL	S
Curb Cuts & Detectable Warning Strips	No Panels

Panels needed at crosswalks.

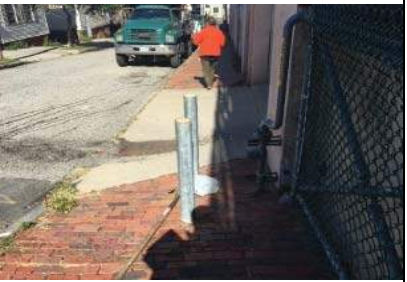
CATEGORY	DESCRIPTION AND GENERAL COMMENTS	RECOMMENDED ACTION	SEE LEGEND		
			COND. LEVEL	LIFE CYCLE	ACTION PRIORITY
Loading Dock or Leveler	Shared loading / dumpster screening. Loading at angle.

Underground lot access at Alder could use sign/flasher.	2	ESL	S
Trash & Recycling Containers (# & Size), Trash Compactor (size)	1 - 8 yd solid, screened	No Action Required	2	ESL	N/A
Fencing					
Locations & Materials	Chain Link

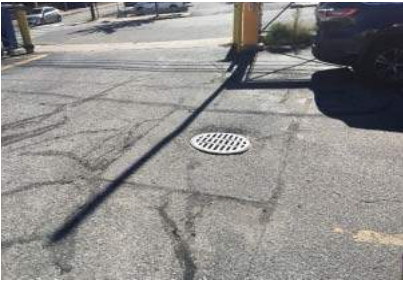
SEE LEGEND		
CATEGORY	DESCRIPTION AND GENERAL COMMENTS	RECOMMENDED ACTION	COND. LEVEL	LIFE CYCLE	ACTION PRIORITY
Flagpoles	None				
Site Drainage					
Ponding	None				
Catch Basins	Good - Pavement patch indicates recent repair.

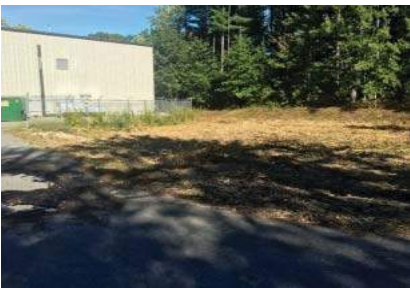
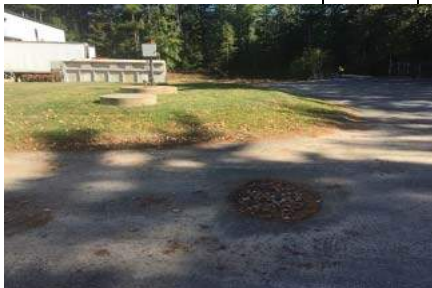
SITE					
Building Entrances					
Connection to accessible route and accessibility	Waldron Way - Good	No Action Required	3	ESL	N/A
Parking					
General Layout Description	Overall good condition	No Action Required	3	ESL	N/A
Paving Materials	Bituminous - Good, small areas of failed paving	Repair paving as necessary	2	ESL	S

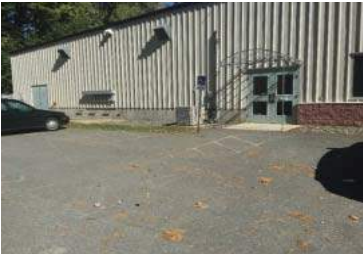
Number of Spaces (Regular & ADA)	26 total spaces including (1 ADA - non-compliant)

Should be 2 ADA spaces given total number of spaces, repaint ADA spaces with compliant aisle dimensions.	1	ESL	I
Size of Spaces	9' X 18'	No Action Required	3	ESL	N/A
Parking Striping Condition	Faded - Good	Repaint parking.	2	END	S
Accessible Parking Signage	Good	No Action Required	3	ESL	N/A
Vehicular Drop-Off & Pick-Up Areas					
Locations	N/A	No Action Required	-	-	-
Car & Bus Separations	N/A	No Action Required	-	-	-
Vehicular & Pedestrian Circulation					
Observed Circulation Patterns	Flush entry door	No Action Required	3	ESL	N/A
Traffic Markings & Traffic Signage	N/A	No Action Required	-	-	-
Walkway Materials	None	No Action Required	-	-	-
Curb Cuts & Detectable Warning Strips	None	No Action Required	-	-	-
Pedestrian Ramp Location & Materials	Good	No Action Required	3	ESL	N/A
DOT School Zone Markings/Signage at Street	N/A

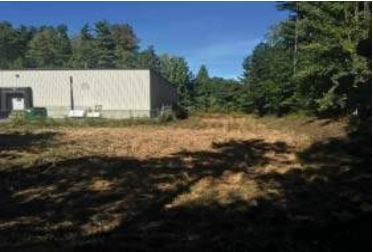
CATEGORY	DESCRIPTION AND GENERAL COMMENTS	RECOMMENDED ACTION	SEE LEGEND		
			COND. LEVEL	LIFE CYCLE	ACTION PRIORITY
Locations & Materials	Chain link with Security wire.	Restore at pond.	2	ESL	I
Site Topography					
Characteristics	Relatively flat.	No Action Required	3	ESL	N/A
Plantings, Trees and Shrubs					
Locations, Types and Densities	Good	No Action Required	3	ESL	N/A
Courtyards & Exterior Gathering Spaces					
Locations, Materials and Characteristics	N/A	No Action Required	-	-	-
In-Site Renewable Energy Resources	Not Applicable				
Site Furniture & Accessories					
Types, Locations, Materials	None	No Action Required	-	-	-
Bicycle Racks	None	No Action Required	-	-	-
Flagpoles	None	No Action Required	-	-	-
Site Drainage					
Ponding	Gravel wetland - Good
