Facilities Assessment of School Buildings

City of Portland and Portland Public Schools

VOLUME 1

February 28, 2017

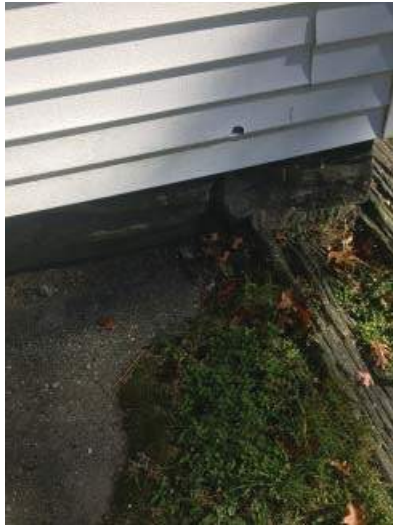
Hole in foundation

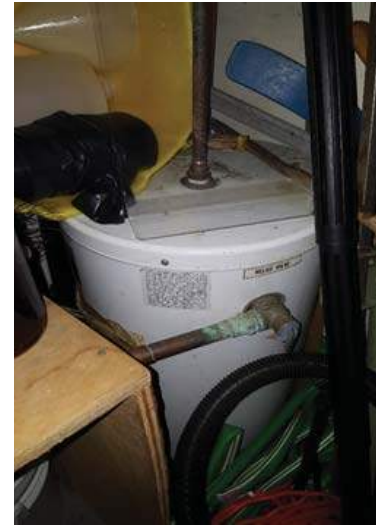
The existing distribution piping and cast iron sanitary piping is beyond its expected service life of 30 years and should be replaced; especially the copper distribution system which appears to have questionable solder joints. The electric water heater is most likely nearing the end of its expected service life and should be replaced.

Electric Water Heater

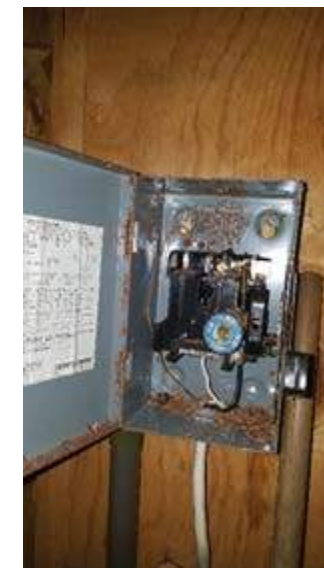
Old fuse panel in shed

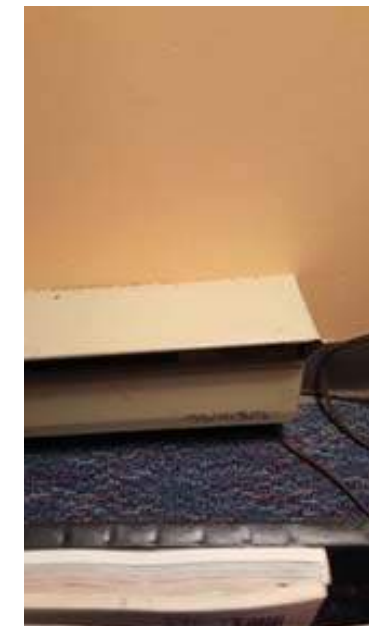
It was also noted that electrical cords are routed in close proximity to electric baseboard heaters. In order to avoid damage to the cords, keep electrical cords at least six inches away from electric baseboard heaters.

Electrical cords routed near baseboard heater

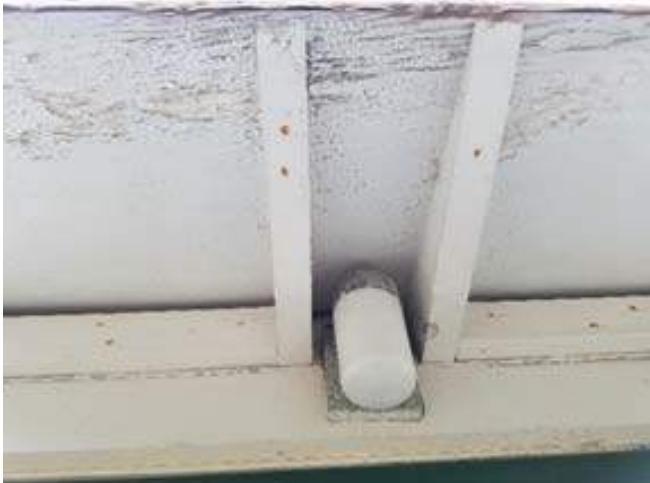
Exterior lighting consists of incandescent luminaires at building entrances and one two-lamp medium based utility lamp hol Outdoor flood fixture der. The fixtures are in fair condition and are at or near the end of their anticipated useful lives. Outdoor lighting should be updated to provide illumination levels per IES recommendations using LED fixtures with full-cutoff optics.

Outdoor luminaire at entrance

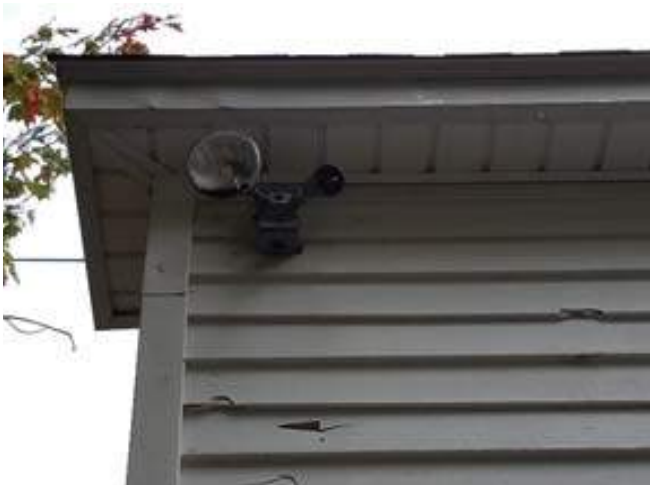
Outdoor flood fixture

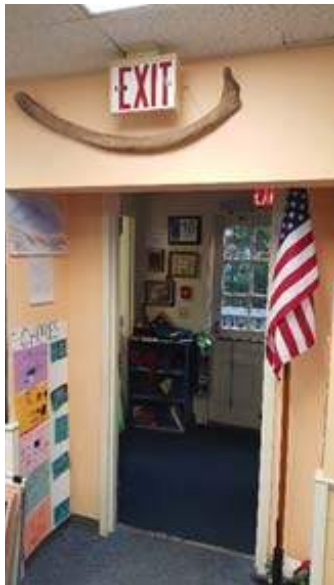
An emergency battery unit with integral incandescent heads is located in the classroom. Incandescent internally-illuminated exit signs are located appropriately to mark exits, but the units are obsolete and one is not currently working. It is not clear whether or not the exits signs have a backup power source. There is No outdoor emergency lighting. We recommend providing outdoor emergency lighting and replacing existing exit signs with LED units that include integral battery backup.

Exit sign

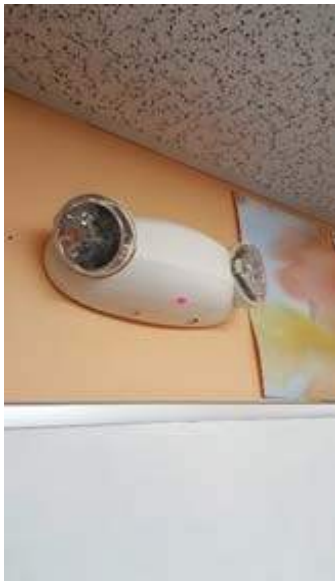
Emergency lighting unit

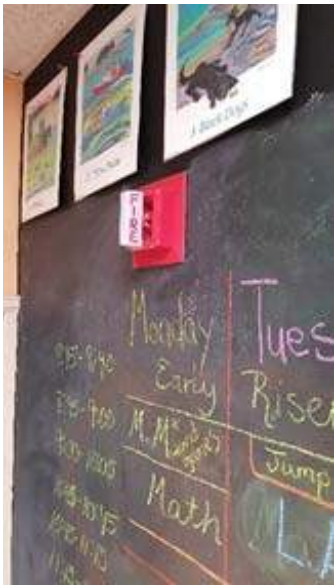
The fire alarm control panel is an ESL 1500 series conventional zoned control panel. It was noted that the backup batteries are not connected. Smoke detectors are located in all rooms. Manual pull stations are located at exits, but are located higher than permitted by ADA. Occupant notification does not comply with ADA. The system should be updated to a fully addressable ADA compliant fire alarm system.

Fire alarm horn/strobe

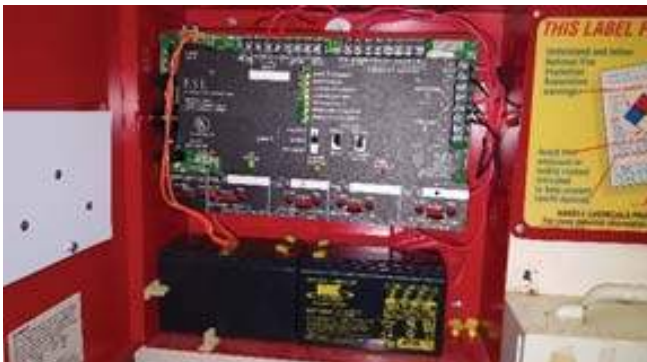
Interior of fire alarm control panel

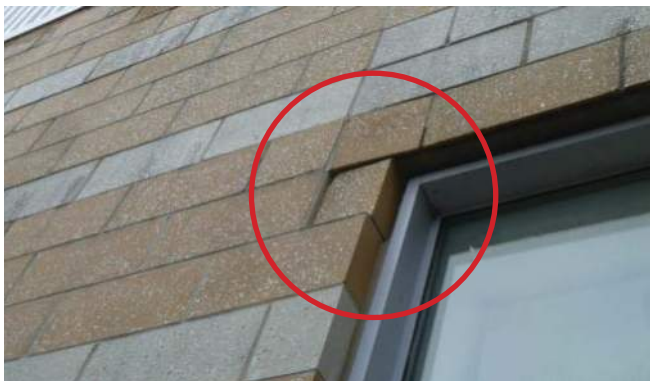
Lintel Condition

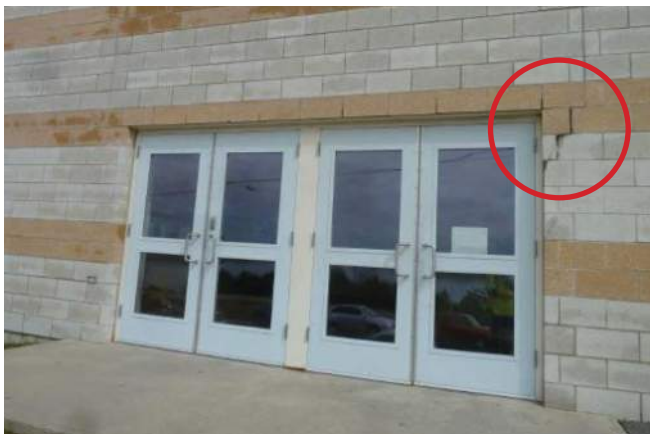
Lintel Condition

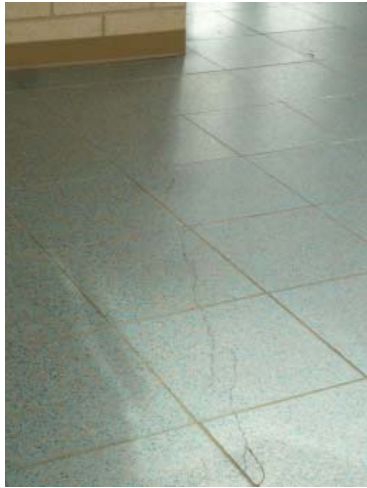
Cracks in First Floor

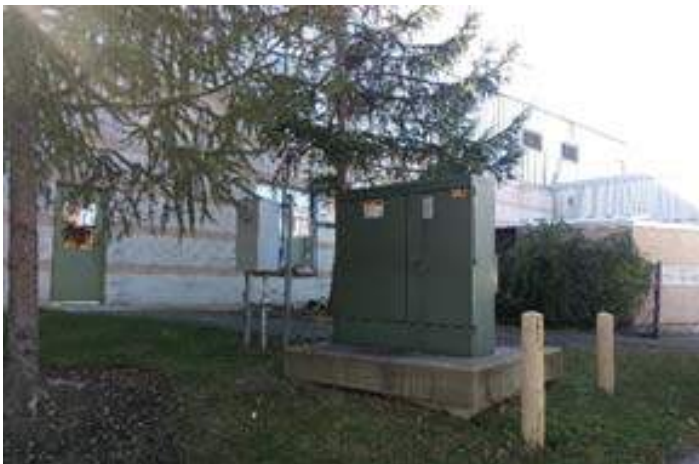
Padmount transformer

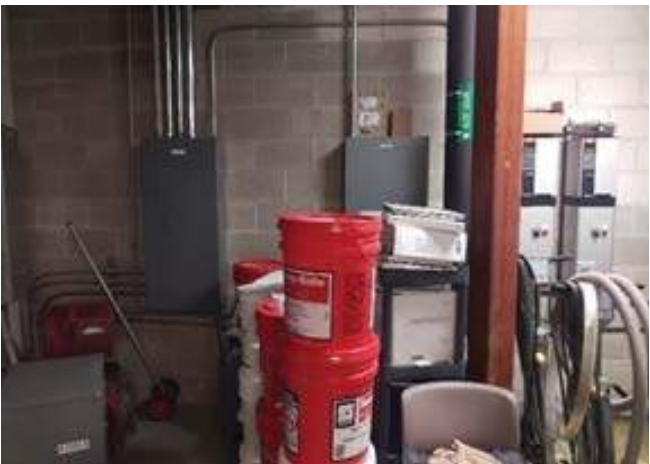
Square D branch-circuit and distribution panelboards are located appropriately for the current program. Feeders are single conductors in conduit. Based on what can be seen from a visual inspection, branch circuits are a mix of MC cable and single conductors in conduit. The power distribution system is in good condition, well within its anticipated useful life, and offers a reasonable number of available spare circuits.

Branch-circuit panelboards

It was noted that some areas that house electrical panels are also used for storage. Care should be exercised to ensure that 30" wide, 36" deep area in front of each electrical panel is clear of stored materials.

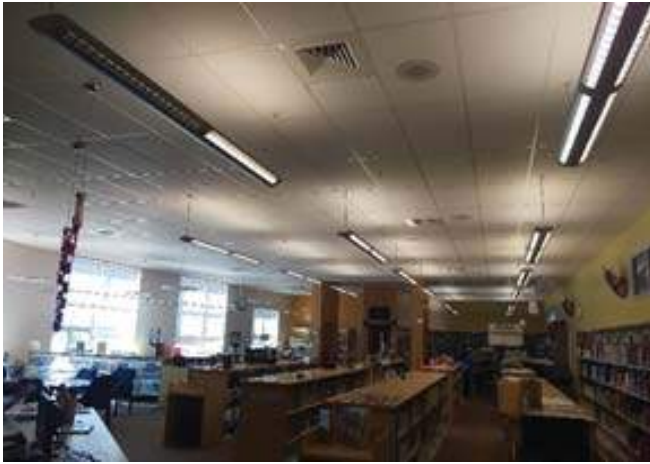
Classrooms are illuminated by dimmable pendant mounted fixtures with direct/indirect distribution. Recessed fixtures with parabolic diffusers are installed in Offices. Toilet rooms are illuminated by recessed lens troffers and mechanical and storage rooms have a mixture of strip lights and surface mounted wrap-around fixtures. Fixtures in classrooms, offices, toilets, and mechanical and storage rooms all are equipped with T8 fluorescent lamps. Corridors have recessed and surface mounted compact fluorescent fixtures. The gym is illuminated by T5 fluorescent high-bay fixtures. The interior lighting is in good condition and has approximately 10 years of anticipated useful life remaining.

Classroom lighting

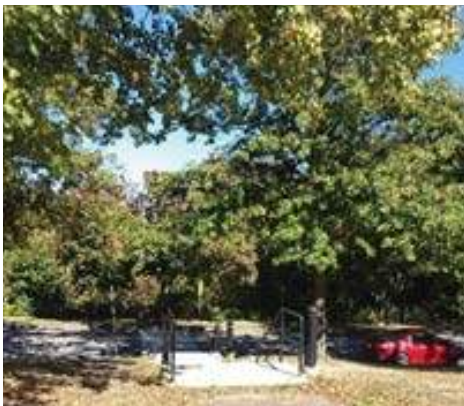
Site lighting consists of metal Halide “shoe-box” style pole lights. There are also some metal halide bollard fixtures installed along a pedestrian that leads to Eastern Promenade, but these have been abandoned due to failures. Building mounted exterior lighting is a mix of LED and metal halide wall packs. Based on a visual inspection it appears that the existing exterior lighting will provide illumination levels consistent with IES recommendations except where the bollard fixtures are not functioning and at the area in front of the building to the west of the main entrance, where we recommend adding lighting. We recommend updating the exterior lighting to LED with full cutoff optics as the existing metal halide units fail.

Abandoned bollard lights

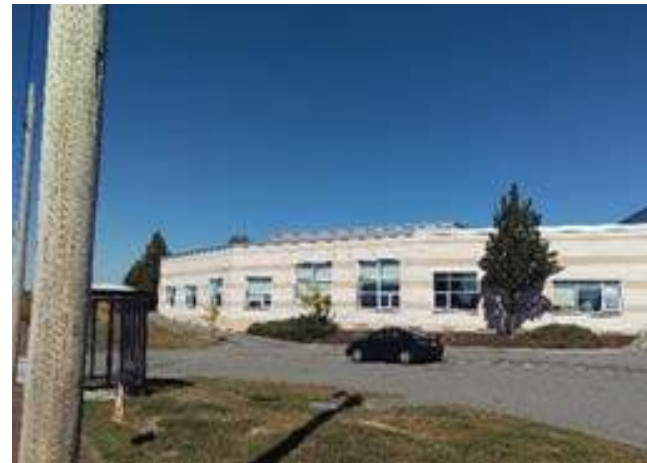
Area to west of main entrance – Additional outdoor lighting is recommended here.

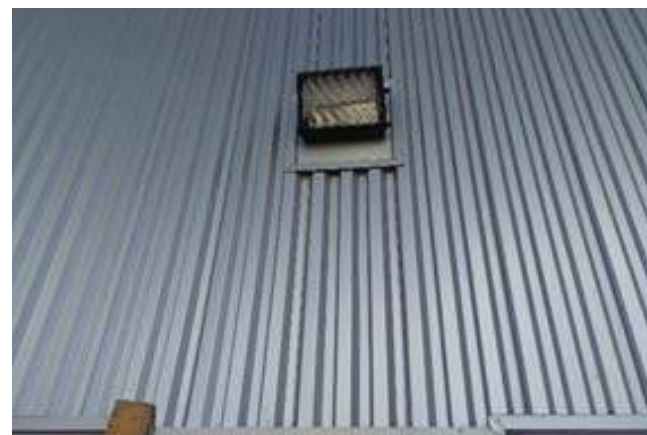
Metal halide wall pack

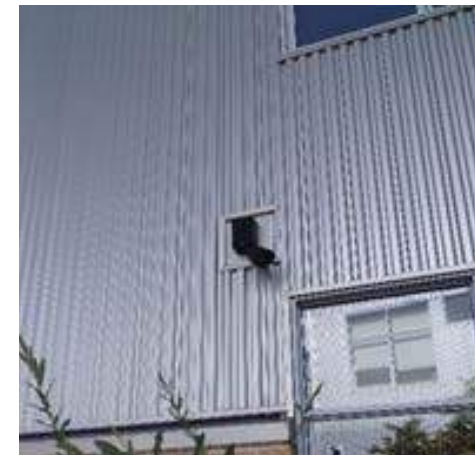
Emergency battery units with integral and remote heads provide emergency lighting for means of egress. The heads are a mixture of LED and incandescent. Emergency lighting includes the areas at the exterior of exits. The LED emergency lighting units are in good condition and offer more than 10 years of anticipated useful life provided they are properly maintained and batteries are replaced as needed. Incandescent units should be replaced with modern LED units as they fail.

Outdoor emergency lighting unit

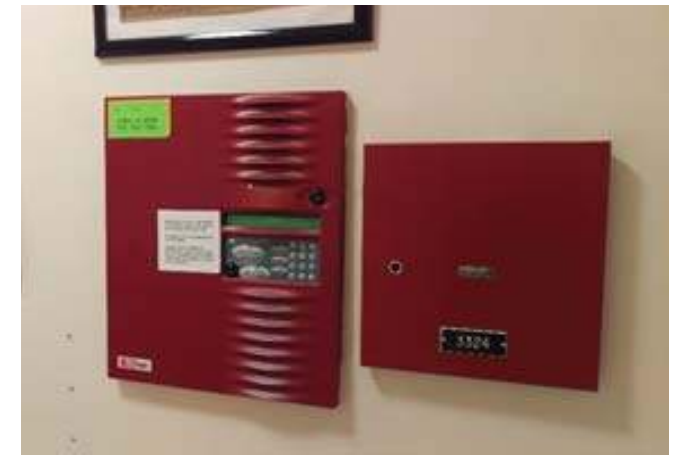
The fire alarm control panel is a 2006 vintage FCI addressable control panel. Alarms are initiated by manual pull stations at building exits, smoke and heat detectors in selected areas, and by activation of the building's sprinkler system. The fire alarm system appears to comply with current codes and standards except that current City of Portland fire alarm standards require smoke detection in egress paths, which this school does not have; existing installations are not required to be updated unless the system is replaced or the facility undergoes major renovations.

Fire alarm control panel

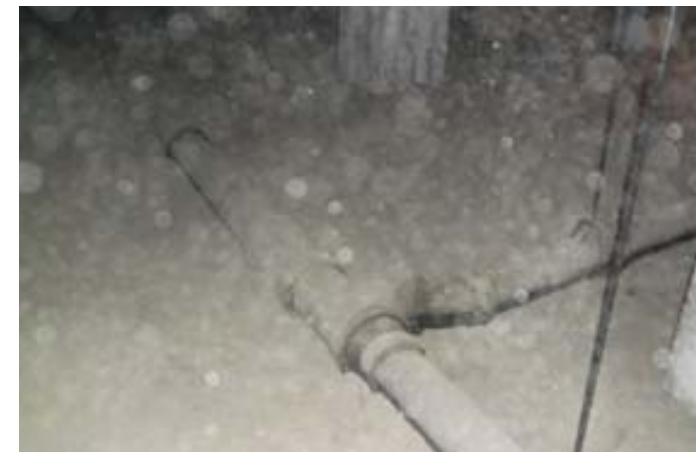
Plumbing sanitary, vent, and rain water piping consists of cast iron original building. Water distribution piping is copper. Most piping is in fair to good condition, however the 1950s piping systems are beyond their useful life of 30 years. Storm water and sewer exit the building as separated systems.

Cast Iron Rain Water Piping

The existing plumbing systems are in fair to good condition considering the age of the original systems. Replacement plumbing fixtures are in near new condition. The original piping systems are beyond their service life of 30 years but in fair to good condition as witnessed in the crawl space. However these system should be upgraded with new PVC and copper piping systems; the copper piping will have lead free solder, a current code requirement.

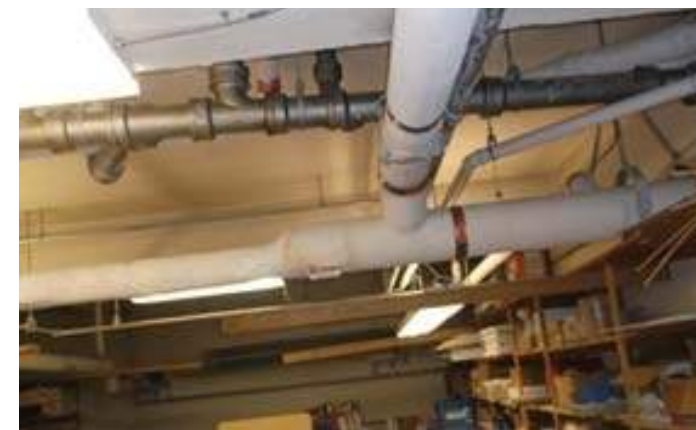
Cast Iron Sanitary Piping

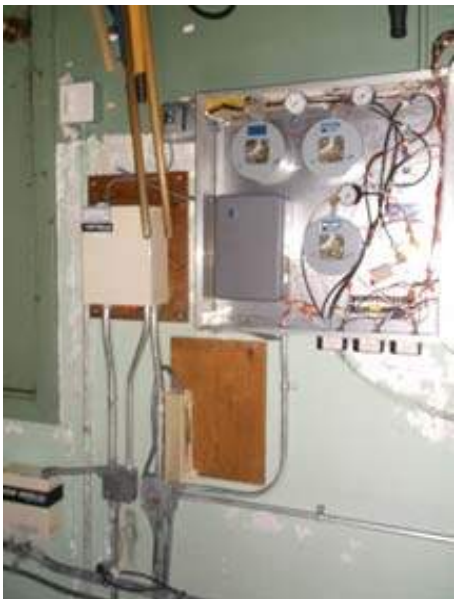
Existing temperature controls are pneumatic and beyond their expected service life. There is some newer DDC electric but it is nearing 20 years old. The existing HVAC systems are simple, comprised mostly of unit ventilators which are generally in fair operating condition given their age. The 65 year old underground steam and condensate return piping is very aged and most likely nearing failure. How and when to replace the equipment depends on whether there are planned building renovations or replace systems as a major HVAC upgrade. The best recommendation is to convert the original building to heating hot water and eliminate the aged steam equipment and steam / condensate piping. Install a hot water heating plant dedicated to Longfellow. All heating and ventilating equipment would need to be replaced/upgraded with new systems at the time of the steam to HW conversion. Also, coordinate the temperature controls DDC electric upgrade at the time of conversion. Basi-

Temperature Controls

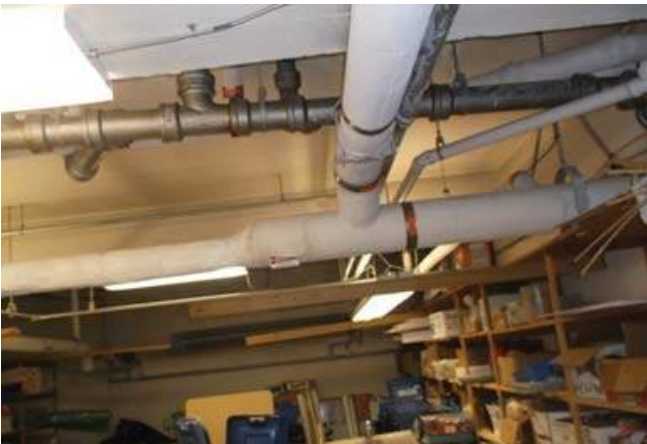
The building is served by the steam boiler plant at Deering High via underground piping. Most all steam and condensate return piping is original to the building, 1952, and is beyond its expected service life of 30 years. Sections of the steam piping is covered with the original asbestos insulation. Maintenance on the steam system has been ongoing as evidence of the recently replaced condensate return pumps, less receiver.

Original Steam Piping with Asbestos Insulation

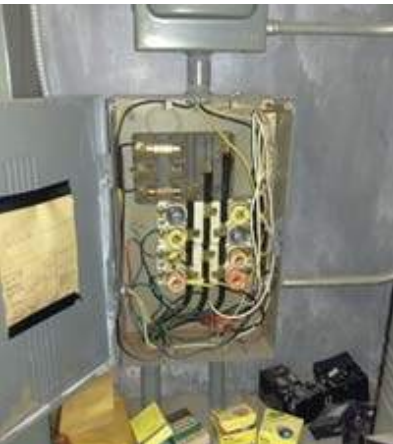
Power is distributed throughout the building via a mixture of fuse and circuit-breaker type Panelboards. Most of the distribution system is very old and has exceeded its anticipated useful life, except for a couple of residential-grade loadcenters that have been added over the years. Power distribution wiring is building wire in conduit. Like the equipment, the wiring has exceeded its anticipated useful life and should be replaced throughout.

An old fuse panel.

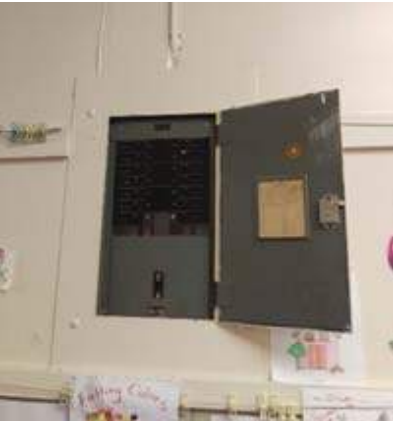
Any old circuit breaker panel – a plastic cover has been field fabricated to cover live parts within.

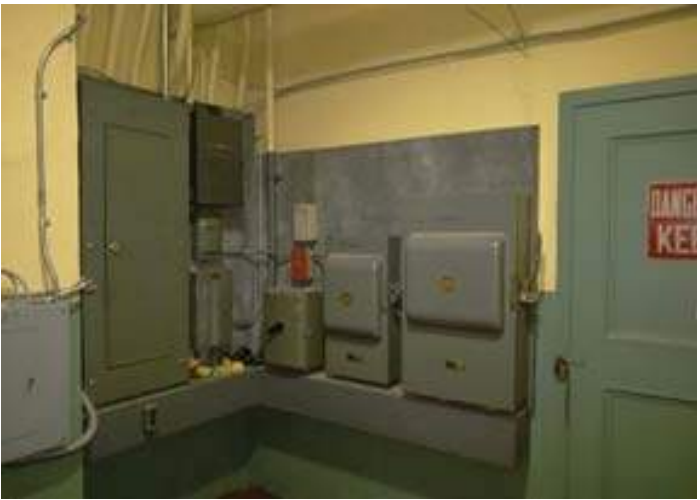
The electrical service is an underground utility primary to a utility transformer vault located within the building; the vault is only accessible to utility company personnel and was not inspected during our visit to the school. The secondary feeder from the transformer vault is installed in a wireway and supplies a series of very old fusible switches that have a combined rating of 600 amps at 208/120 volts, 3-phase, 4-wire. The current service entrance arrangement with the utility transformer vault within the building is an obsolete design. The service should be updated to a modern design with a pad mounted utility transformer.

Service disconnect switches

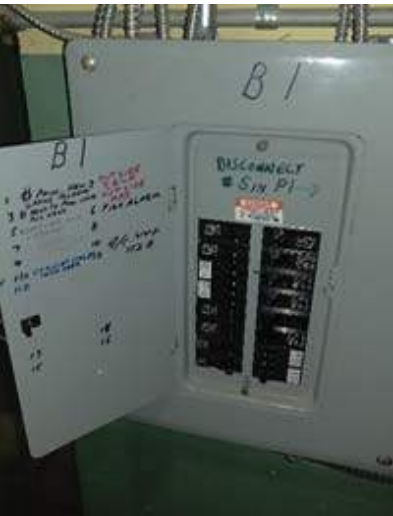
A newer, residential-grade load center

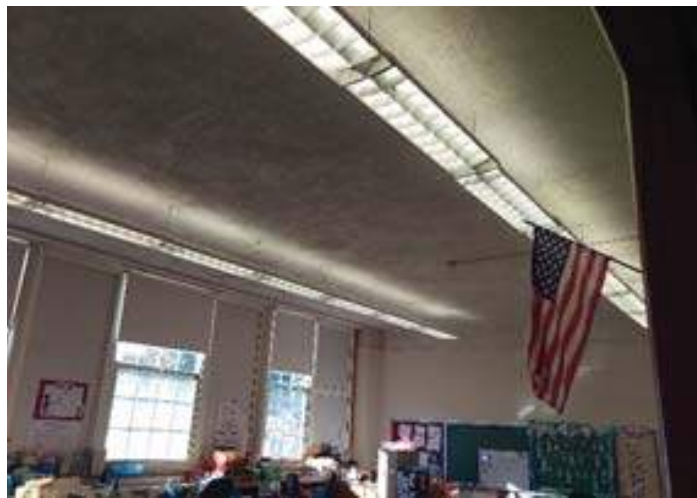
Most interior areas are illuminated by fluorescent fixtures that utilize T8 lamps. Classrooms and corridors have very old louvered fixtures. Offices, toilets, mechanical and storage rooms are equipped with wraparound style fixtures. The Gym is illuminated by high-bay pendant luminaires. The lighting should be updated to LED fixtures with high-performance optics as part of any planned facility renovations.

Typical classroom lighting

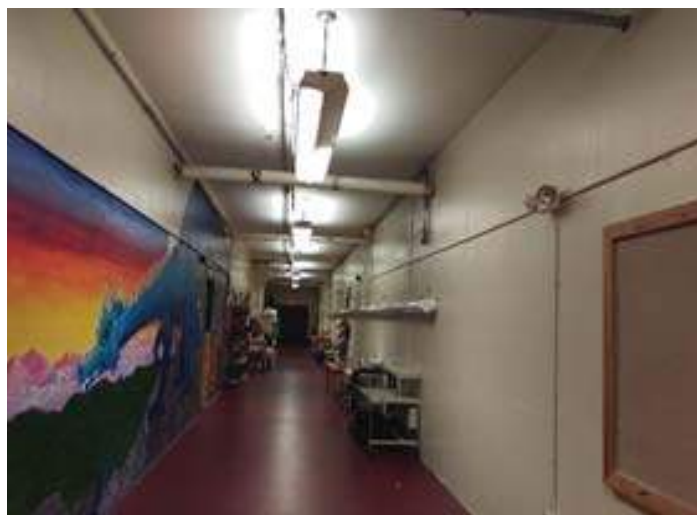
Corridor lighting

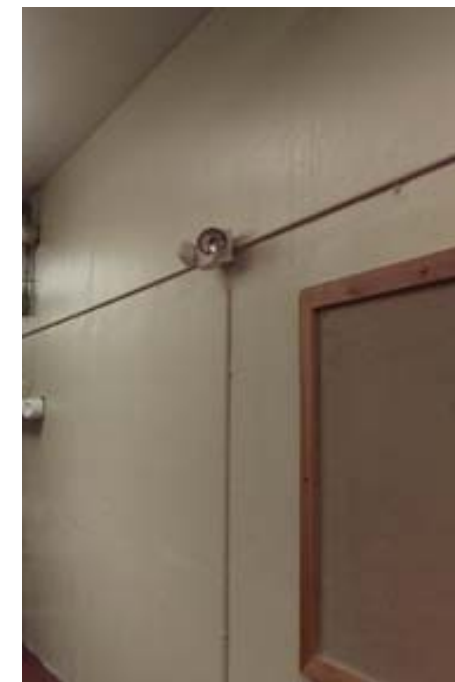
Emergency lighting is provided by emergency battery units with integral and remote heads. The heads are a mixture of LED and incandescent. The LED emergency lighting units are in good condition and offer more than 10 years of anticipated useful life provided they are properly maintained and batteries are replaced as needed. Older incandescent units should be replaced with modern LED units as they fail. Outdoor emergency lighting should be provided at building exits. LED illuminated exit signs with integral battery backup are appropriately located to mark means of egress.

An incandescent emergency lighting unit

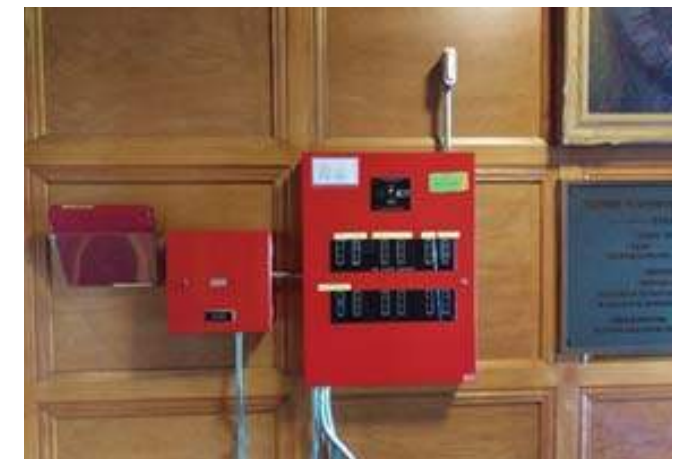
The fire alarm control panel is a conventional zoned FCI control panel. Occupant notification does not comply with ADA or current standards in some areas; the classrooms are not equipped with visual notification appliances. The system has exceeded its anticipated useful life and should be updated to a fully addressable system.

Fire alarm control panel

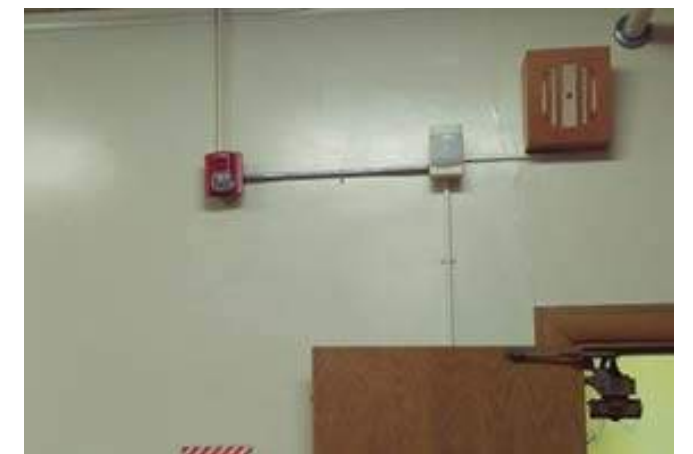
Fire alarm horn/strobe unit

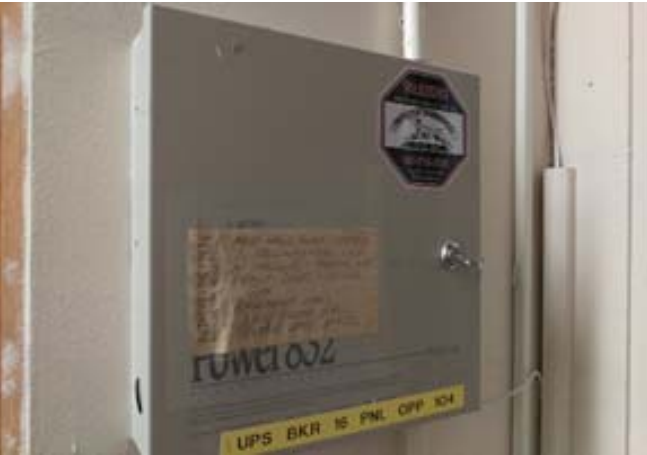
The school is equipped with a DSC intrusion alarm control panel. Alarms are initiated by motion detectors in corridors. There is no panic alarm system. The Intrusion detection system should be updated to a system that is integrated with the district-wide network system.

Security alarm control panel

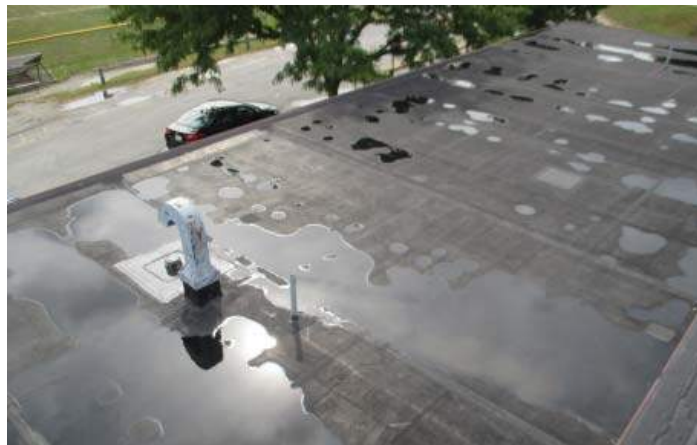
- The low roof beyond the far wall of the multi-purpose room does is very flat and does not shed water well. Recommend providing additional materials to improve roof slope and drainage.

Poor roof drainage at low roof near MPR

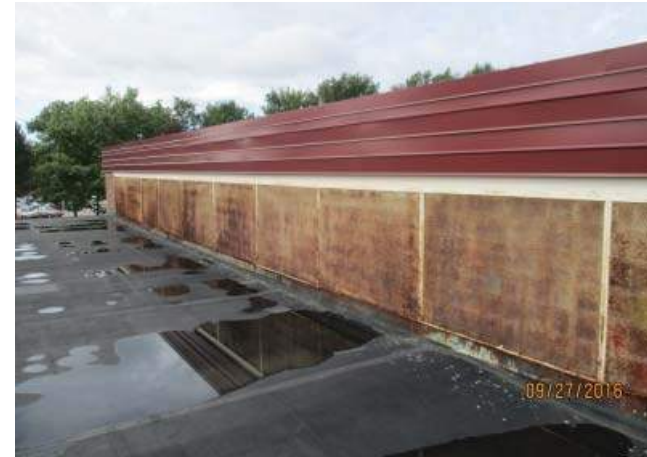
- The clerestory windows in the multi-purpose room are susceptible to wind-driven rain and snow. Leaks in these windows can cause damage to the roof structure over time. The beginning signs of rust/corrosion were observed in the roof joists at these locations. Recommend monitoring this area, and replacing any damaged windows or sealants to prevent moisture infiltration.

Clerestory windows to MPR - monitor for leaks

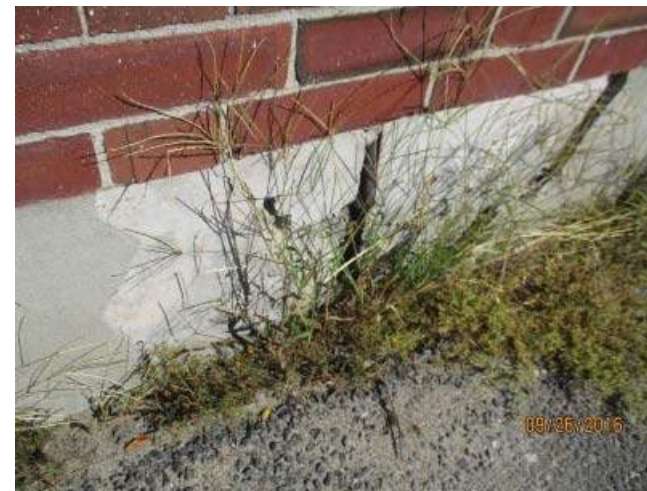
- Window and door lintels are rusting. Recommend replacing them in the near future.
- Foundation wall control joint sealants are in poor shape and should be replaced.

Foundation wall sealant to be replaced

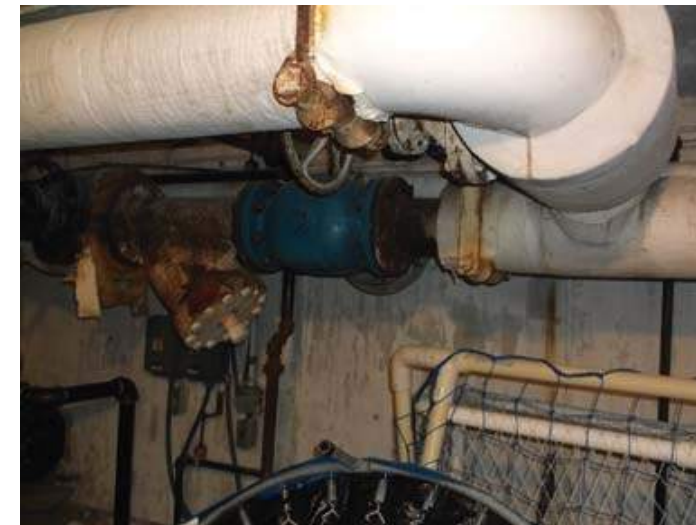
The building is served by the steam boiler plant at Lyman Moore via underground piping (recently replaced piping). Most all steam and condensate return piping is original to the building, 1960, and is beyond its expected service life of 30 years. Maintenance on the steam system has been ongoing to replace traps and update some controls from manual operation.

Original Steam Piping

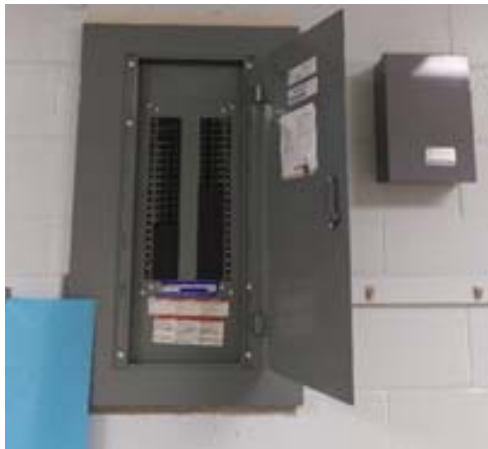
Most branch-circuit panels have been recently updated to modern Square D panelboards. It appears that the new panels were connected to the existing feeders, the conductors of which have exceeded their anticipated useful lives. Four 1960-vintage GE panelboards that are obsolete remain in place. The obsolete GE Panelboards should be updated and the distribution wiring system replaced throughout.

A recently installed Square D panelboard

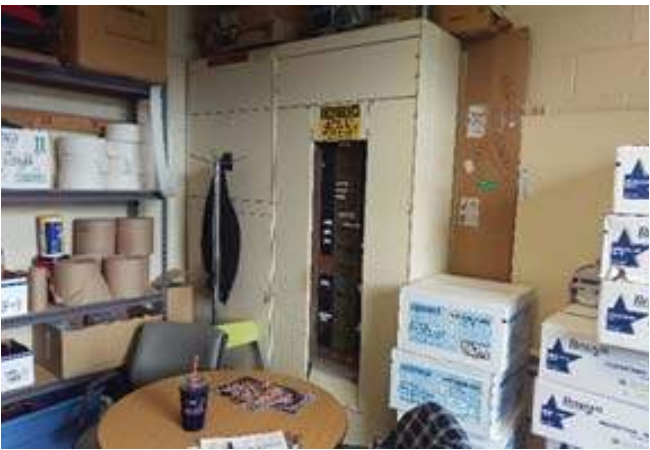
It was also noted that the switchboard is located in a room that is shared with program space. The area in front of the switchboard should be kept clear for a depth of at least 36 inches to provide code-required access to the equipment.

Service entrance switchboard

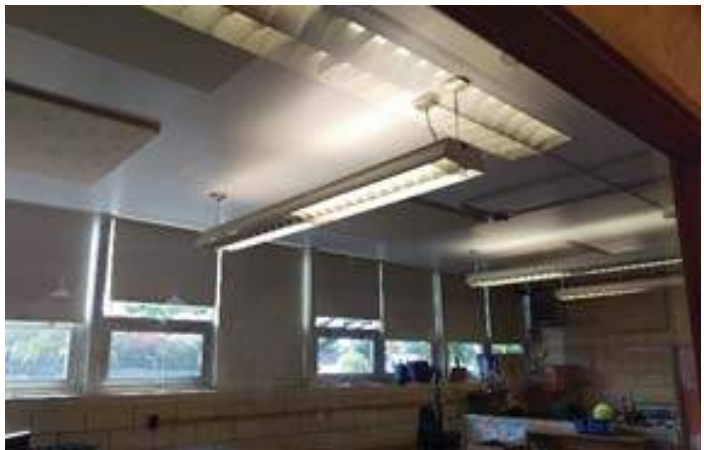
Old louvered fluorescent fixtures.

Most classrooms are illuminated by fluorescent lens troffers that utilize T8 lamps, although some very old louvered linear fluorescent luminaires were noted. Three classrooms have been updated to LED. Individually addressable LED fixtures with Acuity Brands N-Light control are installed in one classroom as a test. Offices and corridors are also illuminated by T8 Fluorescent lens troffers, and T8 fluorescent high-bay fixtures are installed in the gym. Incandescent lighting is still in use in the basement mechanical room. Lighting throughout should be updated to LED with high performance optics as part of any planned facility renovations. All existing fixtures will reach the end of their anticipated useful lives within 20 years.

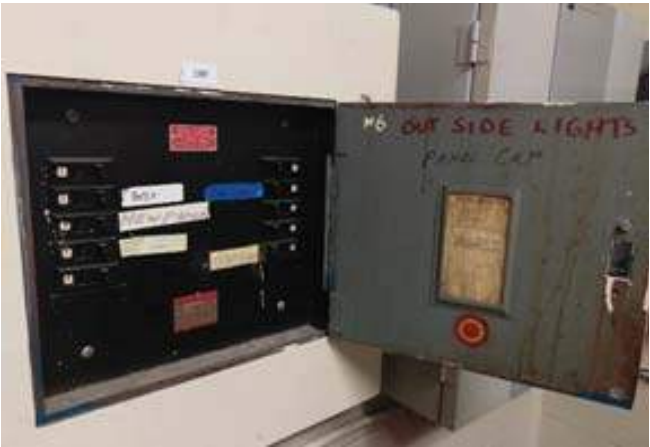
An old GE panelboard

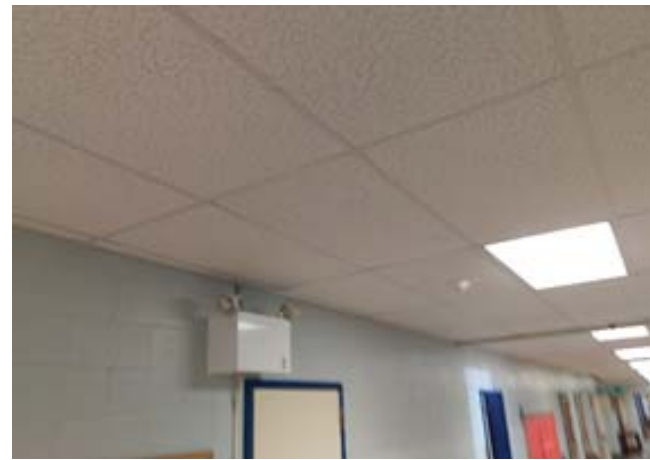
Emergency battery units with integral and remote incandescent heads provide illumination for means of egress. LED illuminated exit signs with integral battery backup are appropriately located to mark means of egress. All existing units will reach the end of their anticipated useful lives within 20 years. We recommend update the emergency lighting units to LED and providing outdoor emergency lighting at building exits.

Emergency lighting unit

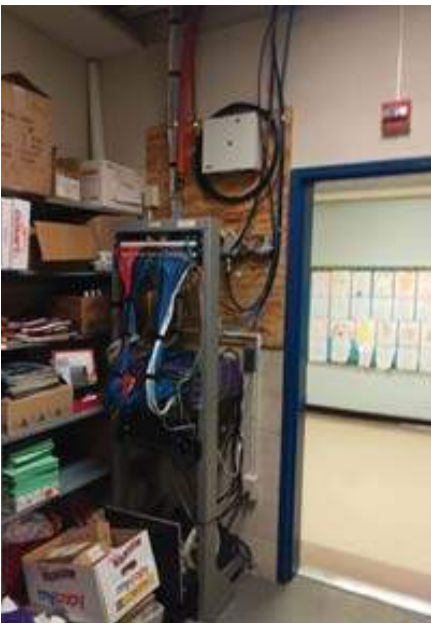
MDF

The data system is served by an overhead fiber optic cable that terminates at the Main Distribution Frame (MDF), which is located in a custodial/storage room and housed in an exposed floor mounted rack. We recommend providing an enclosed cabinet in lieu of exposed rack at the MDF.

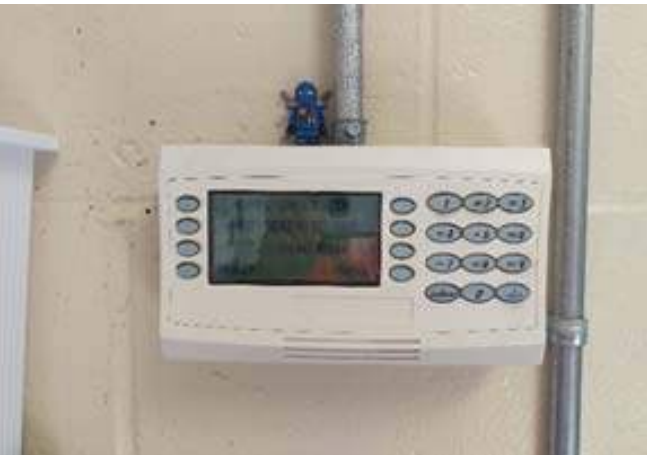
The intrusion alarm system consists of a 2012 vintage Bosch networkable control panel. Alarms are initiated by motion detectors. The system is in good condition but will reach the end of its anticipated useful life within 15 years. The building is not equipped with a panic alarm.

Security system keypad

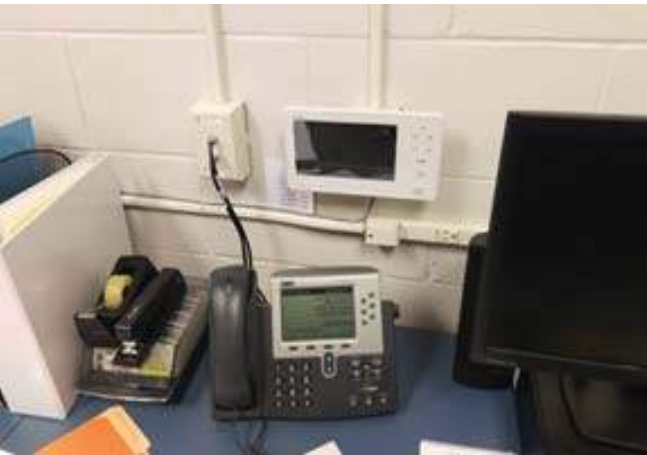
There is no security camera system, but an Aiphone video intercom provides communication with visual imaging and electric access control between the main entrance and the office. There is also an access control keypad at the exterior of the main entrance. We recommend providing digital cameras that are connected to the district servers.

Video intercom unit at main office

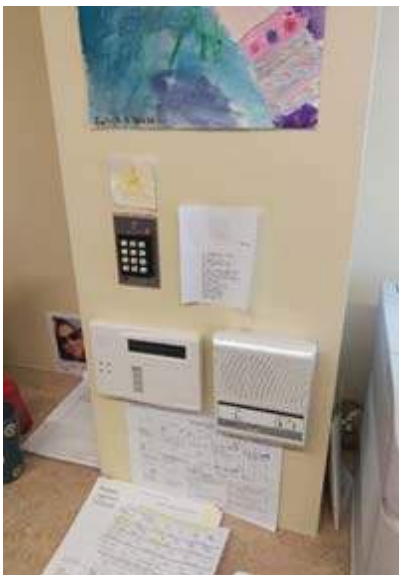
The intrusion alarm system is controlled by a Honeywell control panel that is not capable of being connected to the district-wide network. Alarms are initiated on the system by motion detectors located in corridors and classrooms. A panic alarm system with activation buttons located at the reception desk in the main office is part of the intrusion alarm/access control system. We recommend providing an intrusion alarm control panel that can be integrated with the district-wide network.

Main Office Entry Intercom and Access Control and Intrusion Alarm Keypads

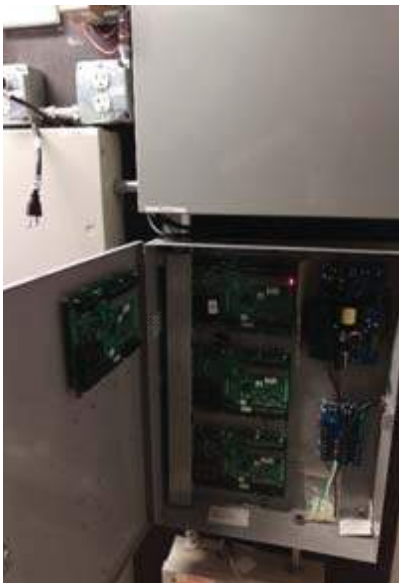
Unused Access Control Panel

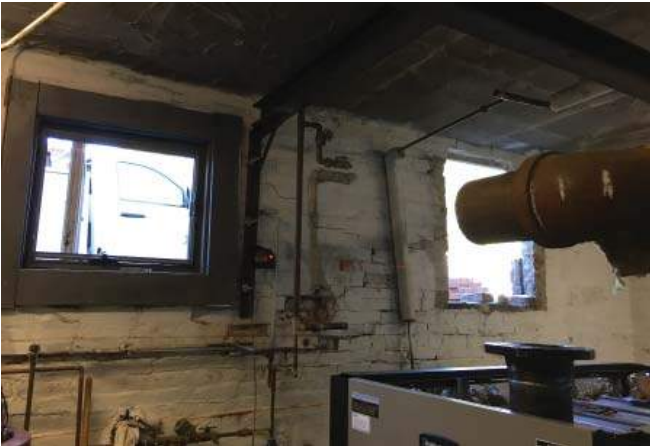
Wall in boiler room

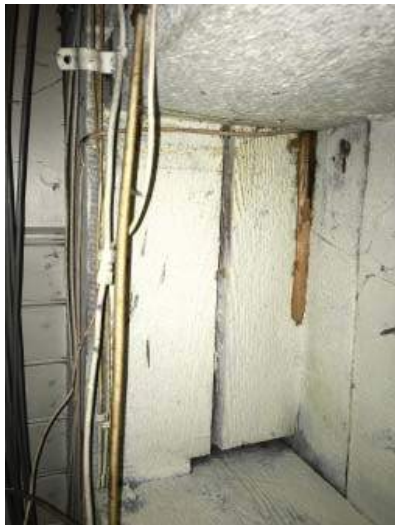
Checked wood in basement

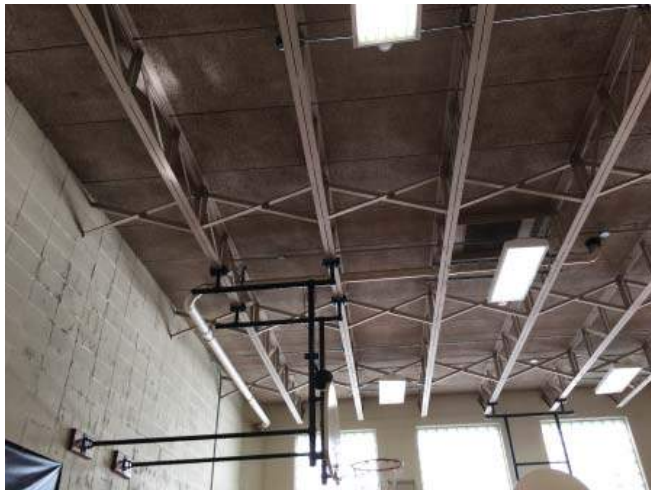
Moisture damage at Gym wall

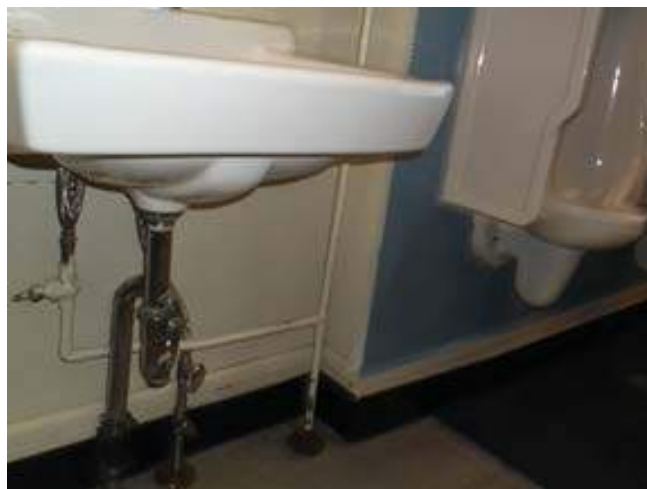
The existing plumbing systems in general appear mostly vintage (with the exception of fixture upgrades) and appear to be functioning with required maintenance. The distribution piping is beyond its typical useful service life of 30 years. A water distribution piping replacement project would provide a piping system with lead free solder, a current code requirement. The 40 gallon water heater is beyond its useful service life and should be replaced.

Lavatory With Vintage Piping

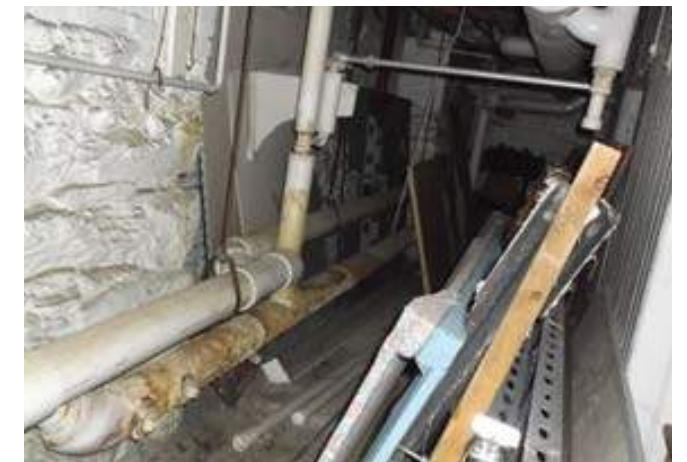
Vintage Steam Piping Insulated and None

The existing HVAC equipment, other than boiler plant are beyond their useful service life and should be replaced. Although the steam boiler is new it is recommended to replace the steam boiler with a hot water boiler to simplify the boiler plant (no HX or condensate pump) for the given size of the building. The building heating would be fin tube radiation throughout with CUHs at vestibules. Building ventilation would be (1 or 2) ERUs to supply fresh air to occupied space and exhaust toilet rooms and other odor producing spaces. The temperature controls should be upgraded at the time of steam to HW conversion, in lieu of its own upgrade project. Heating system conversion can be performed without major building renovations.

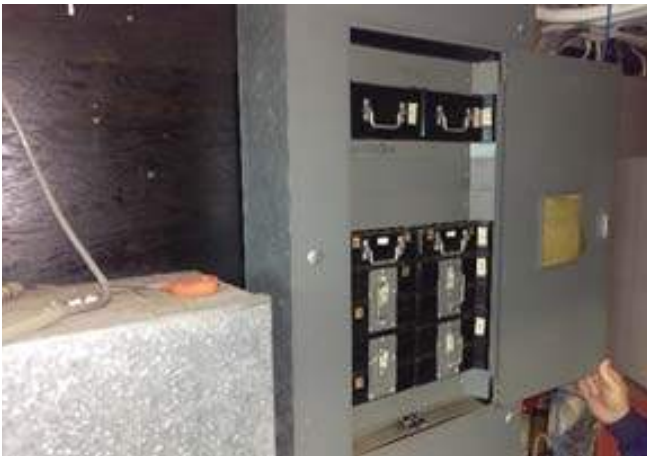
The school has a 200-amp, 240/120-volt single-phase, 3-wire overhead service that terminates at a 1950’s vintage fuse panel. The service entrance conductors and fuse panel have exceeded their anticipated useful lives. We recommend upgrading to a 3-phase service.

Service Entrance Panelboard

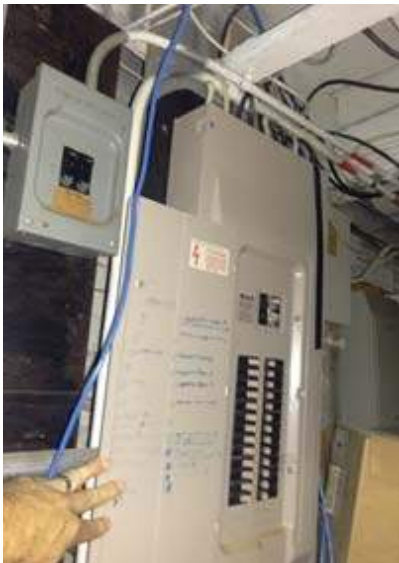
Branch circuit panels in the school are a 1970’s vintage Cutler Hammer residential-grade load center, two 1960’s vintage or older GE panelboards, and one modern residential-grade Siemens load center. Most of the feeders are very old building wire in conduit. The equipment and wiring are at the end of or have exceeded their anticipated useful lives and should be replaced with modern panelboards and feeders.

Old Cutler-Hammer Load Center

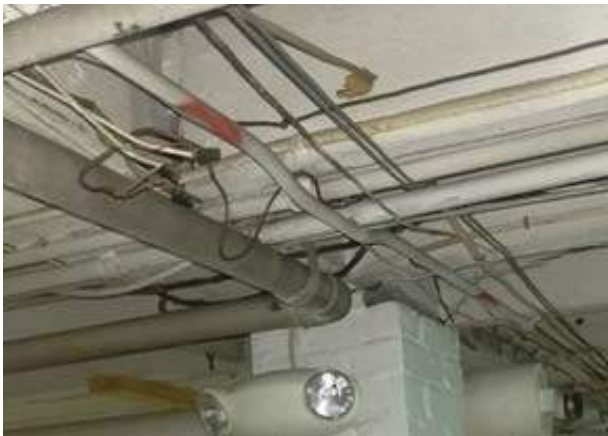
Branch-circuit wiring is a mix of old cloth-covered non-metallic sheathed cable (romex), old BX armored cable, modern romex cable, surface metal raceway, and single conductors in conduit. Extension cords are in use in some places due to a lack of appropriately located receptacles. Much of the wiring is over 40 years old and should be replaced. We also recommend adding receptacles and associated branch-circuit wiring to alleviate the need for extension cords, but the power distribution system must be updated as described above in order to facilitate this action.

Very Old Branch Circuit Wiring

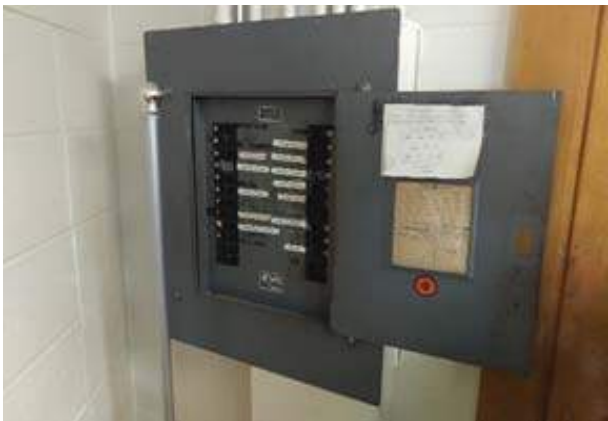
A 1960's vintage panelboard

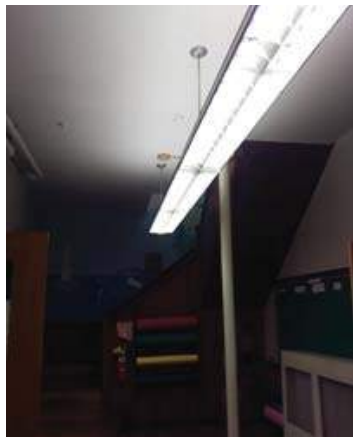
Classroom on the first floor are illuminated by 2011 vintage T8 fluorescent lens troffers; second floor classrooms have old louvered pendant linear fluorescent luminaires retrofitted with T8 lamps. Offices and corridors have a mixture of T8 fluorescent wraparound style luminaires and old louvered pendant linear fluorescent luminaires retrofitted with T8 lamps. The gym is equipped with T8 Fluorescent high-bay fixtures. Old incandescent fixtures retrofitted with self-ballasted compact fluorescent lamps illuminate mechanical and storage rooms. We recommend updating the lighting to LED luminaires with high performance optics as part of any planned facility renovations. All existing fixtures will reach the end of their anticipated useful lives within 15 years.

Old Louvered Fixtures in First Floor Corridor

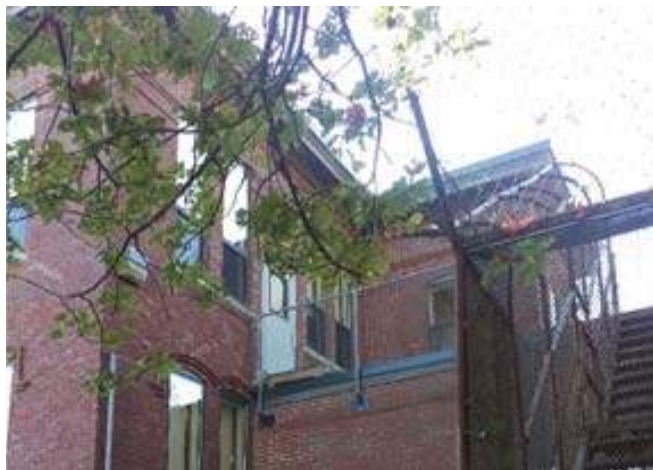
Most outdoor luminaires are LED wall packs, although one HID wall pack and a couple of old recessed incandescent fixtures at entrance canopies were noted. There are no pole mounted fixtures. HID and incandescent outdoor luminaires should be updated to LED fixtures with full-cutoff optics. All fixtures will reach the end of their anticipated useful lives within 20 years.

An HID wall pack

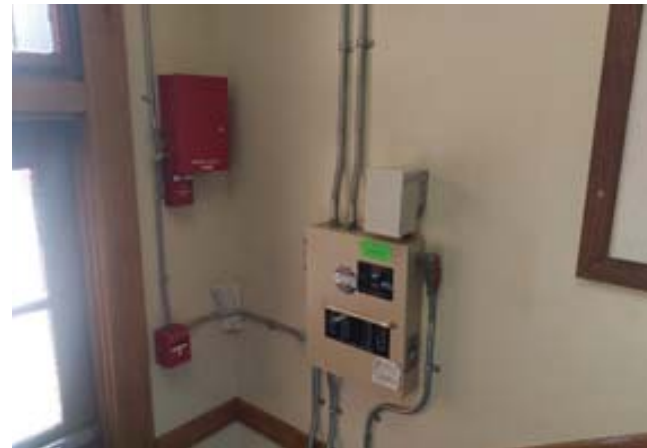
The fire alarm system has a 4-zone conventional FCI control panel. The control panel is obsolete and does not comply with current standards for new systems. The system should be updated to a fully addressable system.

Fire Alarm Control Panel

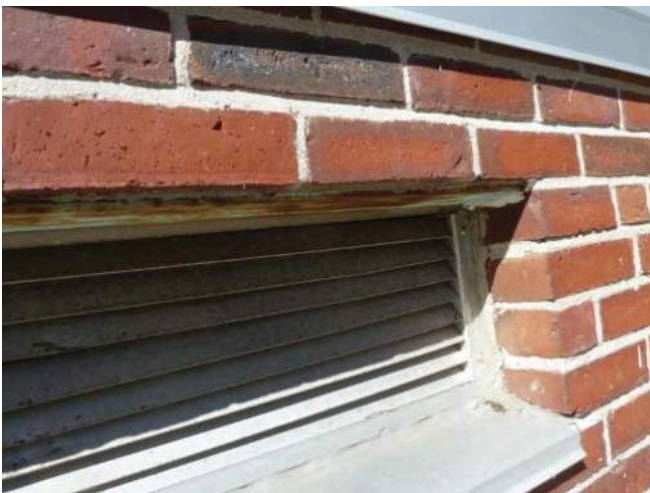
- The original roof was not design for snow drifts.
- One location was noted as having a beam stopping short of its support.
- One lintel is deflecting and needs replacement.

Lintel condition

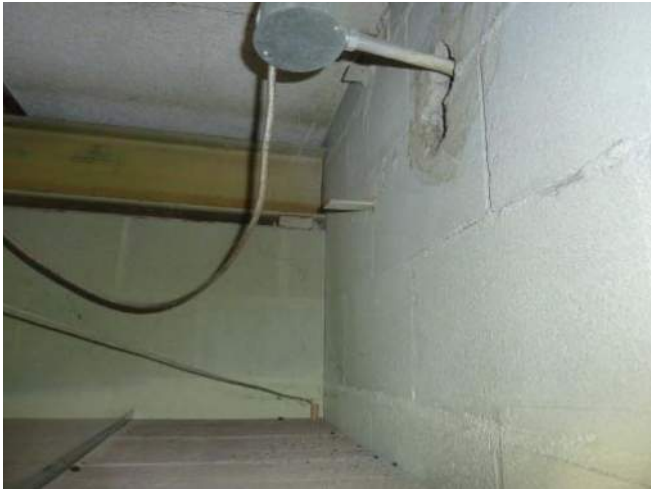
Beam condition
