Facilities Assessment of School Buildings

City of Portland and Portland Public Schools

VOLUME 1

February 28, 2017

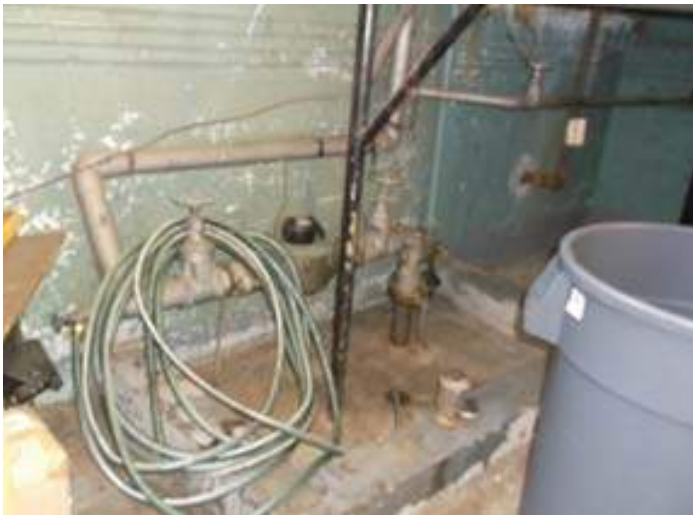
Original Water Entrance

The existing plumbing systems are in fair to good condition considering the age of the original 1960's systems. The original piping systems are beyond their service life of 30 years and replacement is recommended. The existing sanitary and distribution systems should be upgraded with new PVC and copper piping systems; the copper piping will have lead free solder, a current code requirement.

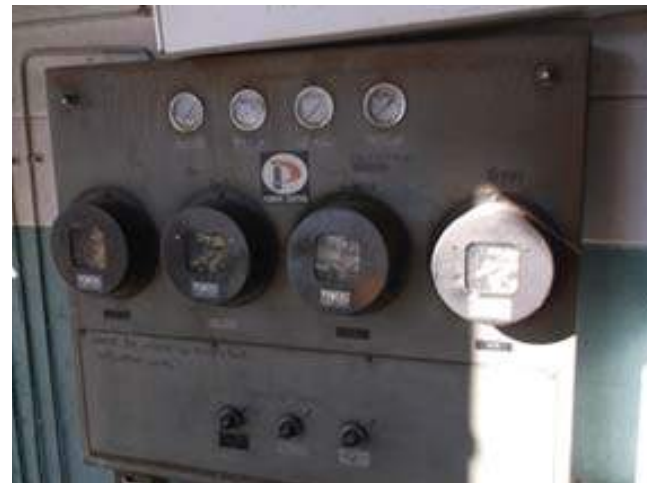
Original Pneumatic Temperature Control Panel

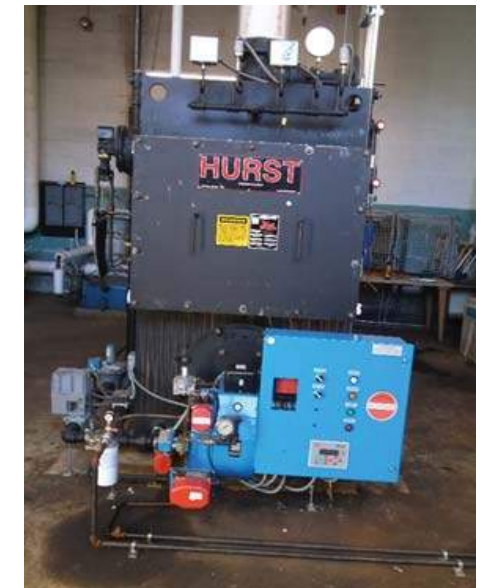
The building is served by a single Hurst steam boiler recently installed in 2112. The boiler is rated at 2,588 #/Hr (2,500,000 BTU/Hr) with dual fuel #2 oil and natural gas. The fuel oil tank is 8,000 gallons. An original condensate boiler feed tank unit has had the duplex pumps replaced over the years. A firetube steam boiler has an expected service life of 30 years.

Steam Boiler

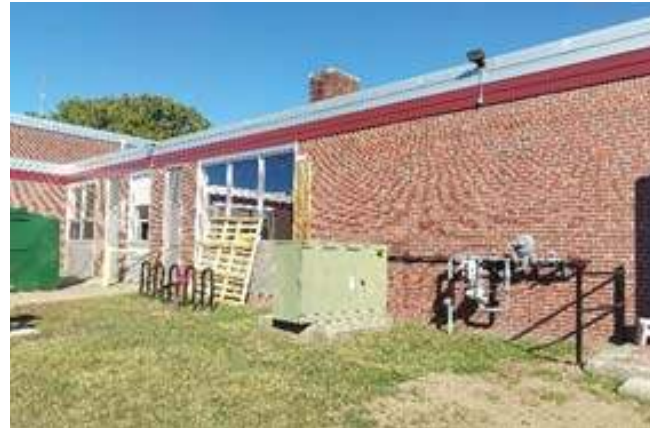
The utility primary is installed in underground conduits from a riser pole to a utility pad mount transformer. The transformer is closer to the building than current Central Maine Power Co. standards allow and the concrete transformer pad is smaller than CMP's current design standard. The school has had repeated issues with squirrels shorting the overhead utility primary, resulting in power outages due to blown utility cutouts. Further investigation by utility company is required to determine cause of shorts due to squirrel activity, but considering the age of the service, it should be updated to current CMP standards.

Utility Pad Mount Transformer

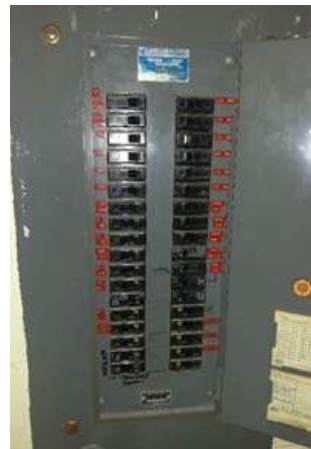
Branch-circuit panels are a mix of early 1960's vintage ITE panelboards and residential/light commercial grade load centers, which are located in the boiler room and a in a corridor. Based on what can be viewed from a simple walk-through of the facility, most of the feeders appear to be building wire in conduit; the load center that is located in a corridor and supplies the modular classrooms is wired using type SE service entrance cable. We recommend updating the distribution system and wiring throughout.

An Original Panelboard

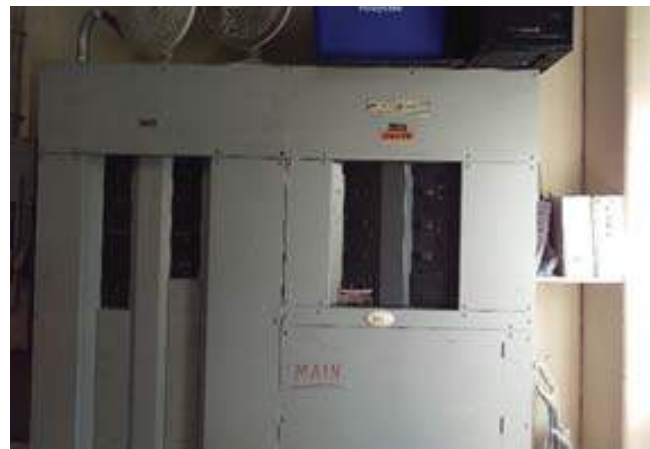
The service entrance to the building runs underground in conduit from the pad mount transformer to a 1962 vintage 450-amp, 208/120-volt 3-phase, 4-wire Bulldog Electric switchboard. The service equipment and conductors have exceeded their anticipated useful lives and should be replaced. In the short term, we recommend performing an infrared scan to assess the condition of terminations and contacts.

Service Entrance Switchboard

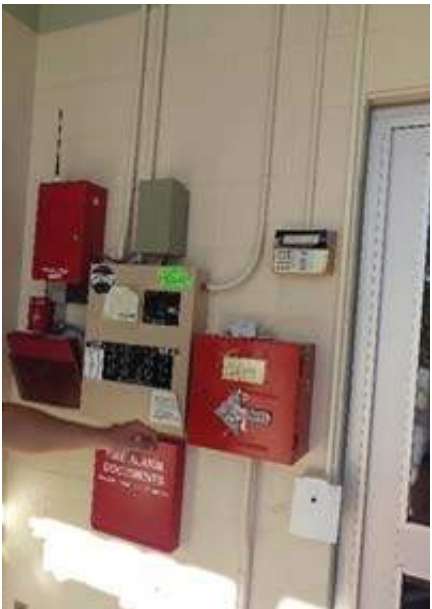
The fire alarm control panel is a 1980's vintage conventional 4-zone FCI control panel. Occupant notification does not comply with ADA or current standards. Some pull stations are not located as required by current standards. The system has exceeded its anticipated useful life and should be updated to a fully addressable system.

Fire Alarm Control Panel

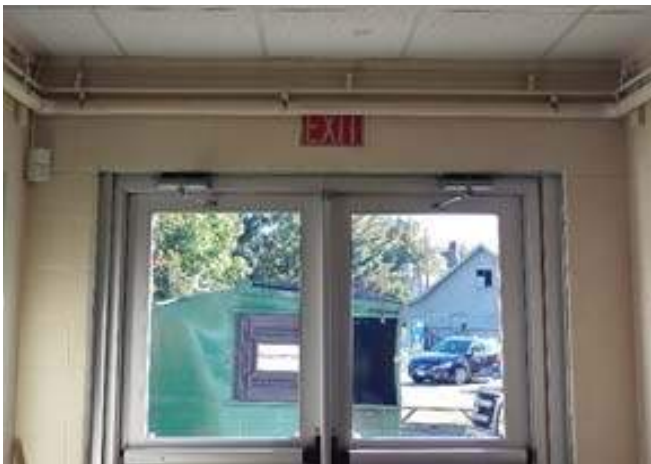
Emergency battery units with integral and remote incandescent heads provide illumination for means of egress. There is no emergency light at the exterior of building exits. Exit signs are appropriately located to mark means of egress, but some of the units are very old and do not have battery backup. All existing units will reach the end of their anticipated useful lives within 20 years. We recommend updating the emergency lighting units to and all exit signs to LED and providing outdoor emergency lighting at building exits.

An Original Exit Sign

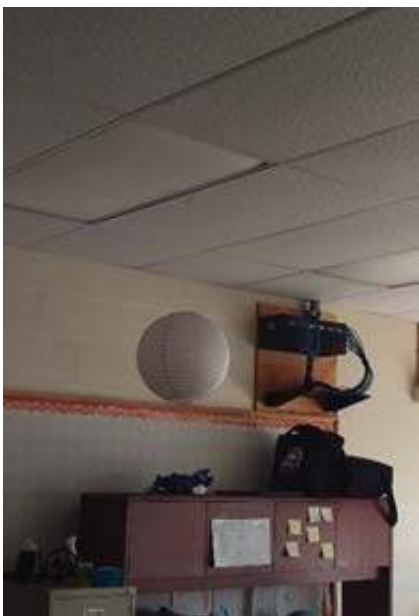
The Main Distribution Frame (MDF) is a wall mounted enclosed cabinet located in a shared space. WIFI network connectivity is available throughout the school. There is an abandoned exposed Category 5 patch panel and some horizontal cabling in a classroom that was once a computer lab. We recommend removing the abandoned Category 5 infrastructure and cabling and provide dedicated equipment spaces to house data networking terminations and equipment.

Abandoned Data Patch Panel

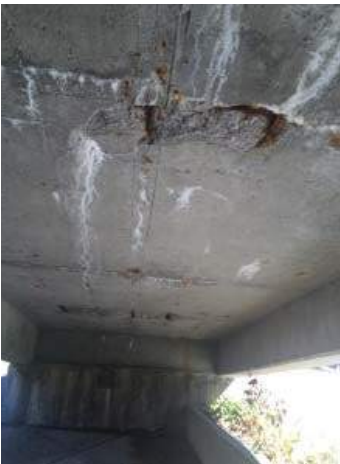
Structural Conditions and Concerns:
Ramp in poor condition and should be replaced or removed.

Ramp

ADA accessibility at this site is poor. The ADA ramp at the front of the building is in rough shape and is not ADA compliant or structurally sound. The ramp needs replacement. The grades at the building entrance are steeply sloping towards the entrance and do not conform to ADA standards. An ADA parking space is needed in the faculty parking lot.

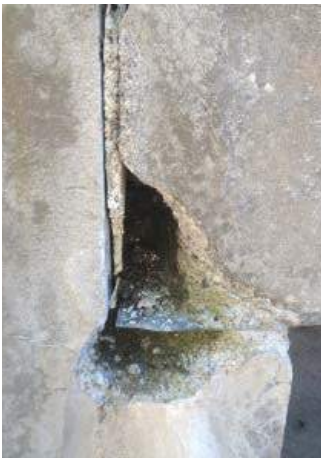
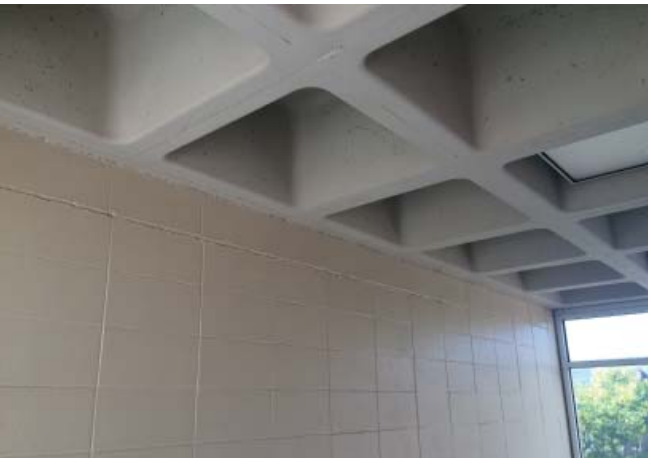
Stair crack

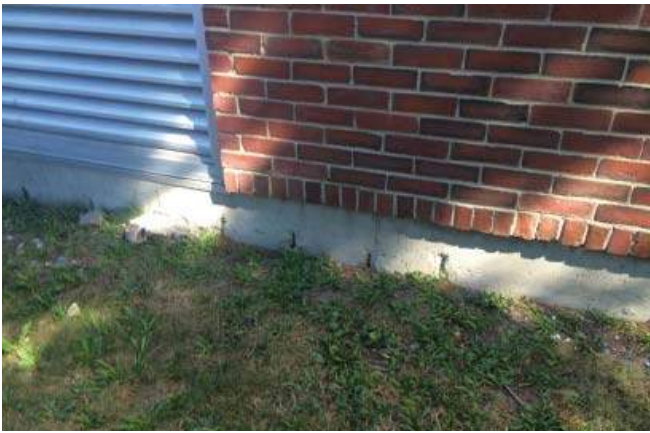
Spalling at foundation

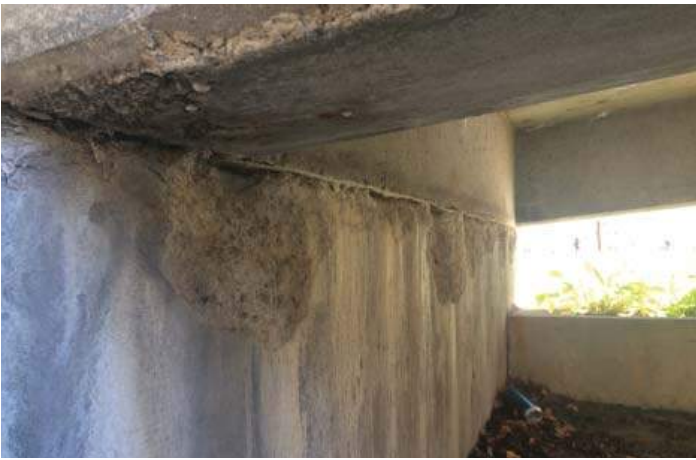
Ramp

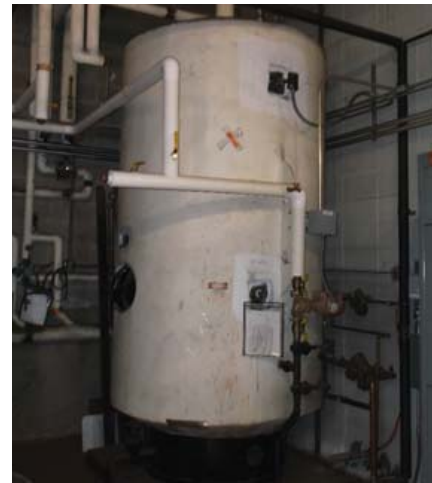
Indirect DHW Tank – Original Vintage

It is recommended to do a complete replacement of all piping systems with PVC piping for storm water and sanitary piping, and copper piping with lead free solder for distribution. The timing of replacement would depend on rate of piping failures or proposed building renovation projects.

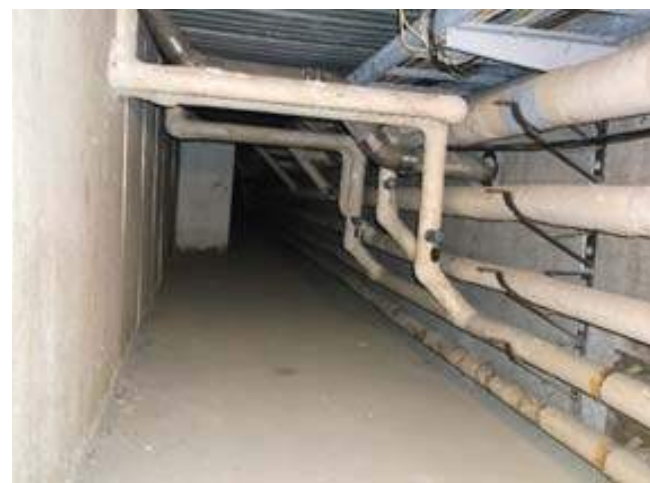
The water distribution, rain water piping and sanitary piping throughout the building is mostly original 1970's vintage and appears to be fair to good condition, however, they are at the end of their expected service life of 30 years.

Vintage Domestic Plumbing Piping Systems

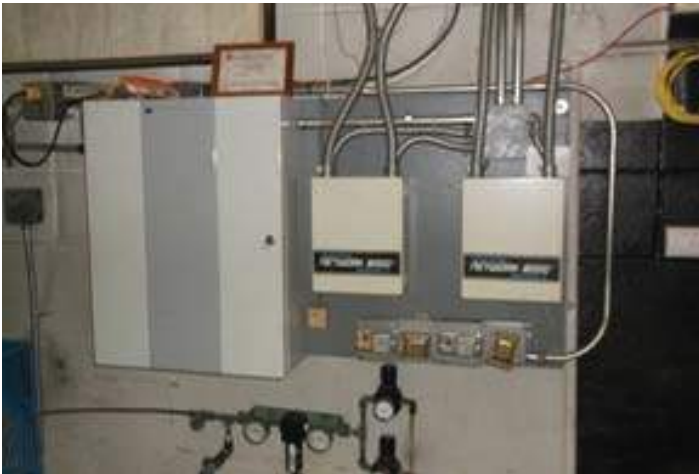
Pneumatic & DDC Temperature Controls

Most all of the BAS pneumatic and DDC electric system is beyond the useful service life and should be replaced with a new BAS. The new DDC system to include all 2-way HW control valves and provide VFD drives for new pumps and fan systems.

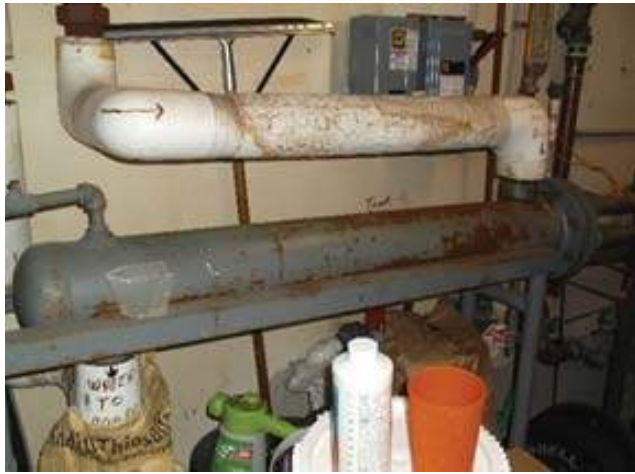
Swimming Pool Water HX Unit

HVAC piping system (45 years old) should be replaced where these systems are beyond their useful service life. Also Replace HX system serving the swimming pool.

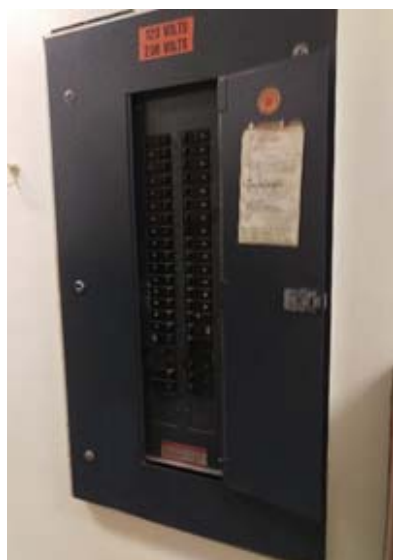
Panels and dry-type distribution transformers in most of the building are early 1970's vintage GE panelboards that have exceeded their anticipated useful lives. A 30-kVA transformer and panelboard were added in the boiler room in 2010, and a small addition currently in progress includes new panels and distribution transformers to serve the addition. Feeders are building wire in conduit; the wiring has exceeded its anticipated useful life. 1970's vintage equipment and its associated feeder conductors throughout the school should be replaced.

Typical 1970's Vintage Panelboard

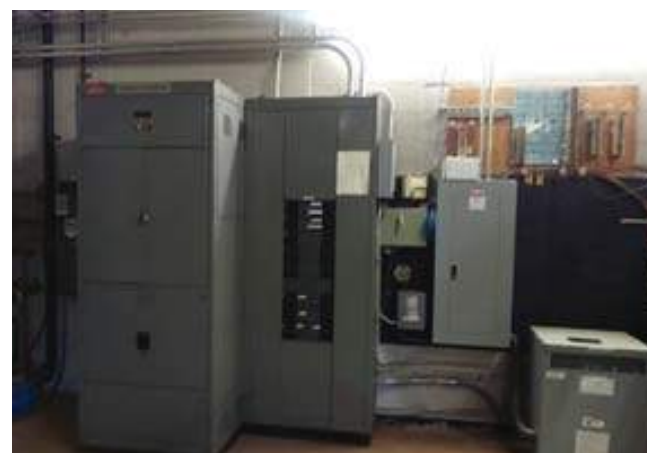
The underground service entrance from the utility transformer is building wire installed in conduit and terminates at an early 1970's vintage 600-amp, 480/277-volt, 3-phase, 4-wire GE switchboard. The service entrance conductors and switchboard are at the end of their anticipated useful lives. We recommend updating the secondary service and updating the underground primary to current CMP standards in conjunction with secondary service update.

Service Entrance Switchboard

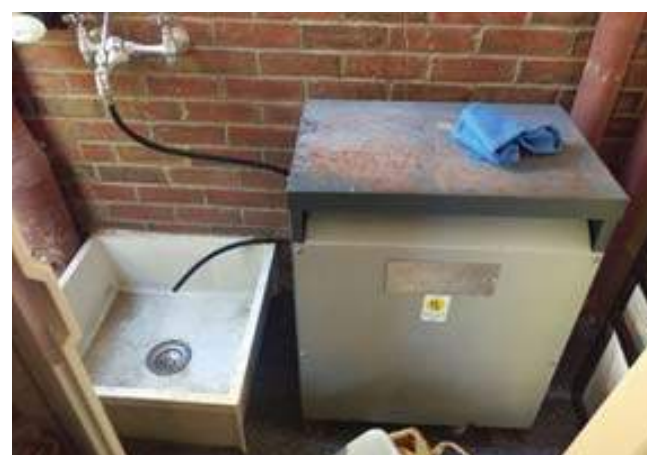
A 1970's Vintage Transformer

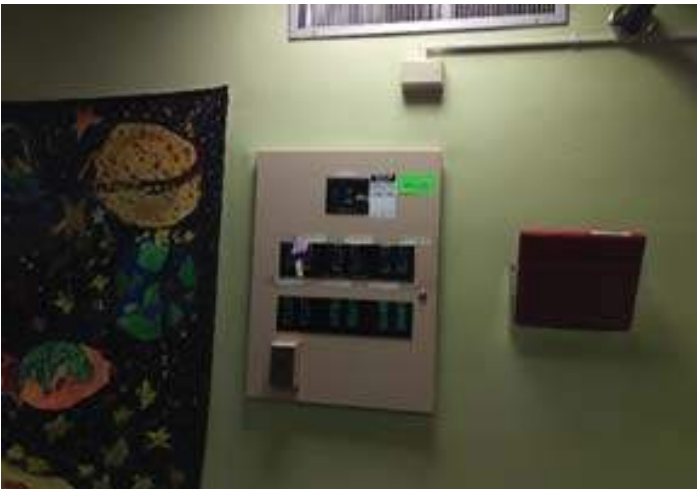
The system has an early 1990's vintage conventional zoned FCI control panel that has reached the end of its anticipated useful life. Occupant notification and pull station placement do not comply with current code or ADA in many areas. A sprinkler valve in the boiler room has no tamper switch. The system should be updated to a fully addressable system.

Fire Alarm Control Panel

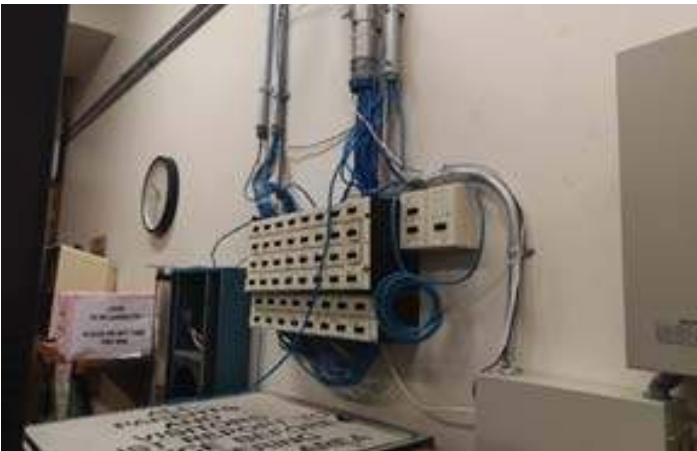
Abandoned Category 5 Infrastructure at MDF

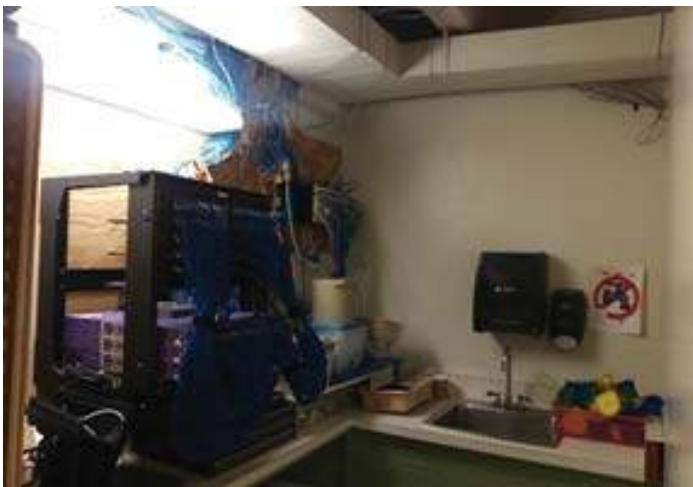
The building has an overhead fiber optic entrance that terminates within an enclosure in a second floor classroom. Intermediate distribution frame (IDF) equipment on second floor is located in an open wall mounted rack that is in a room shared with other program functions. Unused Cat 5 infrastructure is abandoned in place at the second floor IDF and other areas. WIFI network connectivity is available throughout the school. Old infrastructure that is no longer in use should be removed. We recommend providing enclosed cabinets to house infrastructure in shared-use areas.

IDF on Second Floor in Shared Space

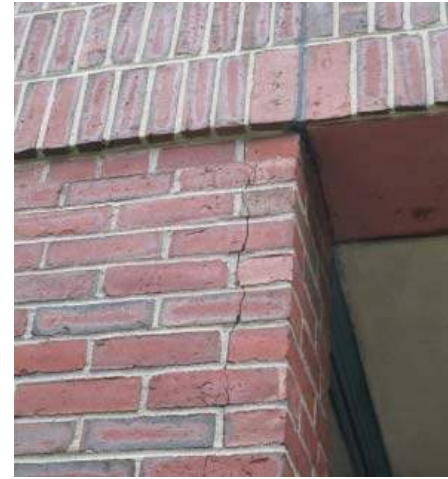
- There are (4) lintels over entries to the classrooms that span in excess of 25 feet. These lintels carry exterior brick weight, as well as roof weight and snow loads. The end reactions at the lintels due to all of the load are significant, and the bearings beneath the lintels are cracked.

Bearing cracks at long spanning lintels

- Recommend repairing the cracks and installing solid/grout filled CMU where possible to prevent future cracks and provide adequate load paths to the foundations.

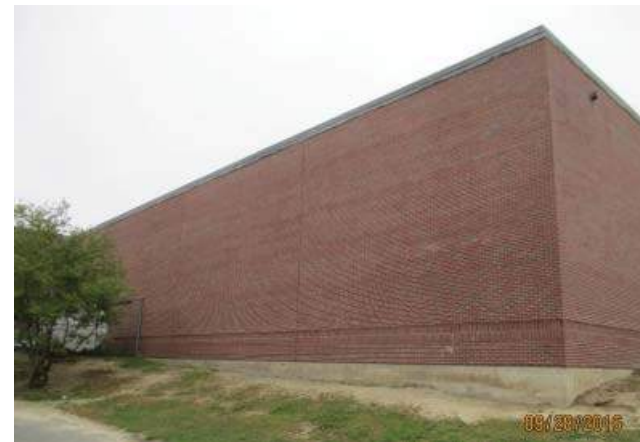
- At one of the exterior building corners at the gymnasium, some of the grading has been swept or washed away. It's likely the foundations at this corner do not have adequate frost protection. Signs of heaving/frost related damage were not observed.

Possible loss of foundation protection at Gym

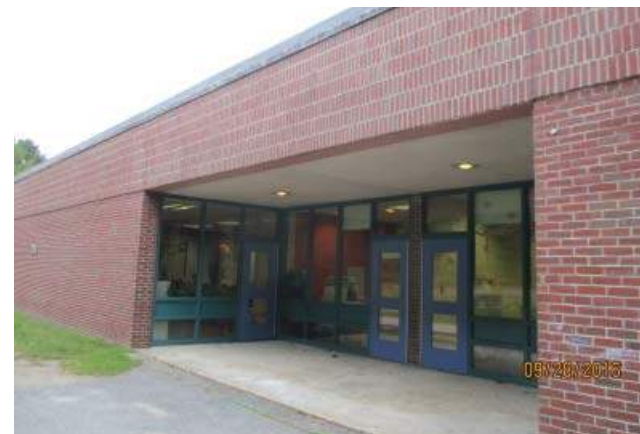
Long spanning lintel

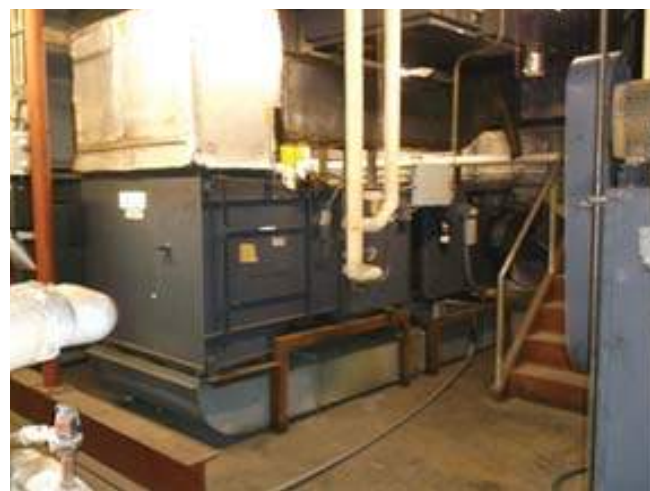
Ventilation air is supplied thru centrally located H & V and AHU ducted units which operate in sequence with inline or rooftop exhaust fans. The H & V units were replace in 2006 and have an expected service life of 25 years. Most all AHUs (heating & cooling) located in the mezzanine were replaced in 2006 and 2008 and have an expected service life of 25 years. The remaining AHUs in the mezzanine (AHU-6, 7, & 8) are original to the building and beyond their expected service life of 25 years; they should be replaced in kind with new efficient AHU systems. The associated exhaust fans have an expected service life of 25 years. The Natatorium dehumidification ventilation unit was installed around 2003 and has an expected service life of 15 years. It has been stated that this dehumidification unit has not been performing as expected, therefore a replacement unit should be considered, especially where it is nearing the end of its service life.

AHU-8 Original Equipment To Be Replaced

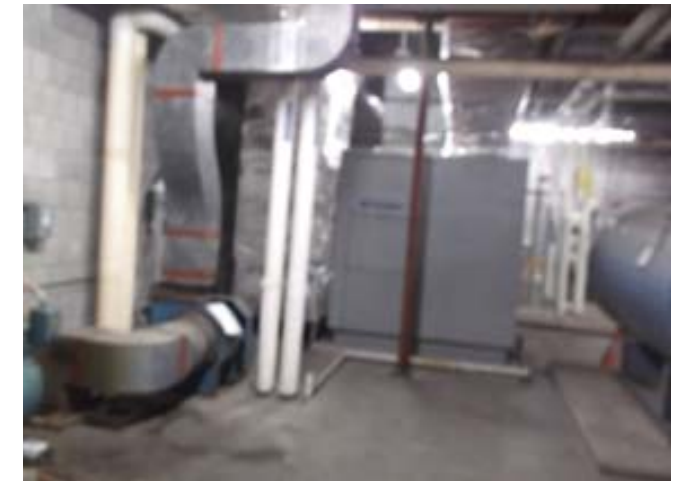
AHU-4 Installed Around 2008

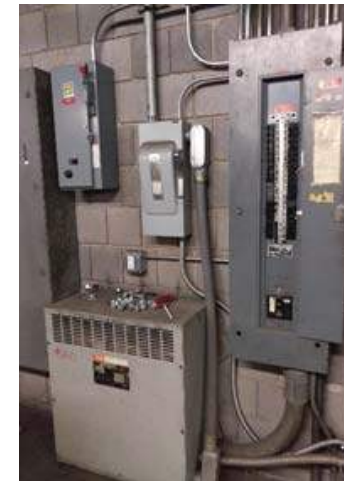
A 1976 Vintage Panelboard and Transformer

Feeders are building wire in conduit. The wiring to 1976 vintage panelboards, transformers, and motor control centers has exceeded its anticipated useful life and should be updated in conjunction with equipment updates.

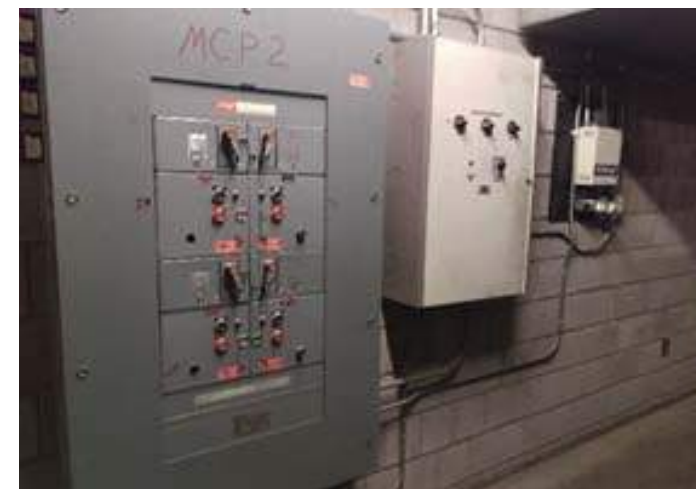
There are two 1976 vintage FPE motor control centers located in the Mechanical Mezzanine. These have exceeded their anticipated useful life and should be replaced.

A 1976 Vintage Motor Control Center

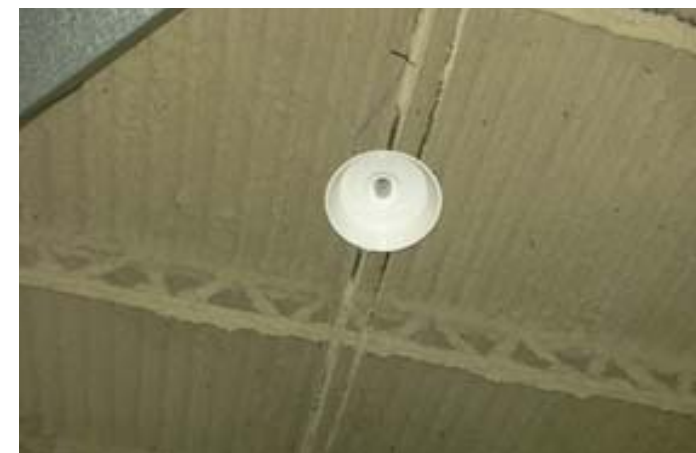
An Incandescent Fixture in the Mezzanine Mechanical Room

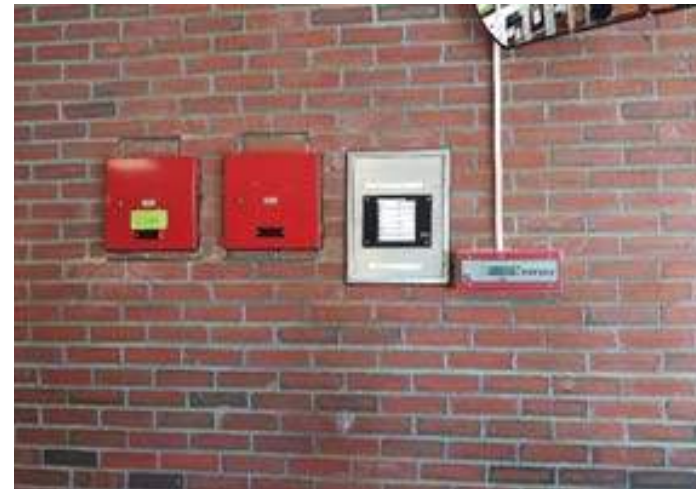
Current Fire Alarm Annunciator and an Abandoned Adjacent Annunciator

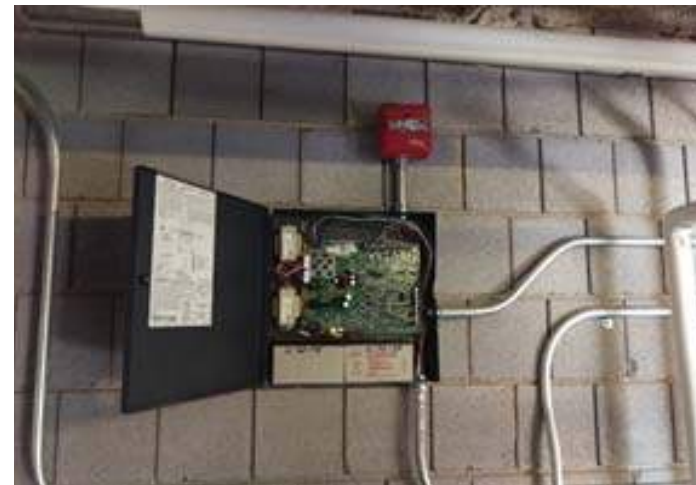
The fire alarm system is an addressable system with a Faraday control panel. The system generally complies with current standards and ADA, although some notification circuit power supplies have batteries that have exceeded their anticipated useful life. Any system batteries that are older than five years old should be replaced. The entire system will reach the end of its anticipated useful life within 15 years.

A Notification Power Supply with Old Batteries in a Mechanical Penthouse

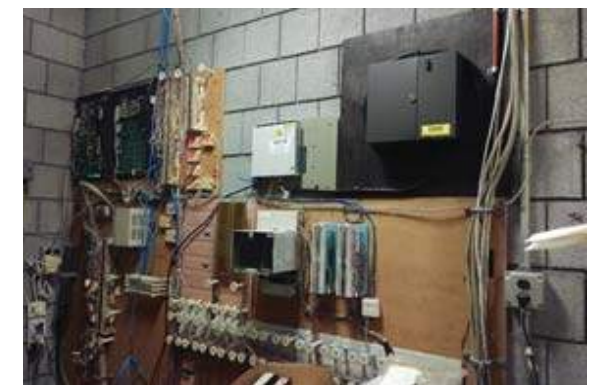
Telephone Utility Demarcation – Much of this equipment appears to be abandoned in place.

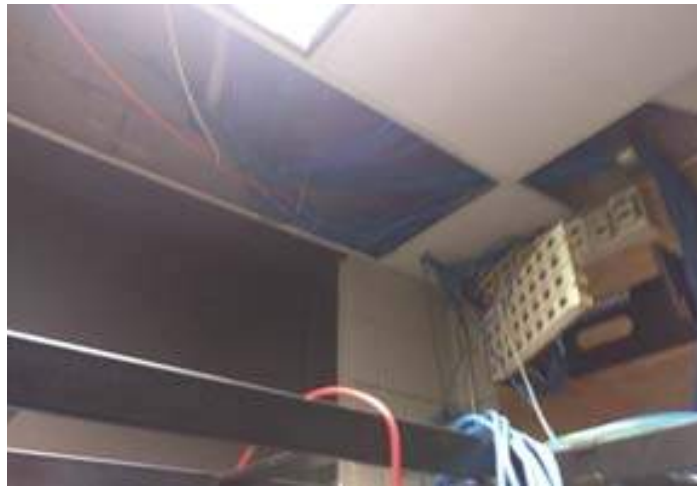
The data networking and telecommunications cable plant has been updated to Category 6, but the old cables and infrastructure were abandoned in place. The intermediate distribution frames (IDF's) are located in spaces shared with other program uses. WIFI network connectivity is available throughout the school. Abandoned cables and telecommunications infrastructure should be removed. Classrooms are equipped with ceiling mounted projectors for audio/visual presentations.

*Abandoned Category 5 Patch Panel & Cable*

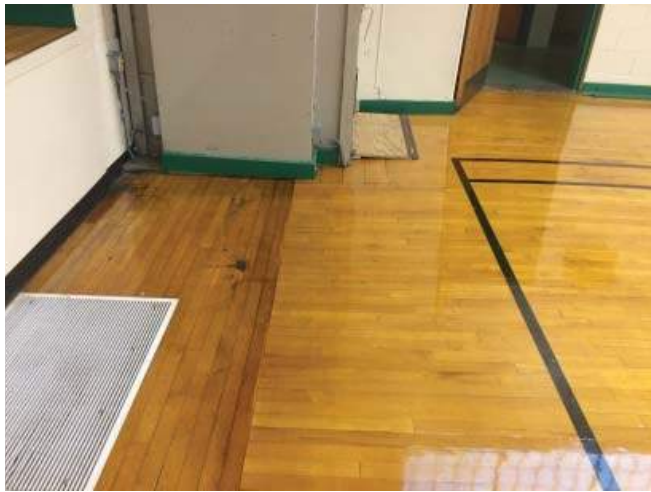
Gym Settlement

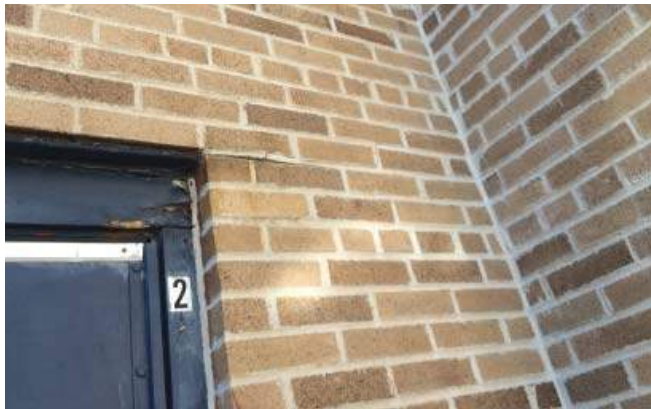
Lintel condition

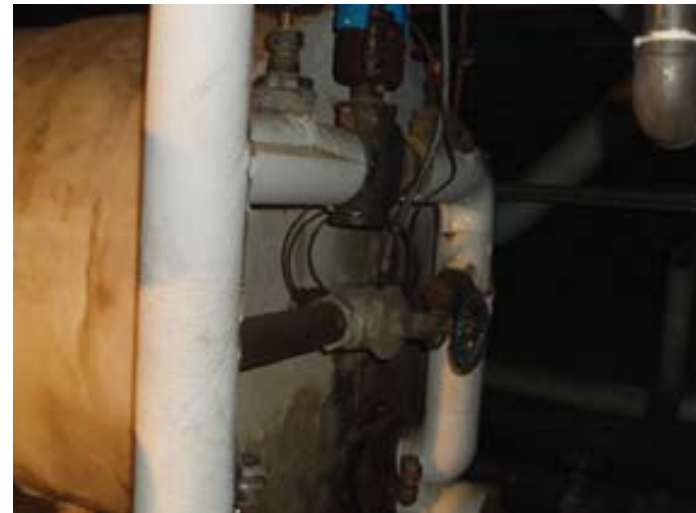
Steam generated DHW & Storage at Gym

The existing plumbing systems and fixtures are well maintained and in good condition considering the age of the original systems. Continued maintenance on plumbing systems is required for the 1996 addition and consideration of plumbing piping systems upgrade of the original plumbing systems. The new piping system will have lead free solder, current code requirement. Replacing the steam generated DHW at the gym with a gas fired DHW, or indirect DHW via HW when a steam to HW conversion project is considered.

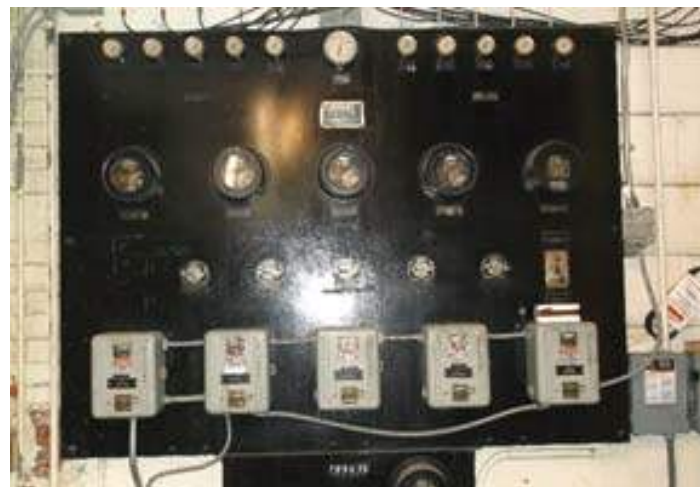
Temperature controls serving the heating system and equipment is mostly pneumatic with little DDC electric in the boiler room and 1996 addition. The pneumatic control system is aged and beyond its useful service life of 20 years. The DDC electric system is nearing the end of its useful service life if the existing equipment is of 1996 vintage.

Vintage Pneumatic Temperature Control Panel

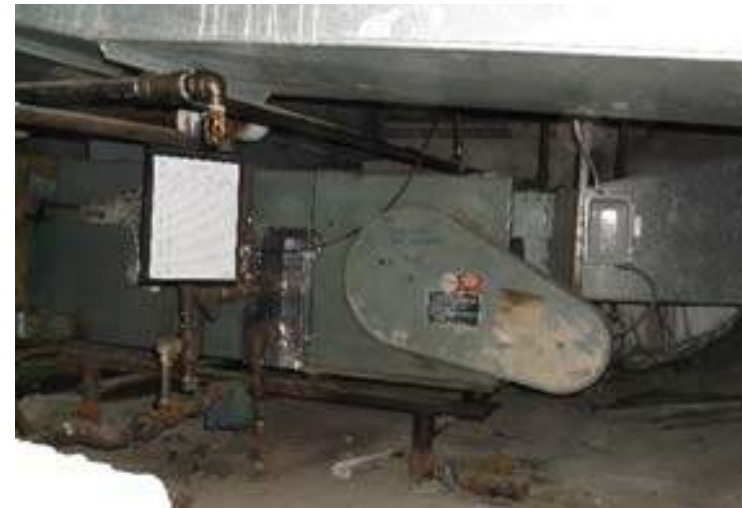
Steam H&V in Crawl Space by Gym

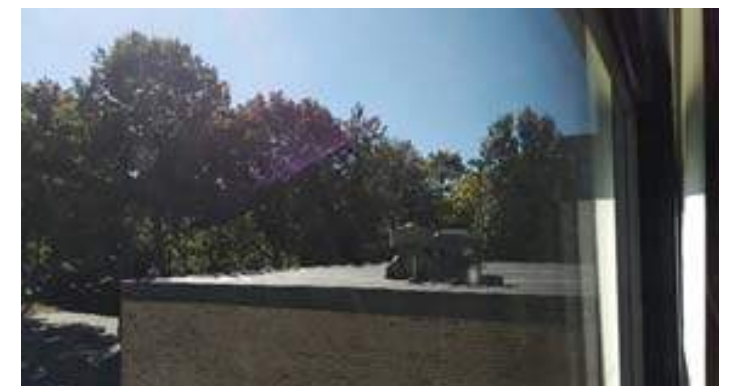
A small 2010 vintage Briggs and Stratton single-phase generator that is located on the roof of the mechanical room provides backup power to the UPS at the City's network core rack via a residential/light-commercial grade automatic transfer switch and load center. This equipment is in good condition, but does not offer capacity to serve any building systems other than the data center it currently serves.

Backup generator on roof

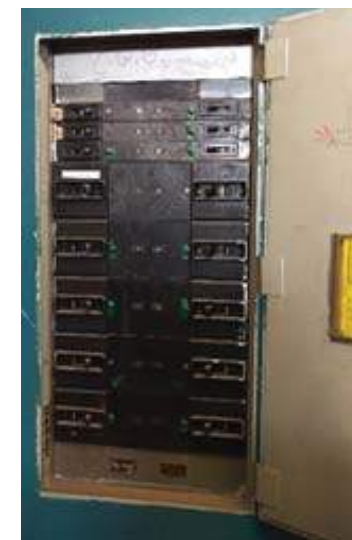
Branch-circuit panels in the school are primarily a mixture of 1950 vintage Trumbull Electric panelboards that have exceeded their anticipated useful life and 1996 vintage Square D panelboards. A New Panelboard was recently added as part of the Health Center project, and a residential-grade Siemens load center is installed in the crawlspace beneath the Fitness Room. It was noted that panel P1A in the boiler room is mounted

1950's vintage panelboard

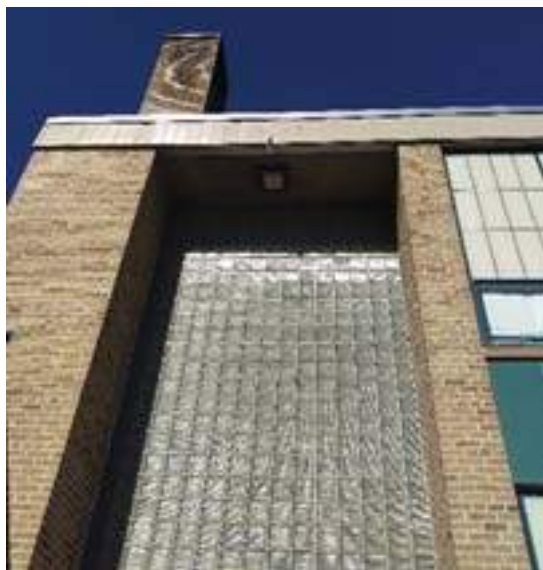
There are no existing pole lights. Building mounted exterior lighting is primarily LED wall packs with full cutoff optics, but recessed fixtures that appear to utilize HID or compact fluorescent lamps remain at in use at a couple of entrance canopies. It appears that some areas of the site are not illuminated to levels recommended by IES. We recommend providing full-cutoff LED pole lights for the site and adding building mounted full cutoff LED outdoor lighting to provide illumination as recommended by IES.

Light fixture at an entrance canopy

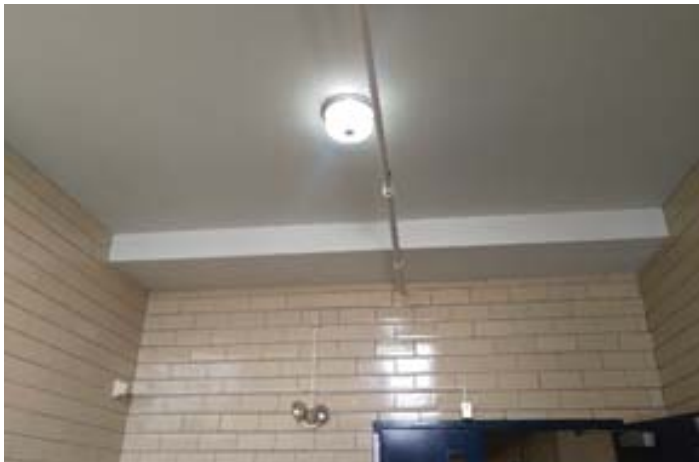
Emergency battery units with integral and remote heads provide emergency lighting for means of egress. The heads are a mixture of LED and incandescent. There is no emergency lighting at the exterior of exits. The LED emergency lighting units are in good condition and offer more than 10 years of anticipated useful life provided they are properly maintained and batteries are replaced as needed. Older incandescent units should be replaced with modern LED units as they fail. Outdoor emergency lighting should be provided at building exits.

Incandescent emergency light heads

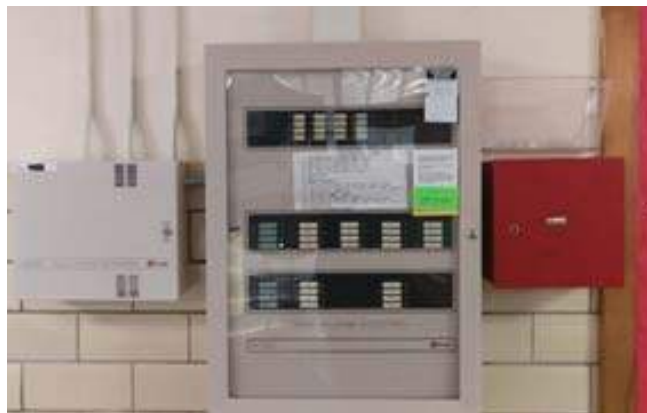
The fire alarm control panel is a Simplex 4002 series conventional zoned system. Occupant notification is not compliant with current code or ADA except in the Health Center. The system has exceeded its anticipated useful life and should be updated to a fully addressable system.

Fire alarm control panel

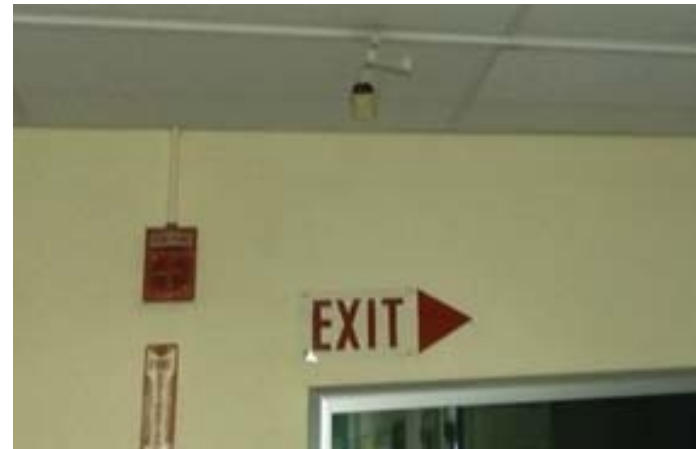
An old horn/strobe

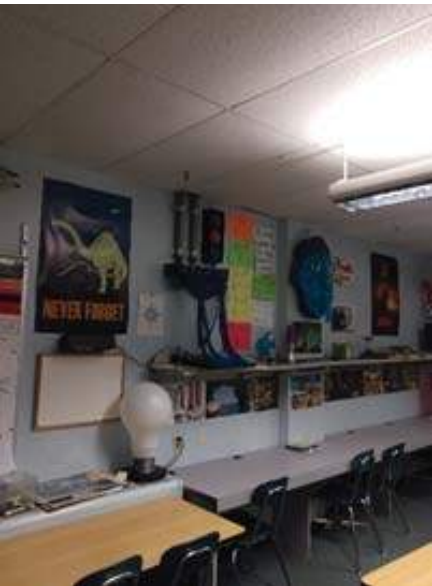
IDF in open rack in a classroom

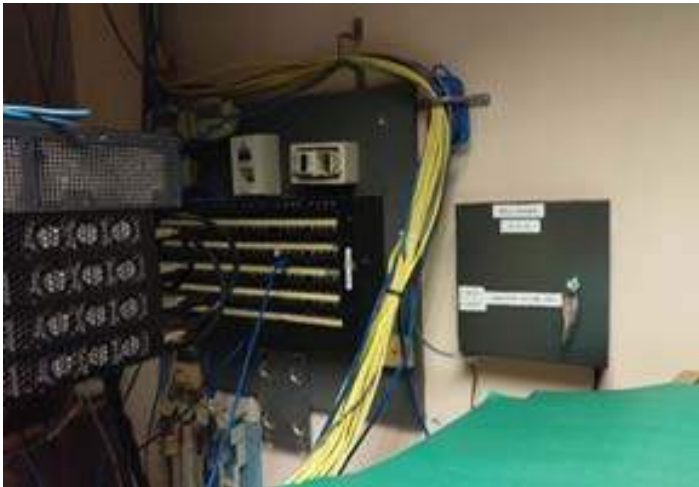
used Category 5 cabling and infrastructure was noted at the MDF location. Abandoned Cat. 5 infrastructure and cabling should be removed. Dedicated equipment spaces to house IDF's should be provided.

Abandoned Category 5 infrastructure

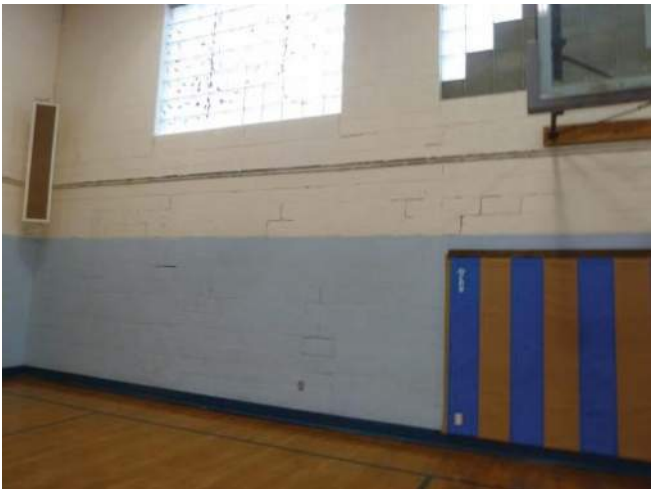
Stepped cracks

Cracks in the north-west building west wall.

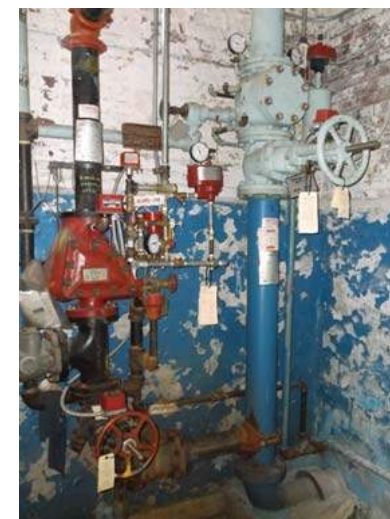
The 6" sprinkler entrance is supplied by municipal water and does not have a testable backflow preventer. The sprinkler system is a complete automatic wet & dry system with (2) risers. There was no obvious fire department connection. There is a labelled "Glycol Loop" serving the cold attic area above the gym entrance. The piping system has what appears vintage 1960s serving the wet riser and later, perhaps 1990s for the dry riser. Recommend contacting the Authority Having Jurisdiction as well as a Sprinkler Design Contractor assess current systems.

Fire Sprinkler Entrance – Dry Pipe Left Riser

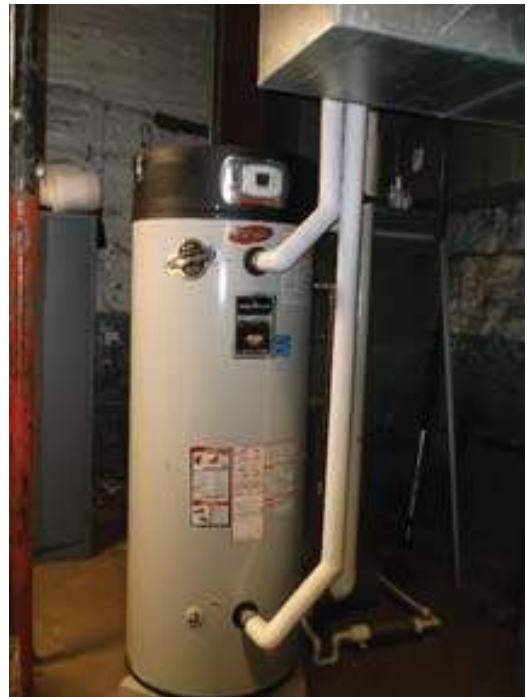
Steam generated DHW & Storage at Gym

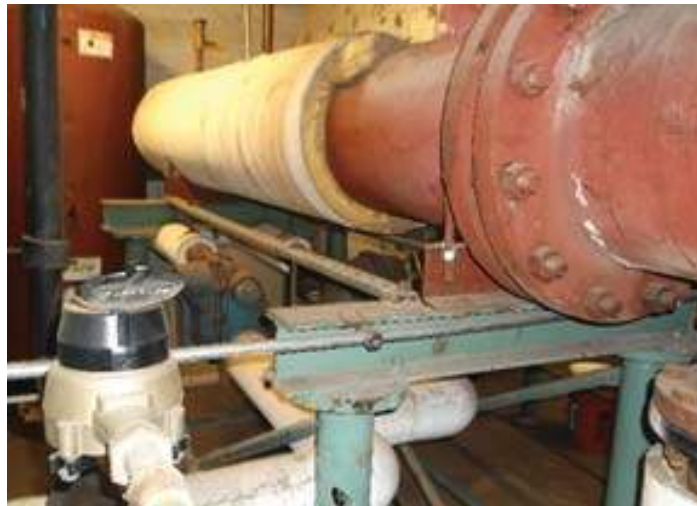
Steam to HW Heat Exchanger

The existing HVAC systems in general are fair operating condition, however, most all equipment is at or near the end of its useful service life (especially the steam system). How and when to replace the equipment depends on whether there are planned building renovations or replace systems as a major HVAC upgrade. It is recommended that the boiler feed pump system be replaced soon regardless of scheduling systems upgrades. The best recommendation is to convert the original building to heating hot water which will replace the aged equipment and steam / condensate piping. Steam piping controls and traps have been maintained but piping failures may increase in the near future. It would be most economical to replace all heating and ventilating equipment with new systems at the time of the steam to HW conversion. Also coordinate the temperature controls DDC electric upgrade at the time of conversion.

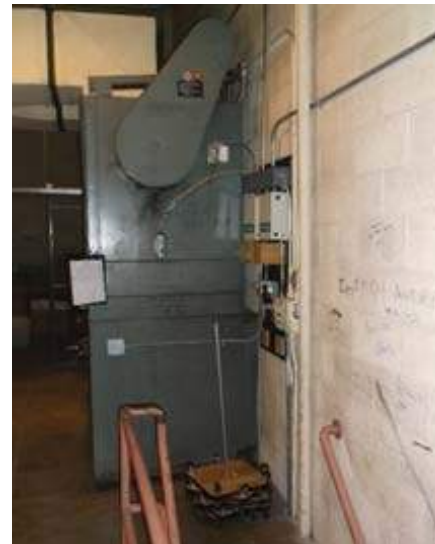
Steam H&V Serving the Gym

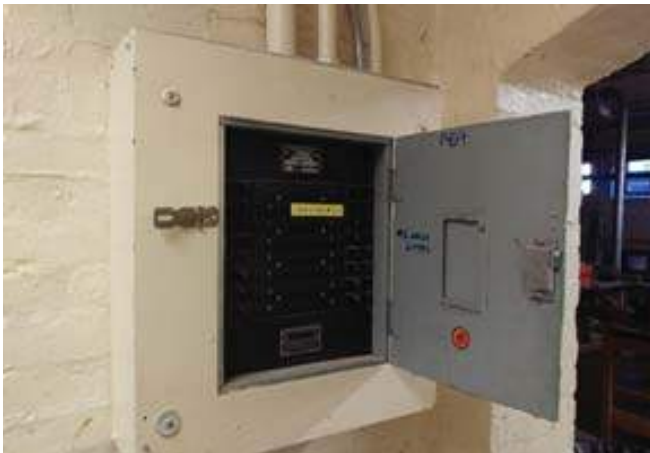
Panelboards are generally 1998 vintage GE panelboards, although there is a 1960's vintage panelboard in a corridor outside of Tech Ed and a 1970's vintage residential/light commercial grade load center on the stage. The panelboard serving Tech Ed is equipped with a contactor controlled by emergency-stop pushbuttons. We recommend replacing the old panelboard near Tech Ed and the load center on the stage in the short term. All Panels will reach the end of their anticipated useful lives within 15 years.

Old panelboard near Tech Ed

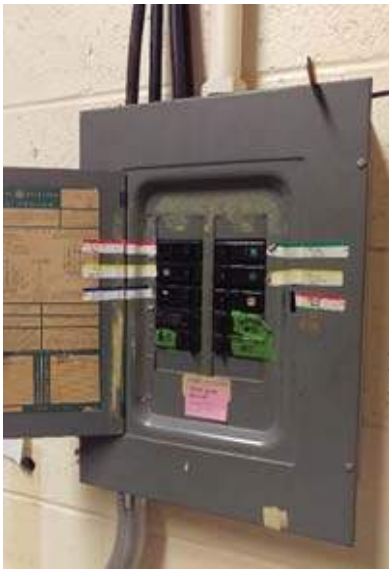
Old load center on stage

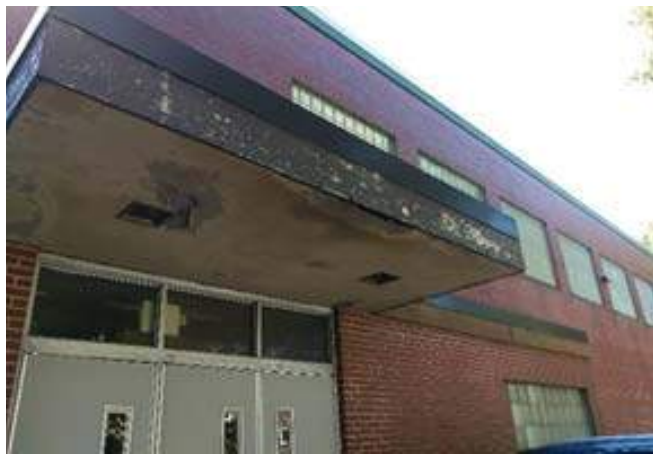
There are no pole mounted site lights. Building mounted exterior lighting is mostly LED wall packs with full-cutoff optics, but some old incandescent fixtures remain at building exits. It appears that some areas of the site are not illuminated to levels recommended by IES. We recommend providing full cut-off LED pole mounted fixtures to provide illumination as recommended by IES. In the short term, old incandescent fixtures should be updated to LED. All existing fixtures will reach the end of their anticipated useful lives within 20 years.

Old incandescent fixtures at a secondary entrance canopy

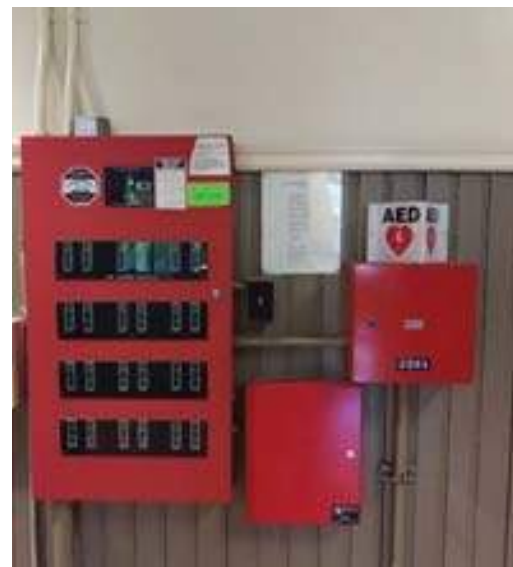
The fire alarm control panel is a 1998 vintage conventional zoned FCI control panel. Occupant notification does not comply with ADA or current standards in some areas; the classrooms are not equipped with visual notification appliances. The system is near the end of its anticipated useful life and should be updated to a fully addressable system within 5 years.

Fire alarm control panel

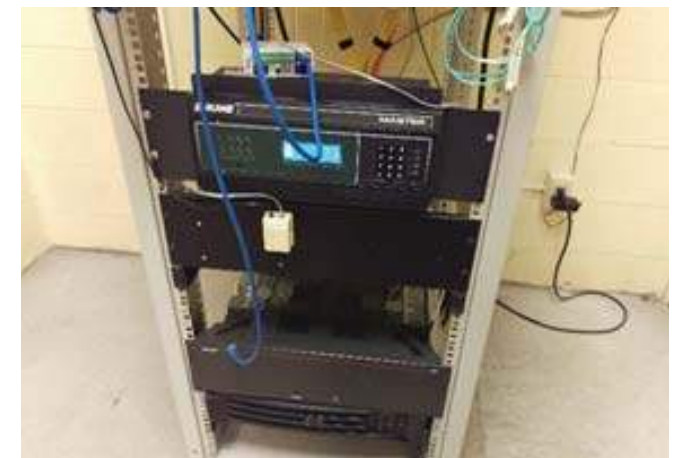
The school is equipped with a 1998 vintage Dukane master clock. A network-connected programmable relay operates program bells and resets clocks. The master clock system is functional but obsolete. Battery clocks can be utilized when system clocks fail.

Master clock and paging amplifier

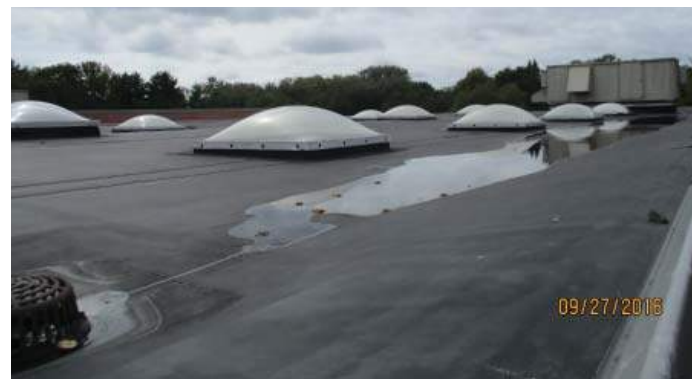
- Area of poor drainage observed at cafeteria roof (2-3" of ponding water). Recommend improving drainage and roof slope at this location.
- Observed stones from higher ballasted roofs blown onto lower roofs. Ballasted roofs are not permitted by current building code for the City of Portland. Recommend removing the ballasted roofs and replacing with EDPM.

Inadequate roof drainage at Cafeteria roof

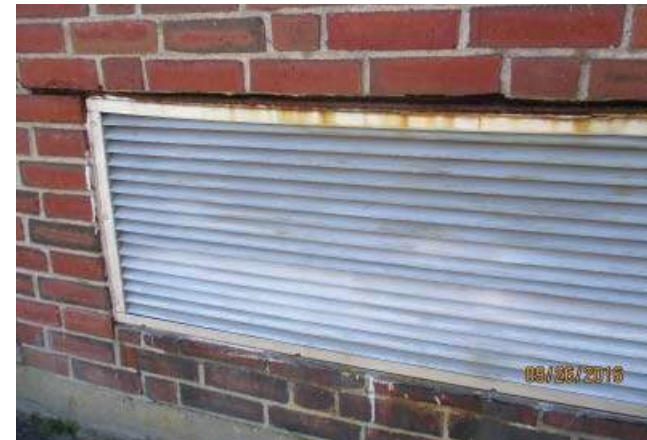
- In older portions of the building, window and door lintels are rusting. Recommend replacing them in the near future. In newer portions, lintels are galvanized and do not require repairs at this time.

Corroded lintel in need of replacement
