Facilities Assessment of School Buildings

City of Portland and Portland Public Schools

VOLUME 1

February 28, 2017

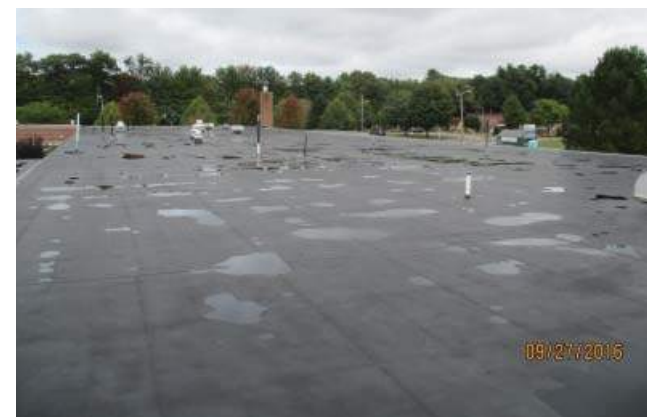
- At areas of newer construction, the base sealants between the bottom of brick and top of foundation have deteriorated, and should be replaced.
- Roof over the first major addition to the original building is very flat and does not shed water well. Many areas of ponding observed. Recommend adding materials to increase roof slope to the drains.

Inadequate roof drainage at classroom addition

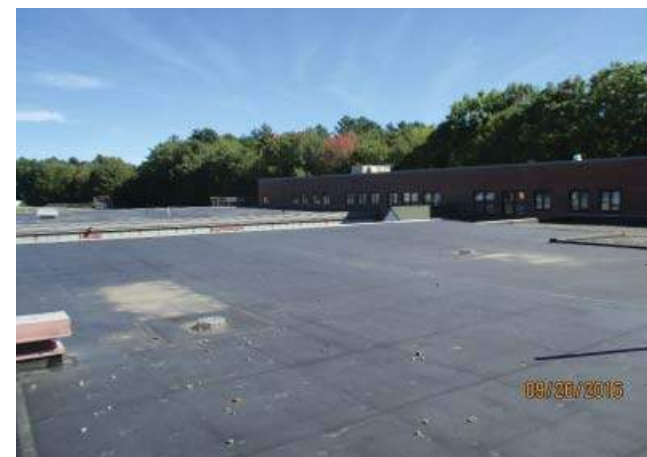
- Area of poor drainage observed at cafeteria roof (2-3" of ponding water). Recommend improving drainage and roof slope at this location.
- Observed stones from higher ballasted roofs blown onto lower roofs. Ballasted roofs are not permitted by current building code for the City of Portland. Recommend removing the ballasted roofs and replacing with EDPM.

Recommend replacement of roof ballast

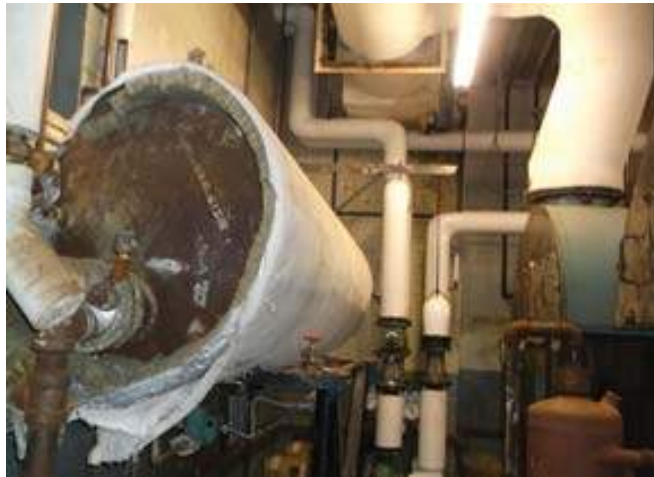
Steam DHW Maker

age of the original systems. Continued maintenance on plumbing systems is required for the 1996 addition. The 1950s plumbing piping systems are beyond their expected service life and will require complete replacement as they begin to fail. The new copper piping system will have lead free soldered joints, a current code requirement. The steam indirect DHW maker is beyond its expected service life; replace unit with a gas fired DHW.

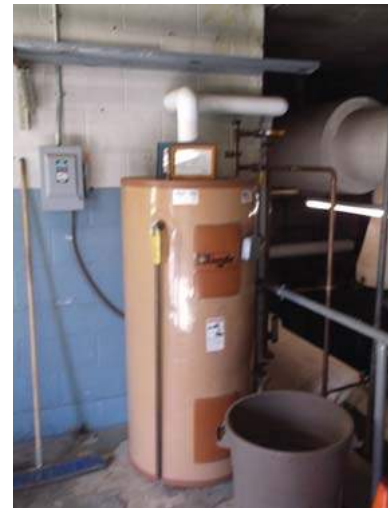
40 Gal Electric Water Heater

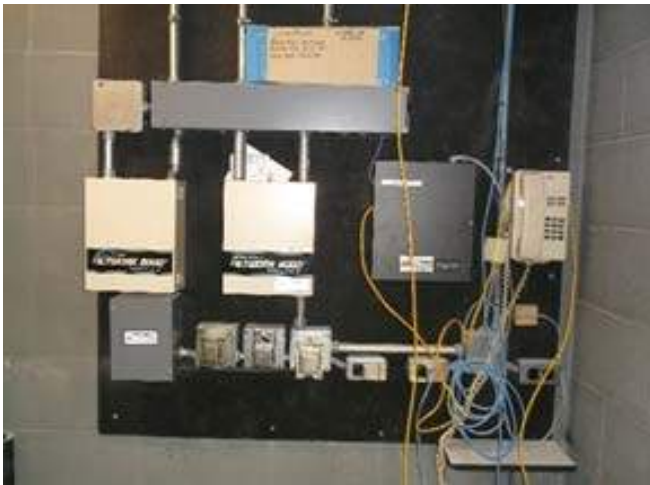
Vintage Pneumatic Temperature Control Panel

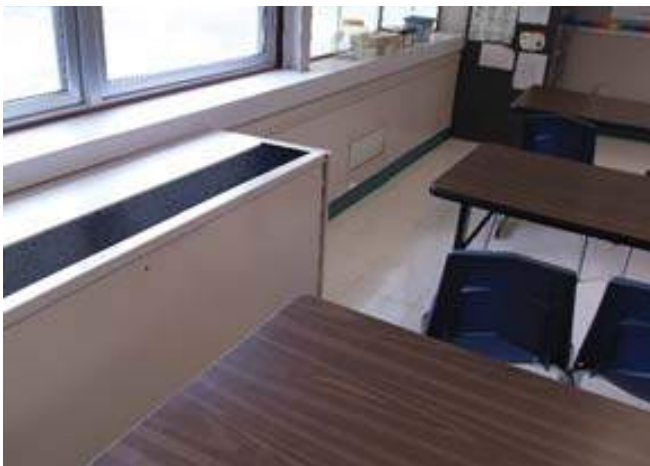
Steam UV in Classroom

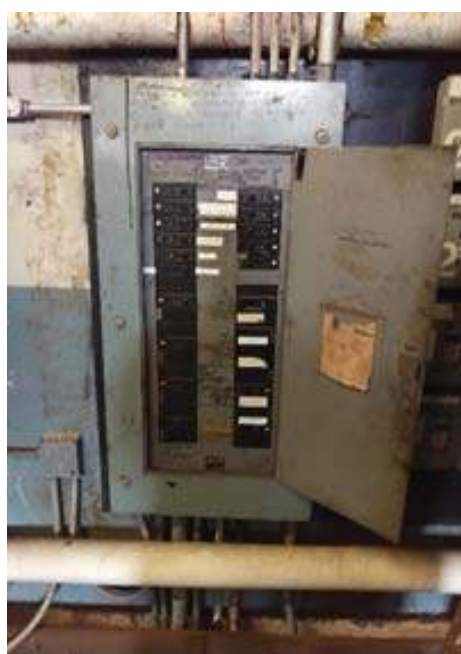
Branch-circuit panels throughout the building are a mix of 1960 vintage and 1995 vintage panelboards. Their feeders are building wire in conduit. The 1960 vintage panelboards and their feeder conductors have exceeded their anticipated useful lives and should be replaced. The 1995 vintage panelboards will reach the end of their anticipated useful lives within 10 years, and their feeder conductors will reach the end of their anticipated useful lives within 20 years.

1960 vintage panelboard in boiler room

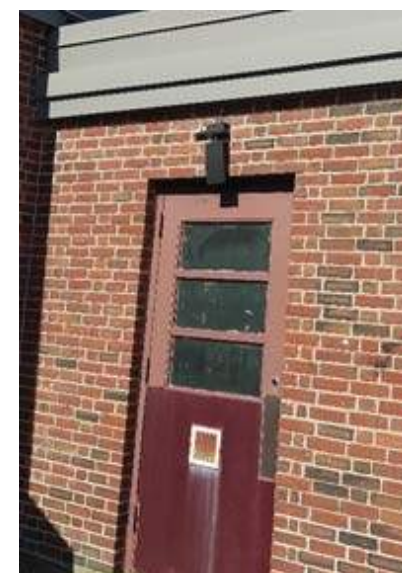
Exterior Building Lighting has been updated to LED wall packs in recent years. Some fixtures are not properly secured and in need of repair or replacement. The building mounted fixtures will reach the end of their anticipated useful lives within 20 years.

A broken wall pack

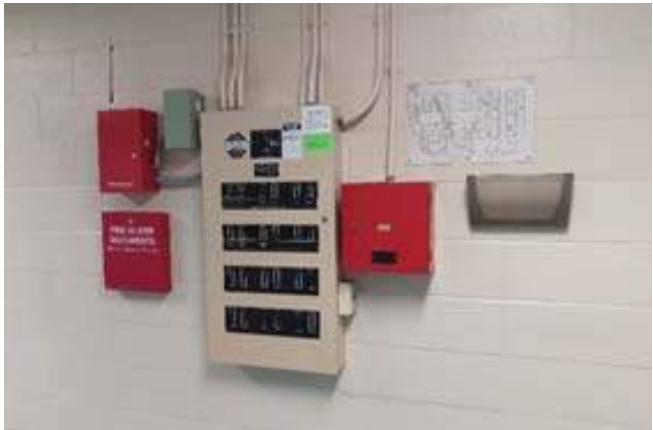
The fire alarm control panel is a 1980's vintage conventional zoned FCI control panel. Occupant notification has been update to comply with ADA requirements in approximately 1/3 of the building, but remaining areas do not comply with current standards. The control panel is obsolete. We recommend updating to a fully addressable system.

Fire alarm control panel

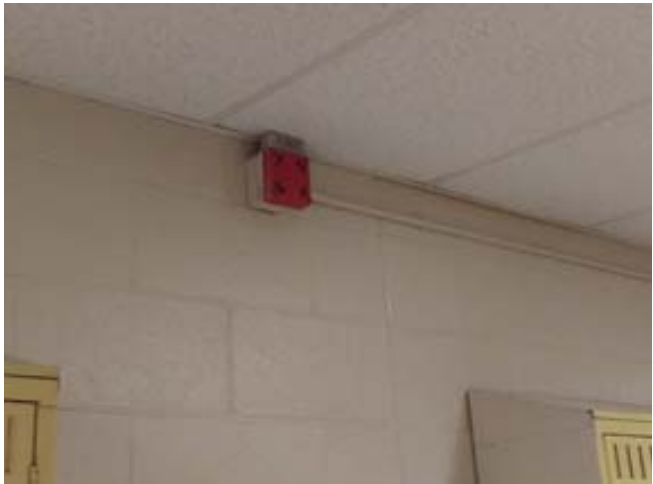
An obsolete notification appliance

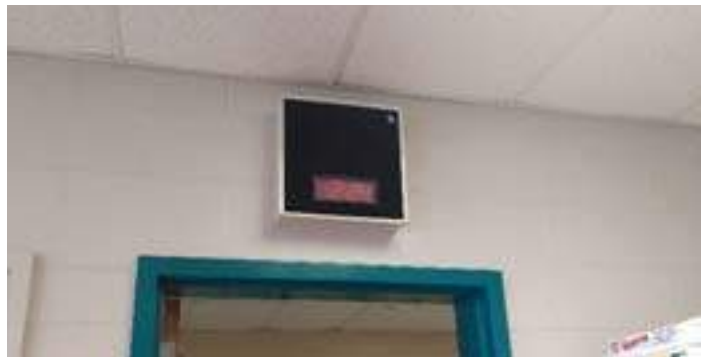
The school is equipped with a 1995 vintage Dukane master clock. A network-connected programmable elay operates program bells and resets clocks. The master clock system is functional but obsolete. Battery clocks can be utilized when system clocks fail.

Typical system clock

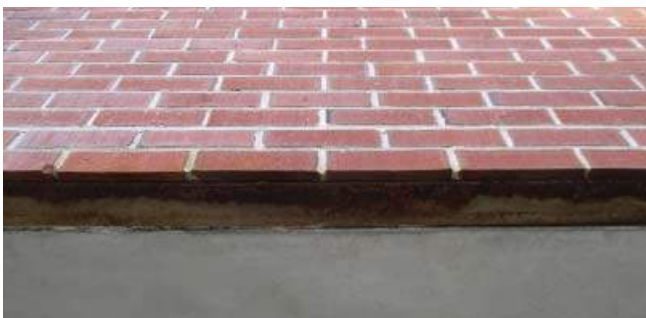
- Lintels at windows and doors, as well as relieving angles at cantilevered construction, are not galvanized and are rusting. Recommend replacing the lintels in the near future. Repairs to relieving angles over large openings and at cantilevered projections will be difficult and expensive. Thus, we recommend monitoring these conditions periodically and performing repairs on a case by case basis.

Corroding relieving angle

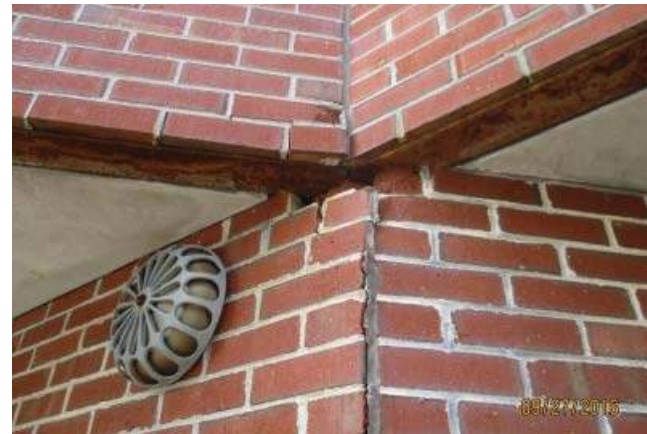
Corroding relieving angle

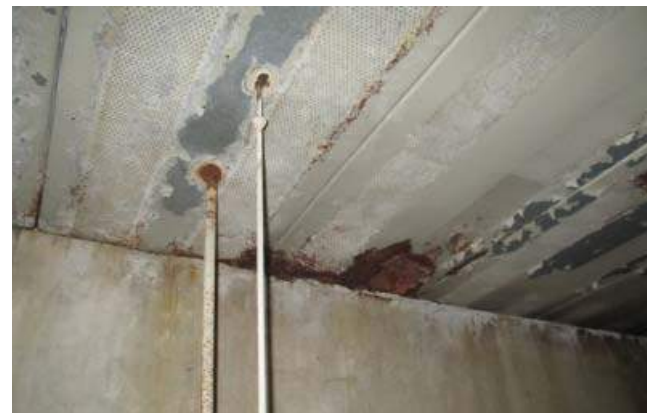
Second floor deck corrosion below bay doors

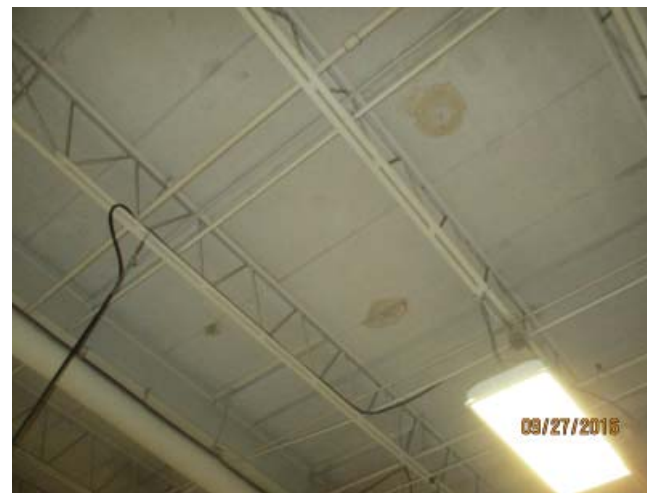
- Tectum deck in both buildings is not connected to roof structure in either building. The tectum can be pulled off the building during a severe wind uplift event. Without the connections, the tectum also does not provide any bracing for the top chord of the roof joists, which reduces the joist capacities. We recommend adding connections to the roof joists in the near future.

Tectum deck with tie down connections

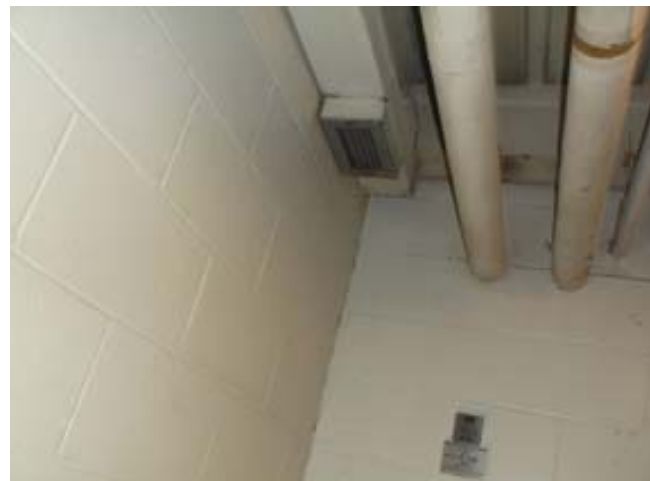
Plumbing sanitary, vent, and rain water piping consists of cast iron original building. Water distribution piping is copper. Most piping is in fair to good condition, however the 1970s piping systems are beyond their useful service life of 30 years.

Vintage Domestic Water Piping

Where the original piping systems are beyond their useful service life, it is recommend to replace the piping systems before they start to fail. Install new PVC piping for Sanitary, vent and rainwater piping systems and new copper piping for CW & HW distribution systems; the copper piping will have lead free solder, a current code requirement.

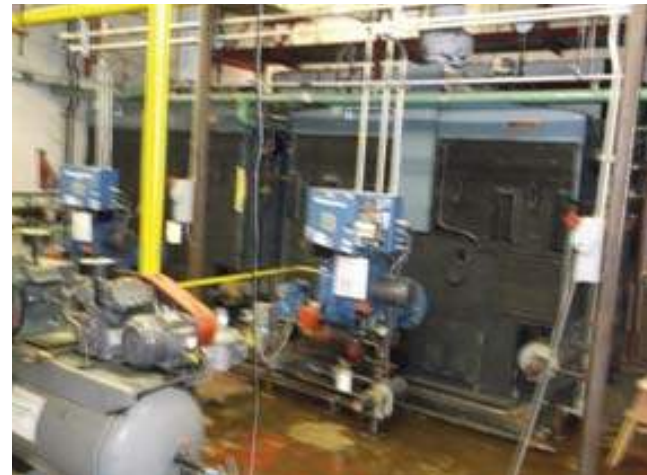
Most all HVAC systems, boiler plant, piping distribution systems, and temperature controls are beyond their expected service life with the exception of a few packaged RTUs on building A roof which are anywhere from recent replacements to RTUs at mid-life. It is recommended to replace the existing heating plant, distribution piping systems, H & V equipment, and heating terminals with new hot water heating equipment and piping. Where natural gas already exists at the building a condensing boiler plant with VFD hot water pumps would provide the most efficient heating system. Replace existing UVs and roof top H & V units that serve Building B with new ERUs and low temperature fintube as a cost effective option. New direct fired gas MUA units will provide makeup air to the shop spaces in lieu of MUA units with HW coils that require freeze protection. The building requires complete new DDC electric temperature controls system with graphics that will integrate with City's front end components.

Existing Steam Boilers

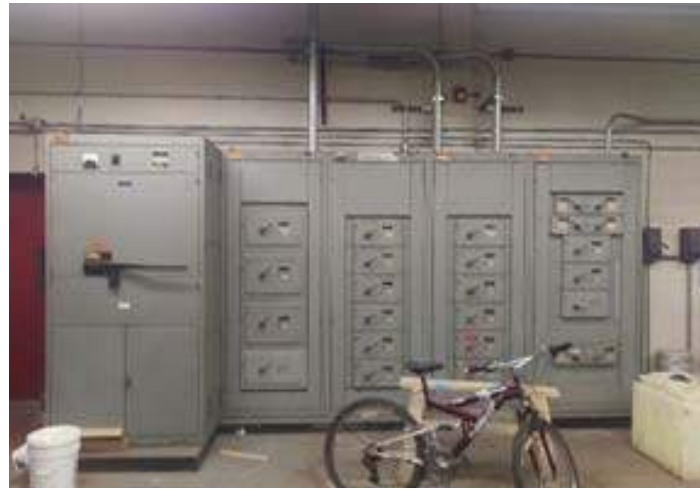
Service Entrance Switchboard

The service is underground, with a primary feeder from overhead utility lines terminating at a utility-owned pad-mount transformer. The service entrance conductors from the transformer are building wire in underground conduit and terminate at a 1976 vintage, 3000-amp, 480/277-volt 3-phase, 4-wire GE fusible switchboard with a ground-fault protected main fusible switch. The switchboard is at the end of its anticipated useful life. We recommend performing an infra-red scan of the service equipment to assess condition of contacts and terminations. In the longer term, the equipment and service entrance conductors should be replaced.

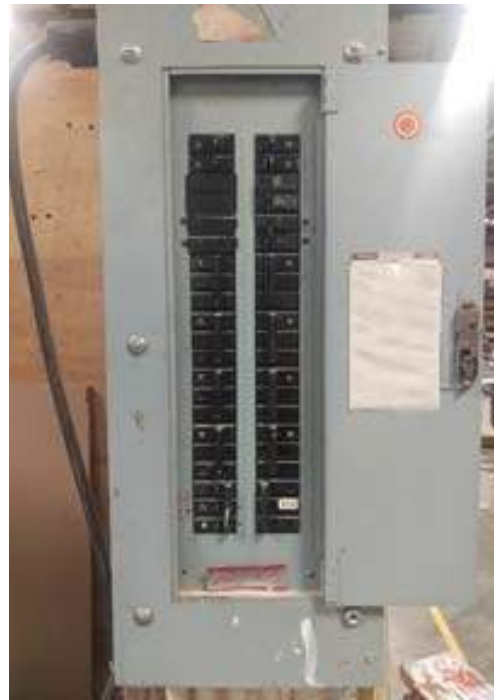
A typical Original Panelboard

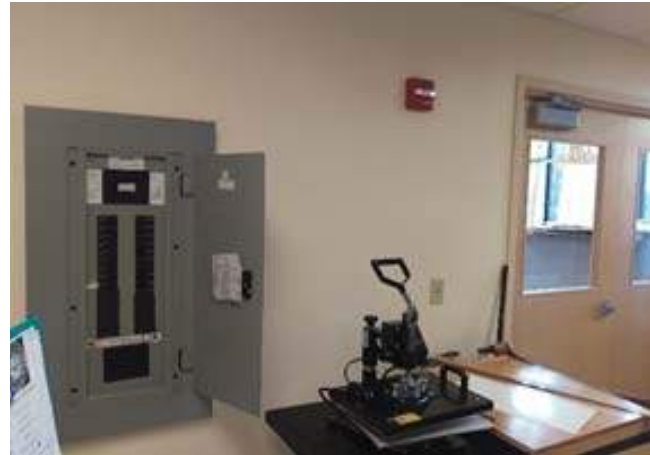
A Newer Panelboard in the CBHS Area

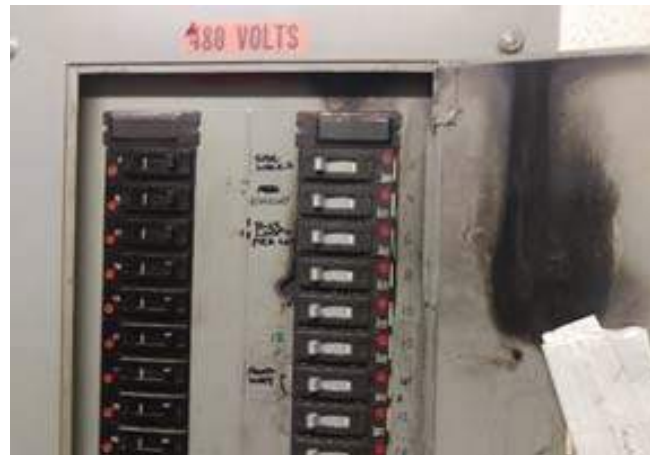
An Old Panelboard that Once Experienced a Fault

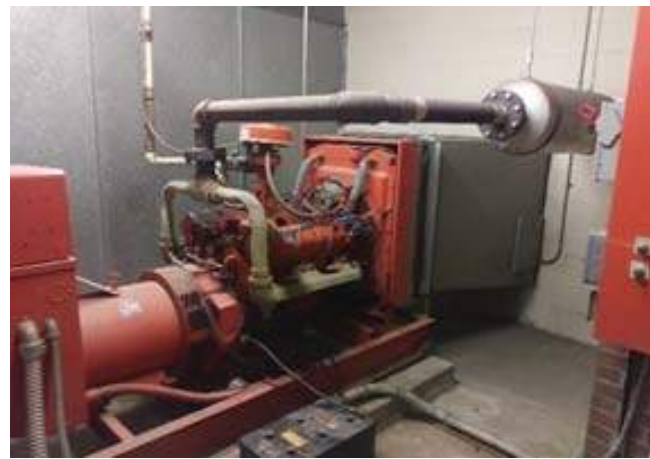
Failed Pincor Generator

The school is equipped with two emergency generators. One is a diesel Cummins unit that was installed in 2010 to serve the Emergency Operations Center (EOC). The other is an 85-kW diesel Pincor unit that appears to be original to the building and has failed. The failed unit was connected to serve the building's heating plant, fire pump, and emergency egress lighting in many areas. Considering that the 85-kW Pincor Generator is essential to operation of life-safety systems in many areas, we recommend immediately replacing it and its associated automatic transfer switch.

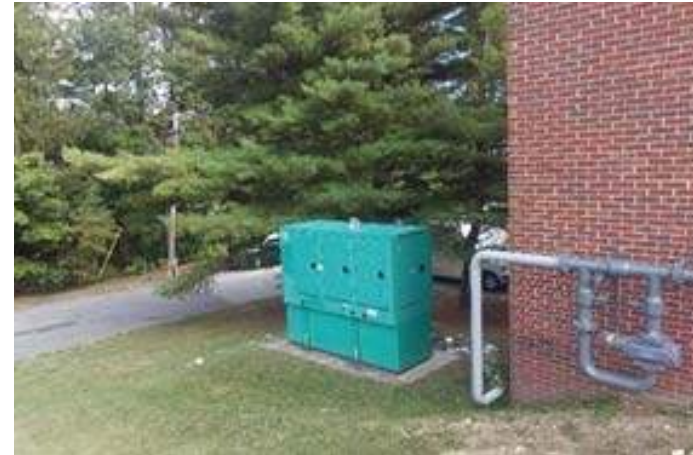
2010 Emergency Generator Serving EOC

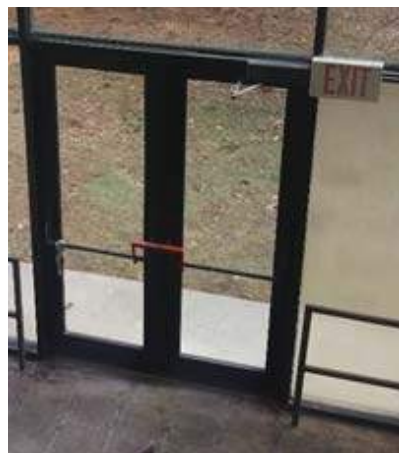
Emergency lighting is provided by emergency battery units in some areas, but other areas currently have no functioning emergency lighting due to the failed emergency generator. Exterior areas of exits do not have emergency lighting. Exit signs with are appropriately located to mark means of egress, although some units currently have no emergency power source due to the failed emergency generator. All existing units will reach the end of their anticipated useful lives within 20 years. As stated in the "Electrical System Distribution" section of this report, the failed emergency generator should be replaced immediately in order to provide functional emergency lighting for all areas. We also recommend providing emergency lighting at exterior of building exits.

An Exit Sign that is Not Currently Working

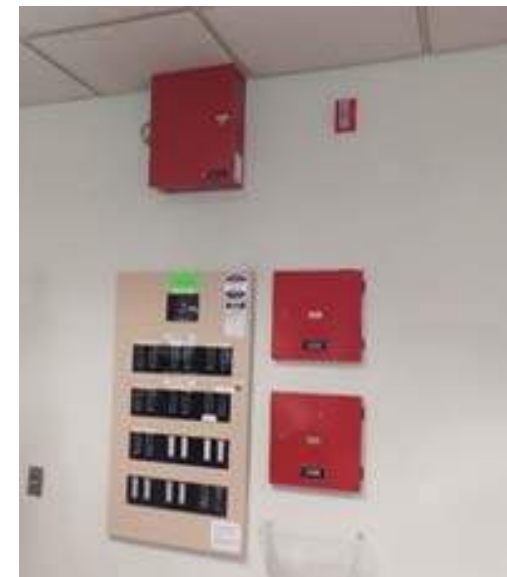
The fire alarm control panel is a 1980's vintage conventional zoned FCI control panel. The system does not monitor the fire pump, and does not monitor various sprinkler system zones separately. Occupant notification in the shop areas does not comply with current standards. We recommend providing a complete new addressable fire alarm system.

Fire Alarm Control Panel and an Obsolete Strobe

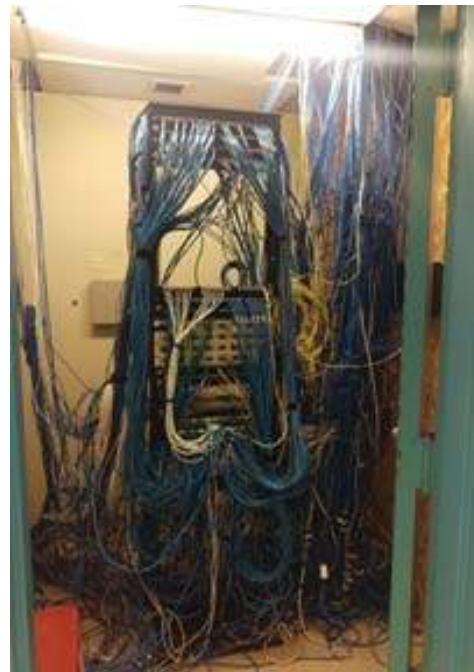
An IDF Where old data cable were abandoned when an update was completed.

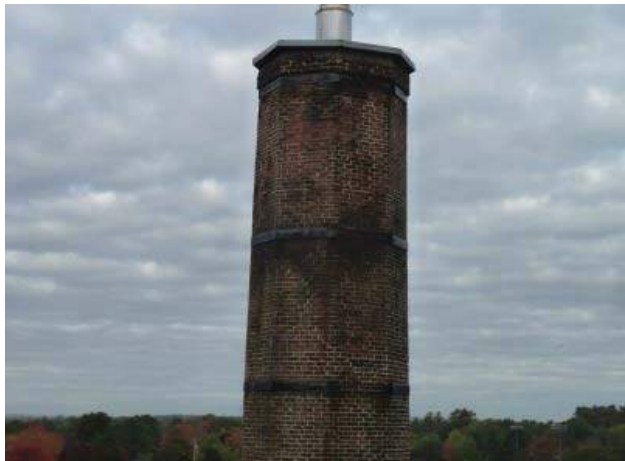
Boiler chimney

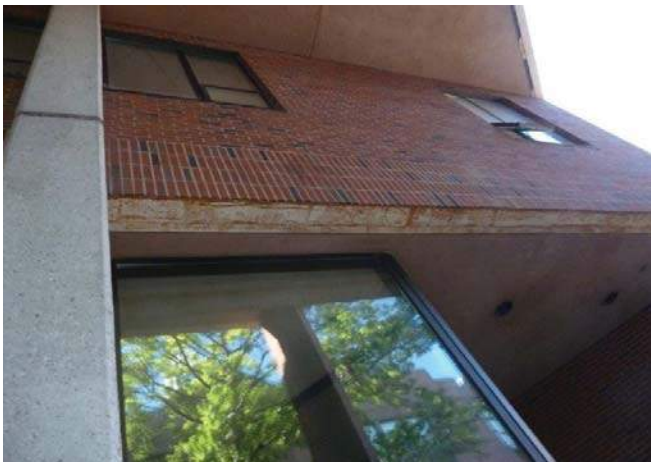
Lintel condition

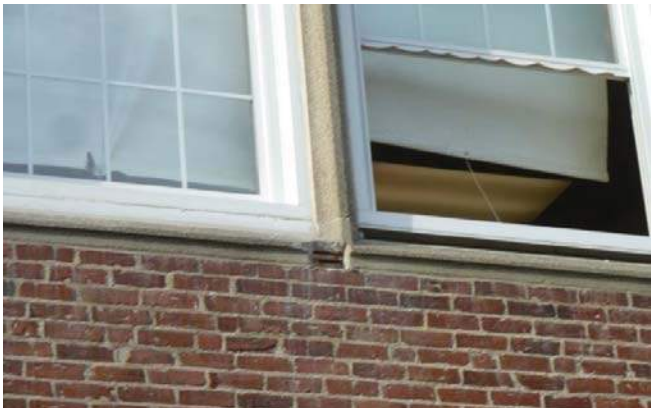
Cast stone condition

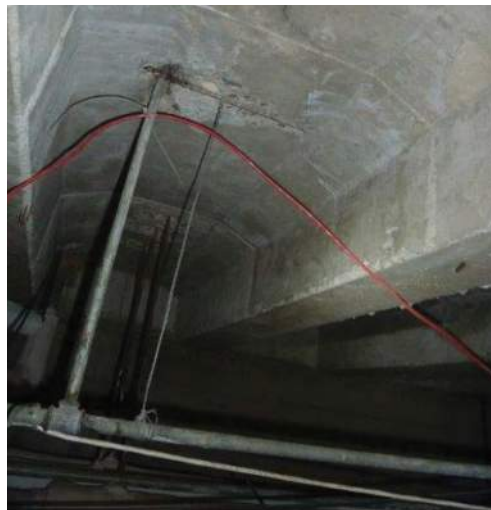
Spalling concrete

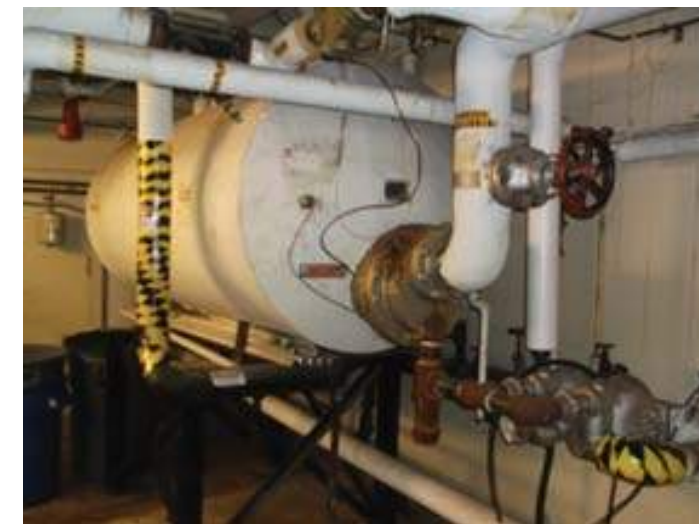
Indirect Steam DWH and Storage Original Bldg

The existing plumbing systems are mostly in good operating condition and maintained. The original building indirect steam to DHW maker/storage unit is past its useful service life and requires replacement. A new indirect DHW maker/storage (500 gal) unit will include controls and a new dedicated condensate return unit. The addition DHW mixing valves and vertical indirect heater/storage are 35 years old are beyond their useful life and should be replaced before a major failure.

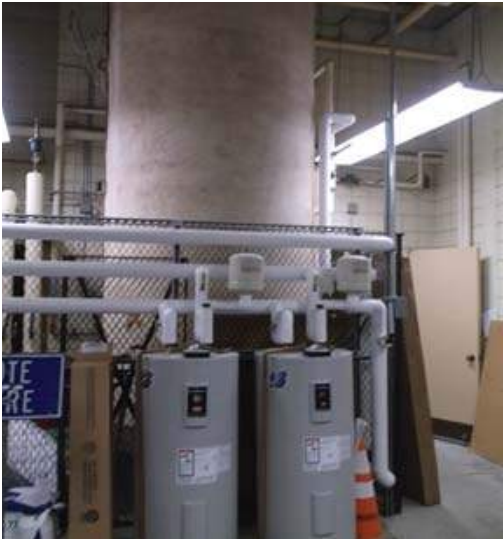
Indirect DWH and storage Addition

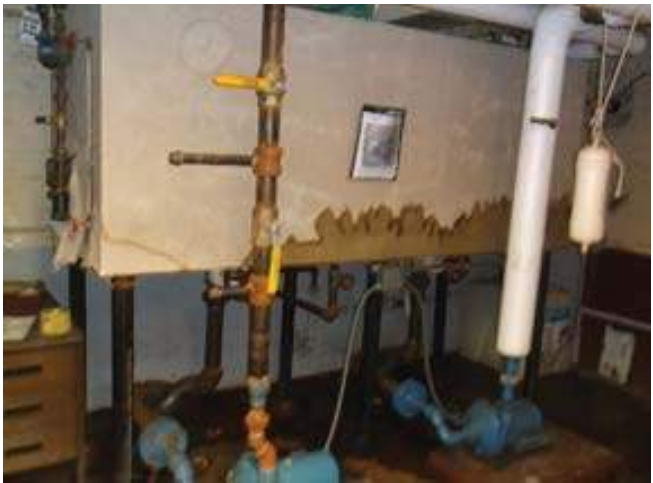
The heating plant is comprised of (3) new Hurst Firetube Series 500 boilers recently replacing the existing steam boilers in 2014. The new boilers have a gross output of 2,678 MBH per boiler. The fuel source is only natural gas where the fuel oil system has recently been removed. The boiler combustion air is supplied via a Tjernlund variable speed combustion air fan installed around 2011. The boiler feed pump tank unit is beyond its useful service life and is in need of replacement due to ongoing leaks and repair.

Vintage Boiler Feed Pump Unit

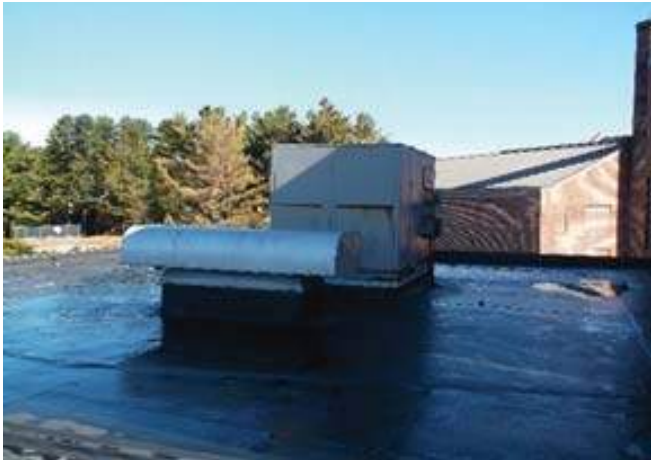
ERU Serving Weight Room

Options for the addition upgrades would be to replace systems such as the gym H&V units with a single rooftop unit and combination ERU module with economizer cooling ability and replace the weight room rooftop ERU with new in kind. Both of these systems are in currently in need of repair and beyond their useful service life. Other systems serving the addition locker rooms, cafeteria, admin could have in kind upgrades with OA ventilation brought up to current codes.

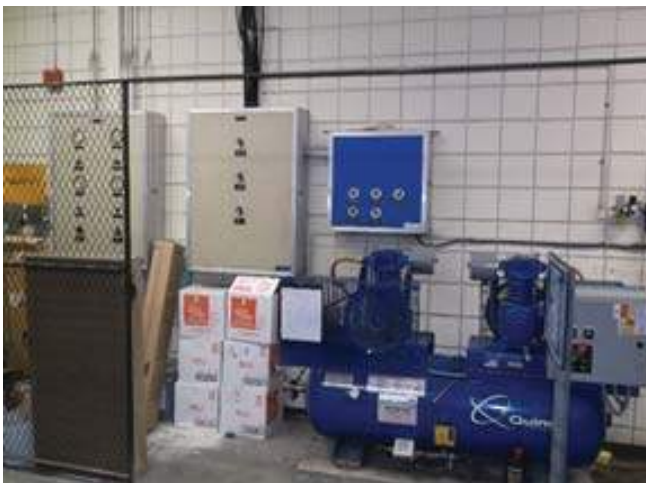
Vintage Pneumatics Addition

Temperature controls are aged and beyond their useful service life and should be replaced with DDC electric controls in the near future. A controls upgrade could be coordinated with the HW conversion project or possibly beforehand if coordinated for future basis of design air handling systems.

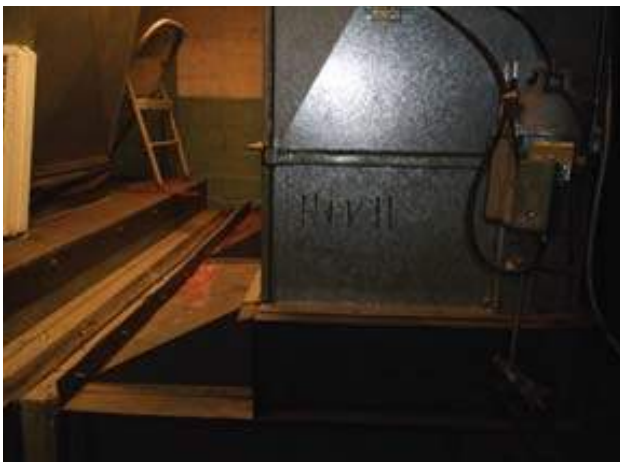
AHU-11 Serving 1st Flr Adjacent to Boiler Rm

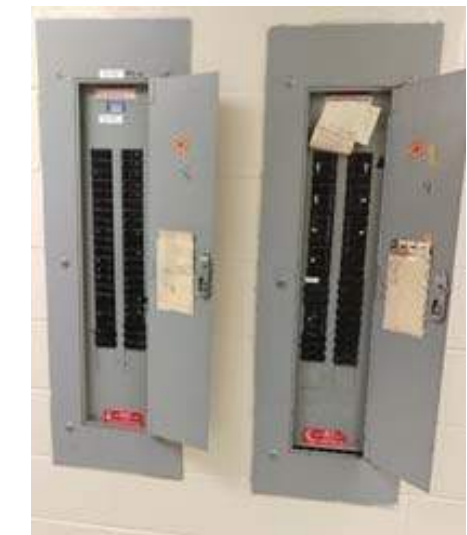
Typical 1983 vintage branch-circuit panelboards

The anticipated useful life of branch-circuit and distribution panelboards is generally considered to be 30 years, although many environmental factors such as cleanliness, moisture, salt content, and temperature can impact the actual performance life of circuit breakers and electrical equipment. It is very common for electrical equipment to remain operational and in use for significantly longer. The biggest concern regarding older panelboards is whether or not the circuit breakers will operate as designed in the event of a fault in the circuit. While circuit breakers can be tested, the testing is generally more costly than simply replacing the circuit breakers when dealing with branch-circuit and smaller distribution-type devices. The 1983 vintage panels and light-commercial-grade load centers should be replaced with modern panelboards. Panelboards that are mounted higher than permitted by NEC should be relocated.

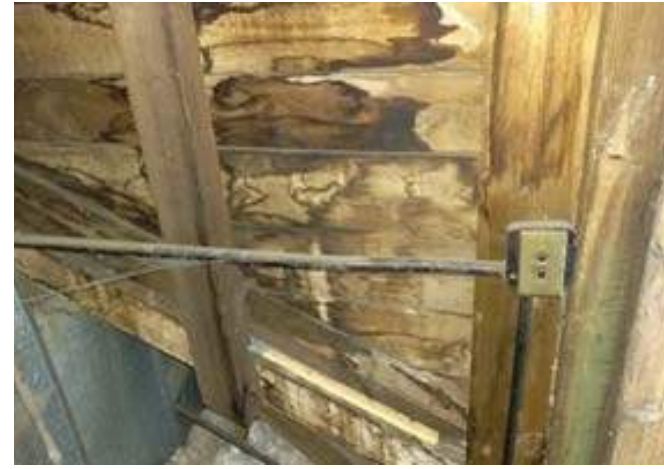
A very old, obsolete light switch in attic. Wiring is presumed to be obsolete cloth-covered conductors.

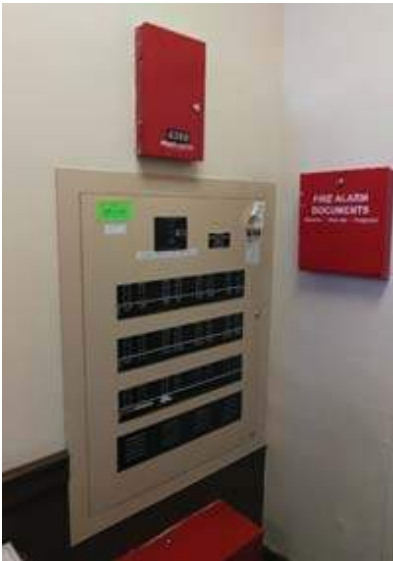
The fire alarm control panel is a 1980's vintage conventional zoned panel that is obsolete. Heat detectors protect most areas, although some attic spaces that have no sprinkler protection also have no automatic fire detection. Many manual pull stations are not located as would be required by current code. Occupant notification generally does not comply with ADA or current standards. The system should be updated to a fully addressable system.

Fire alarm control panel

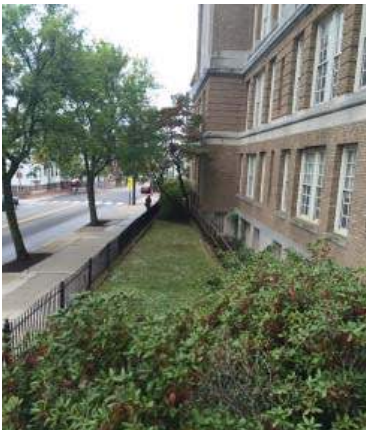
The failing railing and retaining wall are a safety concern. The railing is in desperate need of replacement and the retaining wall needs to be replaced or braced to avoid collapse into the building.

Retaining wall

- Remodel or replace ADA ramp at entrance with a landing which meets ADA requirements of a minimum of 60” X 60”.
- Define ADA parking space(s), paint and stripe and sign appropriately.
- Delineated pedestrian walkway and parking in alley between PHS and Church.
- Repair or replace spalling concrete curb.
- Enforce no parking rules at loading dock.
- Install trash and recycling receptacles around exterior of school.
- Replace decorative fencing throughout site.
- Replace failed railing and replace or brace leaning retaining wall.
- Install bike rack(s).

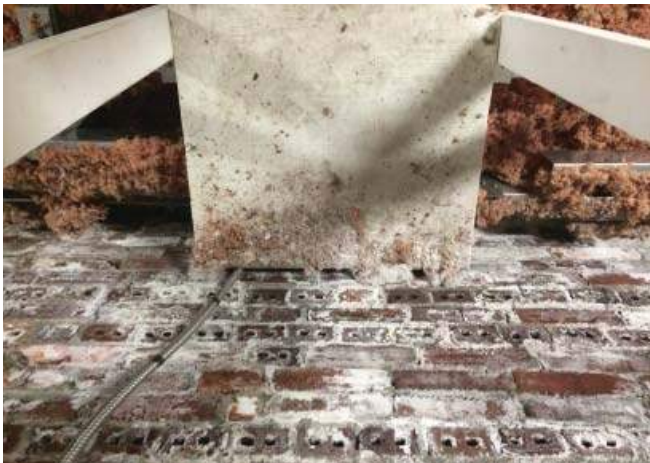
Efflorescence

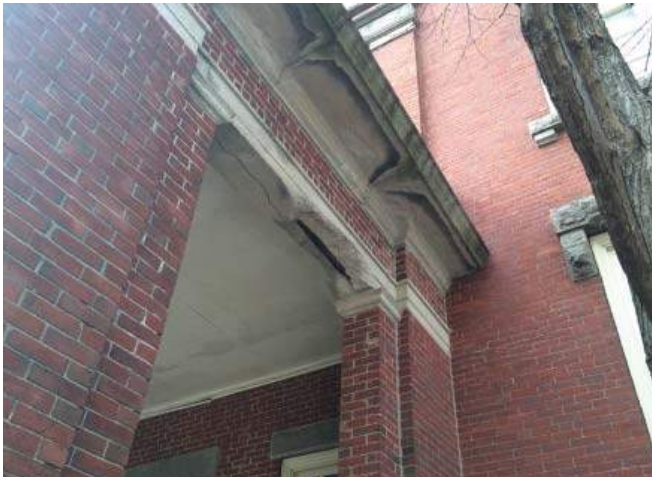
Lintel condition

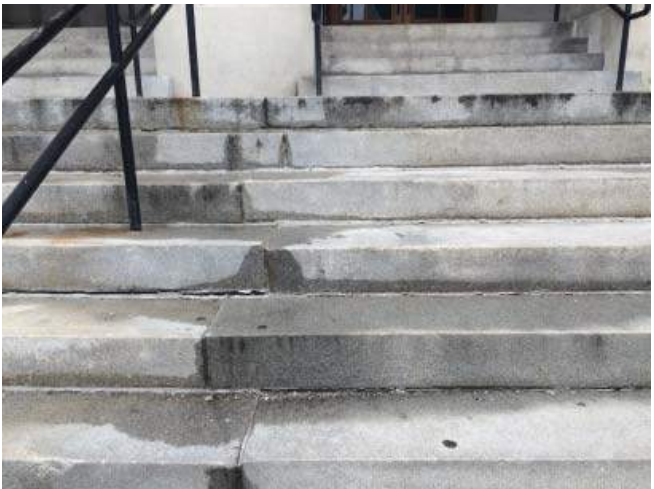
Steps

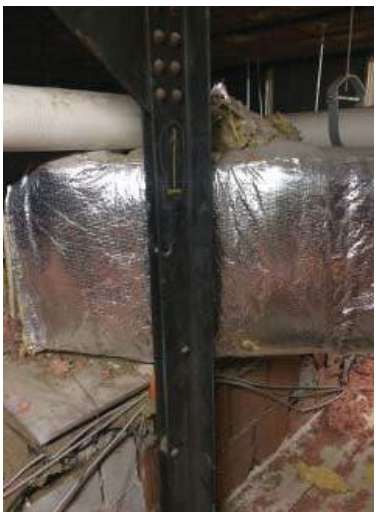
Missing rivet

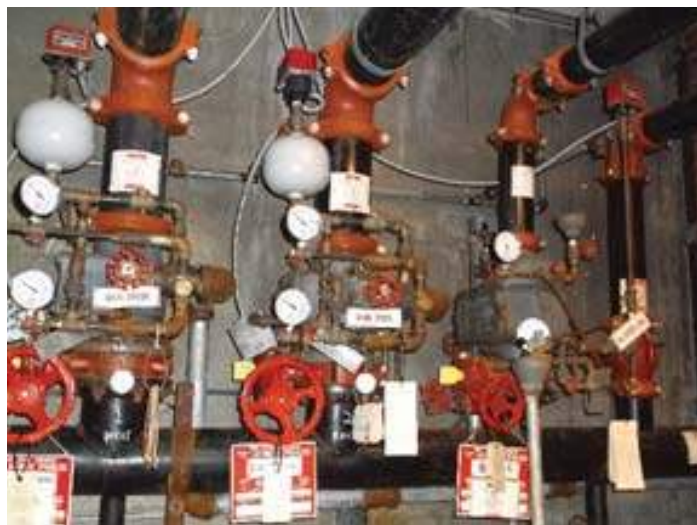
The 6" sprinkler entrance (1990 circa?) is supplied by municipal water. The complete automatic sprinkler system is a combination of (2) 4" wet risers, (1) 3" dry riser, and a stand pipe riser. There is a 4" storz fire department connection. Fire sprinkler piping has an expected service life of 40 years and sprinkler heads have an expected service life of 25 years. If it is verified that the existing sprinkler system was installed around 1990 then replacement of the sprinkler heads would be required at this time.

Fire Sprinkler Entrance

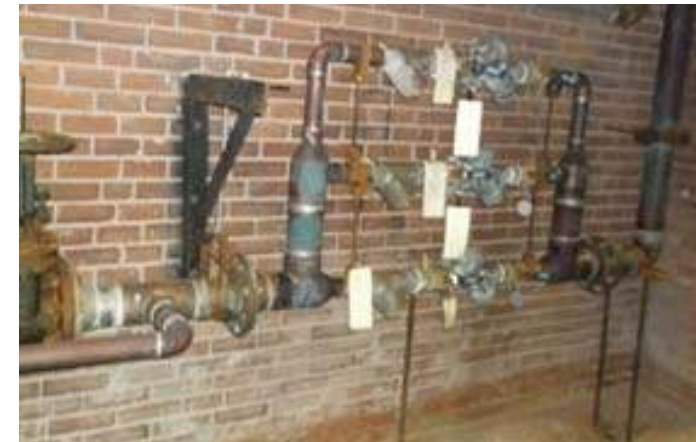
The piping systems appear to be adequate although they are at or very near the end of their service life; consideration of complete replacement would depend on rate of piping failures or pending building renovation projects.

Domestic Water Entrance

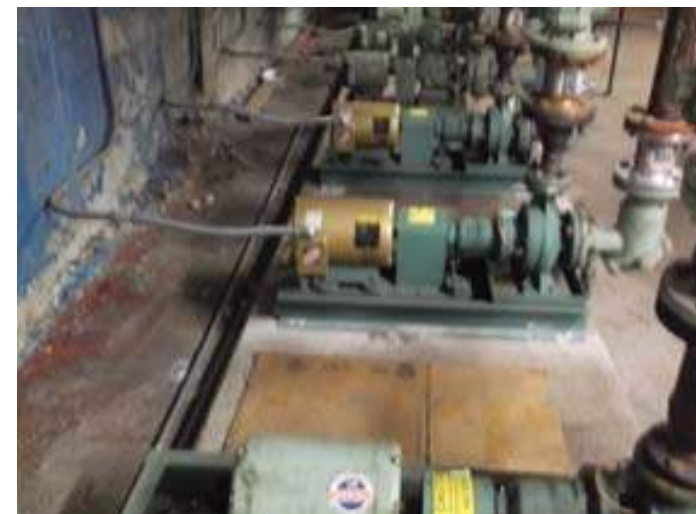
Bank of Base Mounted HW Building Pumps

Heating pumps are at the end of their useful service life and should be replaced with new efficient pumps that have VFD operation.

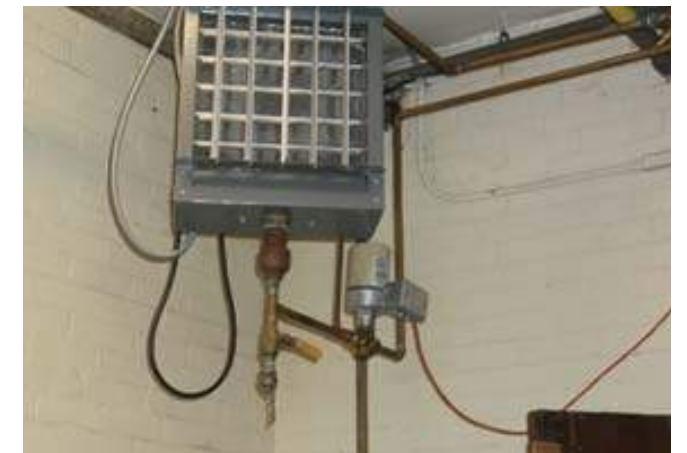
The building automatic control system (BAS) is comprised of DDC electric from the 1990s with upgrades continuing thru the maintenance program. Vintage hydraulic actuators are failing and leaking and being replaced with modern direct drive Belimo type actuators. The typical expected service life of DDC electric components is 20 years.

Unit Heater with Hydraulic Valve Actuator

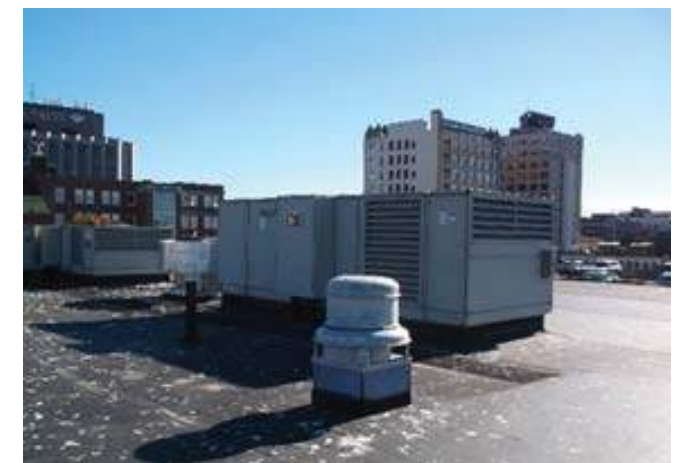
The existing HVAC systems in general (with the exception of the boiler plant) are in fair to good operating condition. However, most all RTUs, H&V units, and heating terminals are at the end of their useful service life. Portland Building Facilities personnel stated that the RTU coils are wearing thin from water velocity erosion which contributed to a recent coil failure. Glycol water sampling should be conducted to determine if water quality is causing tubing erosion/corrosion as well.

1990s Vintage EF and RTUs

It is recommended to replace RTUs and H&V air handlers in kind with new efficient models with VFD fans. Other equipment such as VAV and duct coils should be replaced as well where they are at or beyond their useful service life.

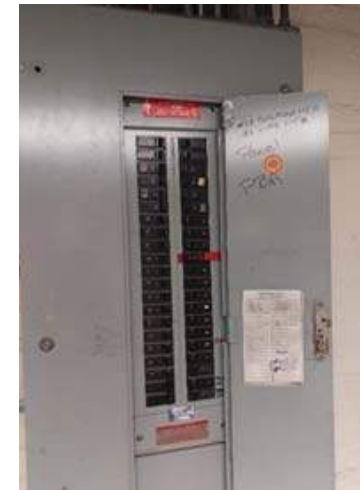
Based on what can be seen from a simple visual inspection the feeders are building wire in conduit. Wiring should be replaced in conjunction with panelboard updates. All power distribution wiring will reach the end of its anticipated useful life within 20 years.

A Typical 1970's Vintage Panelboard

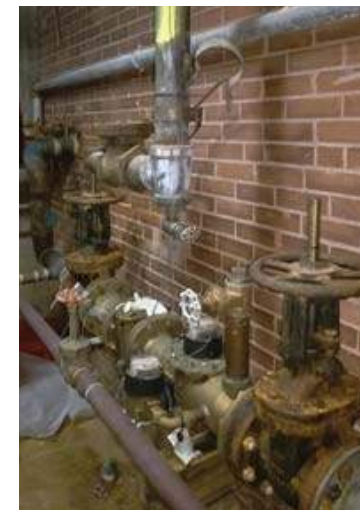
Domestic Water Entrance with No Grounding Electrode Connection

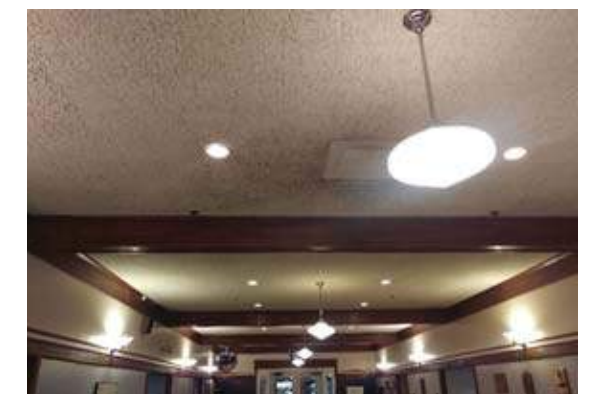
Most of the interior luminaires are at or near the end of their anticipated useful lives. The main office lighting provides illumination measured at approximately 7 footcandles average during our visit, which is significantly lower than IES recommendations of 30 footcandles for reading. Illumination in the Gym is also lower than IES recommendations, measured at approximately 20 footcandles average during our visit whereas IES recommendations 50 footcandles for high-school competitive play with a small number of spectators. Common area auditorium lighting is controlled only by circuit breakers, and the theatrical dimming racks are obsolete. We recommend updating lighting throughout the school to LED and fixtures with high-performance optics that provide illumination levels per IES recommendations. We also recommend updating the lighting controls throughout the auditorium area.

Main Office lighting

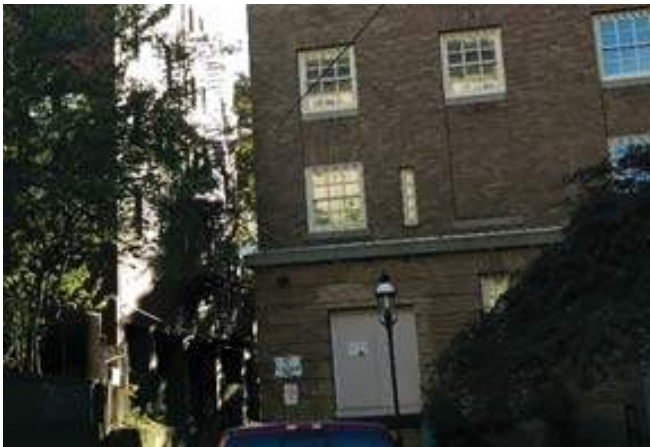
Site Lighting is provided by pedestrian-scale pole lights that do not have full-cutoff optics. Building mounted exterior lighting is a mixture of LED wall packs and High-intensity-discharge (HID) wall packs. The HID wall packs and pole lights are obsolete and should be updated to LED fixtures with full-cutoff optics. All existing fixtures will reach the end of their anticipated useful lives within 20 years.

A Pole Light and Wall Pack

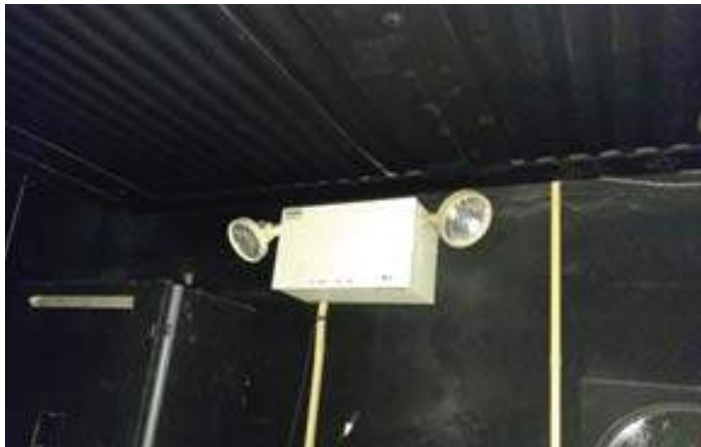
Emergency battery units with integral and remote incandescent heads provide illumination for means of egress. There is no emergency light at the exterior of building exits. LED illuminated exit signs with integral battery backup are appropriately located to mark means of egress. All existing units will reach the end of their anticipated useful lives within 20 years. We recommend updating the emergency lighting units to LED and providing outdoor emergency lighting at building exits.

Typical Emergency Lighting Battery Unit

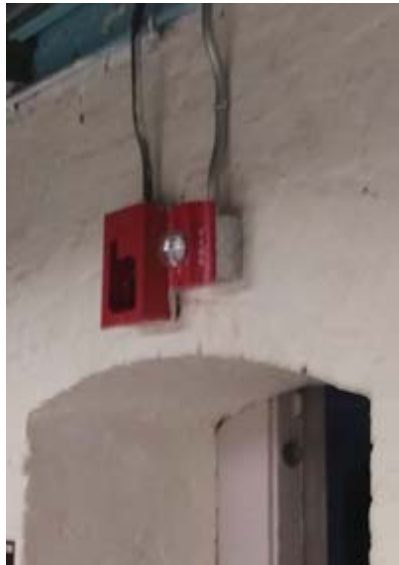
Fire alarm control panel is a recently installed addressable Silent Knight model 5820XL. Occupant notification and sprinkler system monitoring have been updated, but old initiating devices and zone wiring remain. Each old zone is monitored as an addressable point. Many old notification appliance backboxes are open; blank covers should be provided for old notification appliance backboxes. We recommended updating initiating devices and wiring to fully addressable.

A New Notification Appliance Adjacent to an Old Backbox

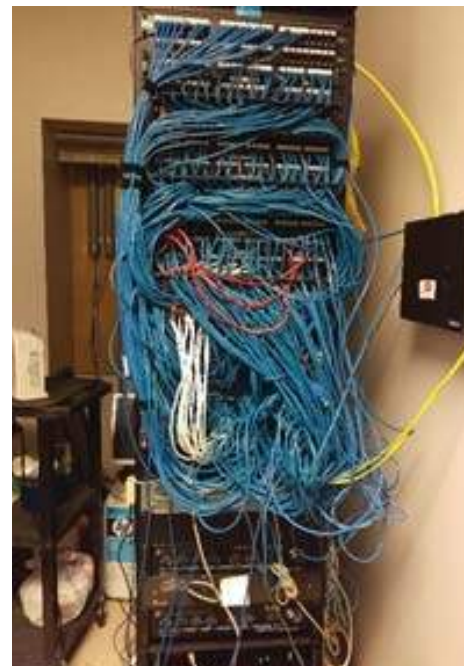
The school has a 2012 vintage Category 6 data network cable plant. WIFI network connectivity is available throughout the school. Some network equipment and terminations are housed in open racks in spaces shared with other program uses such as storage. We recommend providing enclosed cabinets to house infrastructure in shared-use areas.

An Intermediate Distribution Frame (IDF) with Paging Amplifiers

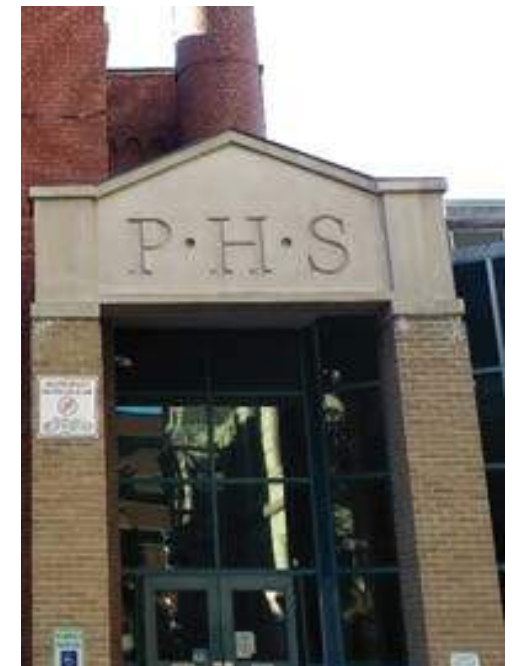
The school is equipped with a security camera system consisting of network-connected cameras located at the exterior of building entrances. There are no existing interior cameras. We recommend that interior security cameras be added to monitor high-risk areas and areas not readily visible to staff.

Security Camera at Building Entrance

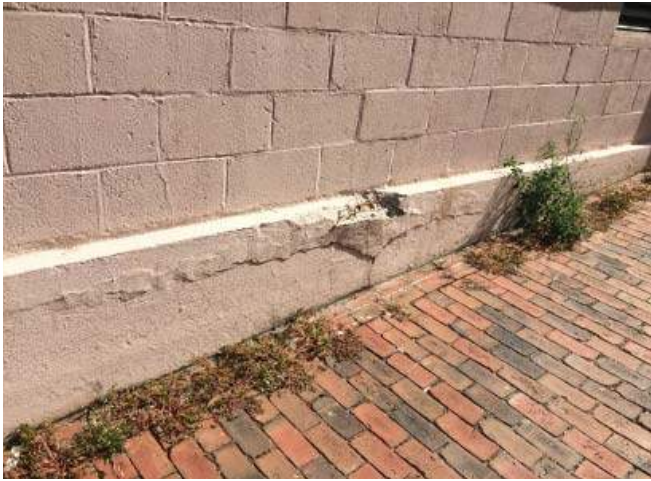
Spalling at foundation

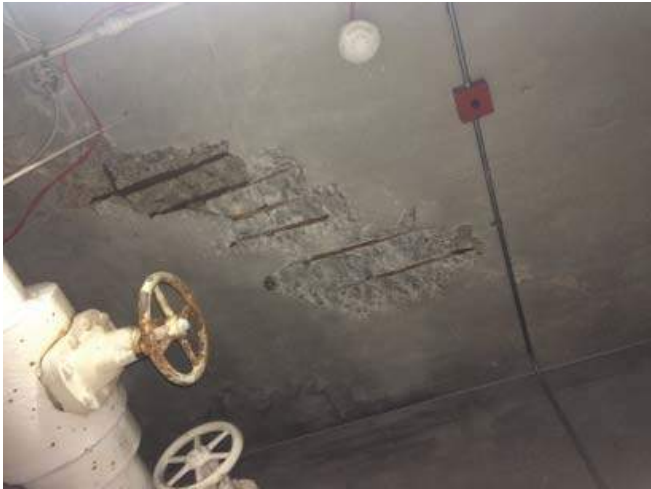
Concrete spalling

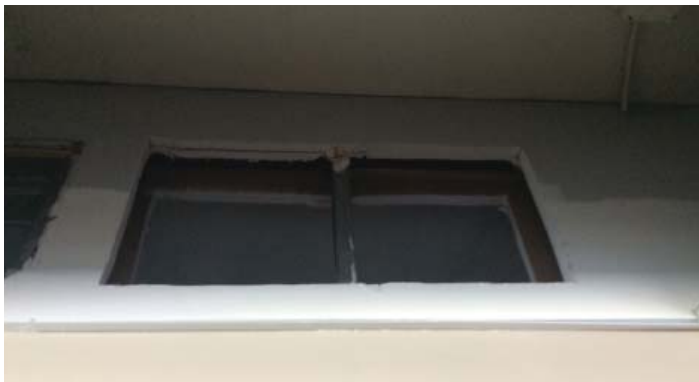
Opening in fire wall
