Facilities Assessment of School Buildings

City of Portland and Portland Public Schools

VOLUME 1

February 28, 2017

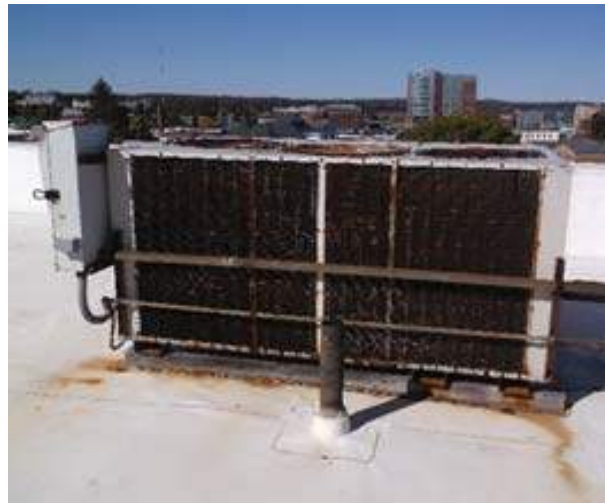
In general the HVAC systems are in good operating condition, with the exception of AHU-2 and RTU-10. AHU-2 is beyond its useful service life in its current condition and should be upgraded with new condensing unit, hot water coil, VAV supply, and ERU ventilation. RTU-10, as mentioned previously, is beyond its useful service life and should be replaced in kind with a hot water duct coil. The steam boiler feed unit is beyond its useful service life and should be replaced in kind. A variable speed combustion air fan should be added to make the current combustion air system code compliant. The steam boilers have about 10 years left expected service life. Where the steam boiler plant will have 10+ years of service life left, it is recommended that to add a steam to HW heat exchanger and convert the remaining steam system and terminal units to HW, this will allow converting to HW boilers in the future with minimal upgrades to the HW system. The existing range exhaust fans should be upgraded to NFPA compliance with fire suppression or remove the hood and range. The second floor front administration (Cumberland Ave side) should have the ductwork zoning completely reworked to supply adequate ventilation and cooling air to the current floor plan.

AHU-2 Condensing Unit

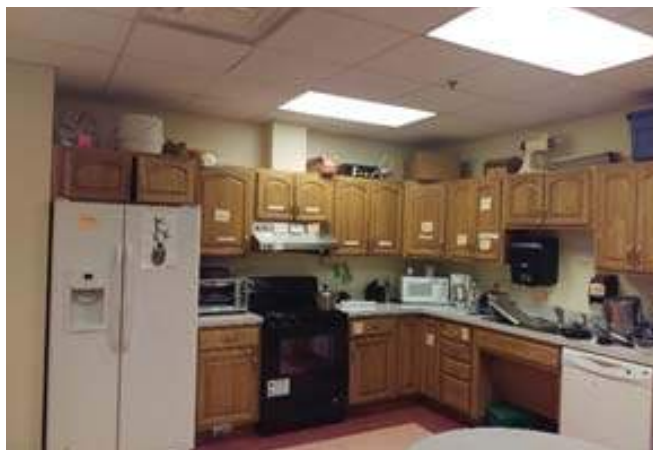
Non-Compliant Range Hood

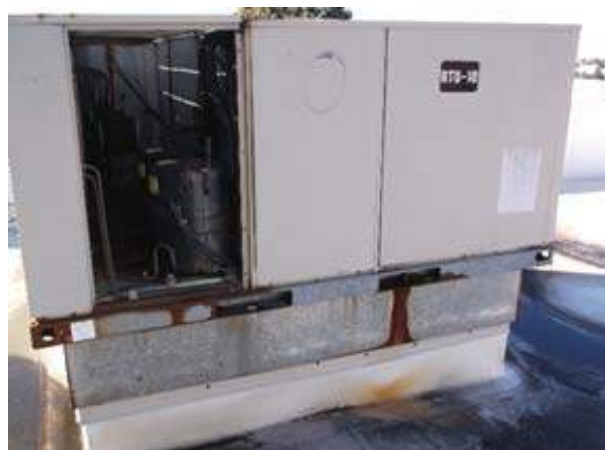
AHU-1 was upgraded in 2014 to a hot water coil VAV air system with ERU ventilation air serving VAV air terminal throughout the first floor. AHU-2 is a steam coil VAV bypass system serving terminal throughout the second floor. Packaged rooftop air conditioning units serve the 3rd floor with either hot water coils or electric duct coils. RTUs have been replaced in kind in 2014 except RTU-10 which is 1908's vintage and beyond its useful service life.

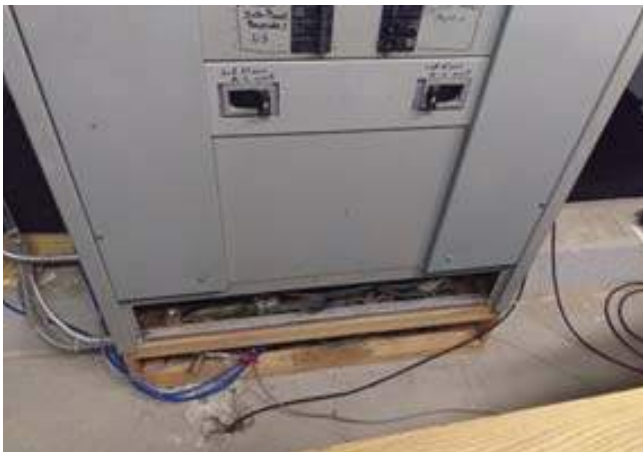
Panels are primarily a mixture of 1987 vintage ITE panelboards and residential/light-commercial grade load centers manufactured by Square D, GE, and Siemens. An Eaton Panelboard was added in the Bayside Learning Center when that portion of the building was fit up in 2014. Main Distribution Panelboard MDP is fully utilized and missing a portion of its trim cover, leaving conductors within exposed.

Missing trim on MDP

A cover should be provided for the open portion of the MDP. The 1987 panelboards and residential-grade load centers should be replaced as part of any planned renovations to the district office facility.

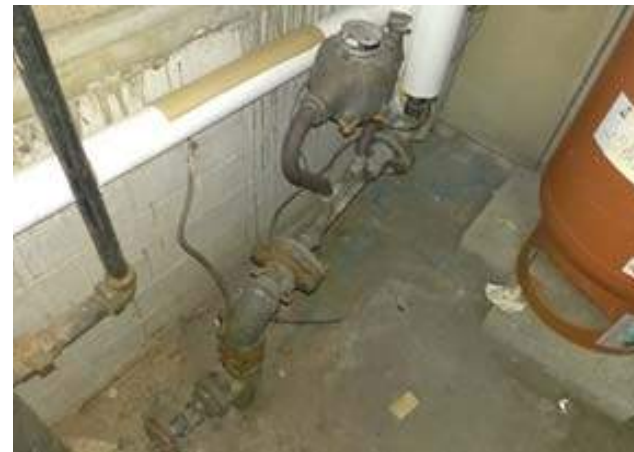
No grounding electrode connection is made at the water main. The National Electrical Code (NEC) requires an underground metal water pipe that is electrically continuous and in contact with the earth for at least 10 feet to be utilized as part of the grounding electrode system for the building. We recommend providing a grounding electrode connection at the water main as required by code.

Grounding electrode connection at water main has been cut off.

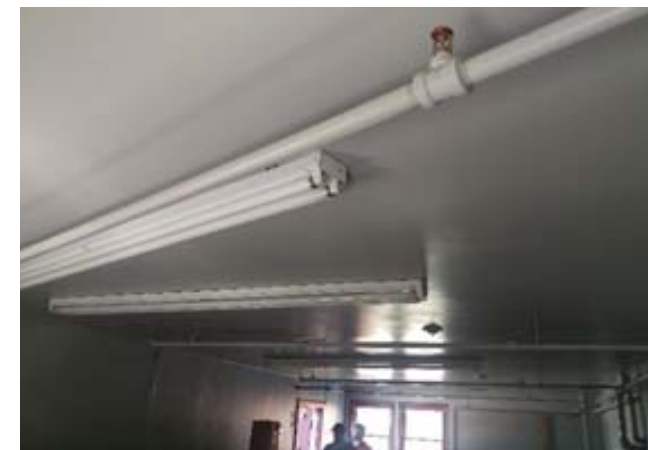
T12 strip lights on 4th floor

Lighting in the Bayside Learning Center is almost new and has nearly 20 years of anticipated useful life remaining. The lighting in other areas should be updated to LED as part of any planned renovations to the spaces. Luminaires using T12 lamps should be replaced with LED units as the existing units fail.

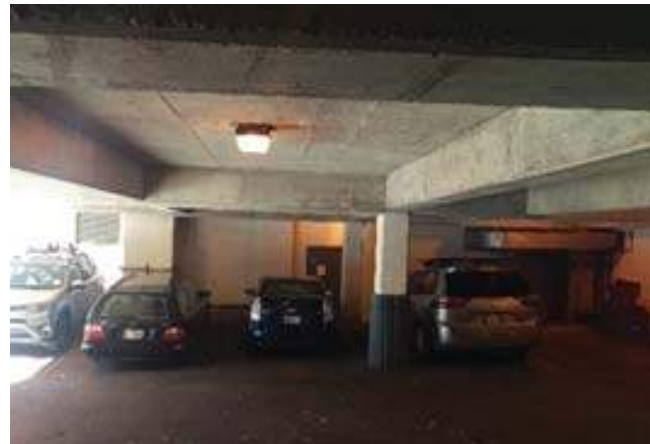
Outdoor lighting consists of building mounted LED full cutoff wall packs, an LED flood, and some decorative LED wall mounted fixtures. High-pressure sodium lighting is used in second floor parking garage. With the exception of the second floor parking garage, the lighting appears to be fairly new and has approximately 15 years of anticipated useful life remaining. The parking garage lighting is obsolete, with one fixture currently not functioning, and should be updated to LED.

Second floor parking garage lighting

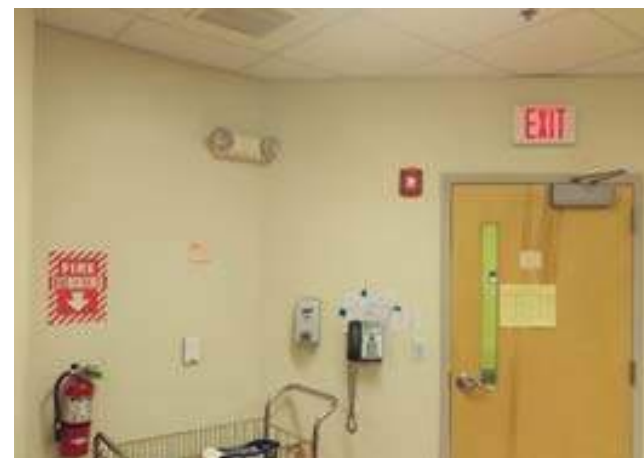
Emergency battery unit with incandescent heads.

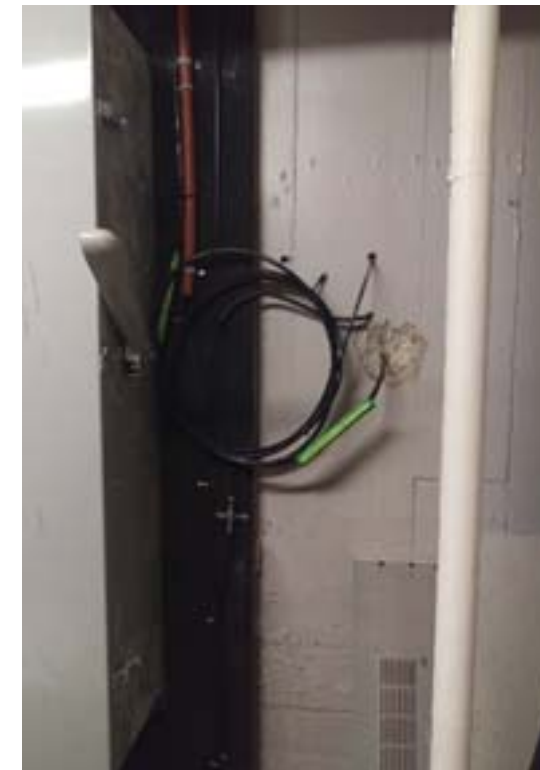
Cable Television (CATV) Service is overhead and enters at a backboard located in the main electric room on second floor. The entrance cable is not sleeved in conduit where it penetrates the building exterior wall. A conduit sleeve and sealing are recommended for CATV service cable penetration through the building wall.

The building is served by a Time Warner single-mode fiber optic data cable that enters the building at the Main Distribution Frame (MDF), which is located in a dedicated room on the 3rd floor. The entrance cable is not sleeved in conduit where it penetrates the building exterior wall. There are intermediate distribution frames (IDF) on the second and first floors. The second floor IDF is housed in an open rack located in the electric room. Horizontal cabling is a mix of Category 5e and Category 6. It was noted that some old data cabling that is no longer in use is abandoned in place. A conduit sleeve and sealing are recommended for the fiber optic service cable penetration through the building wall. An enclosed cabinet to house the data equipment in electric room should also be provided. Unused abandoned cable should be removed.

Fiber Optic and CATV entrance cables

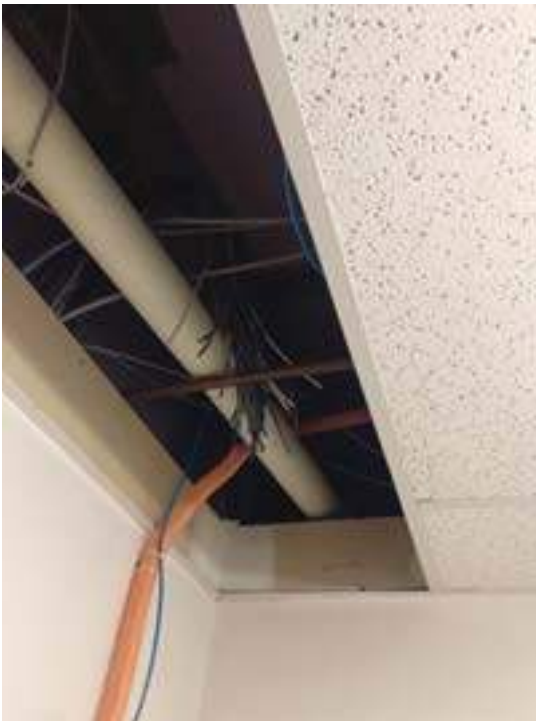
Abandoned cables in First floor IDF room

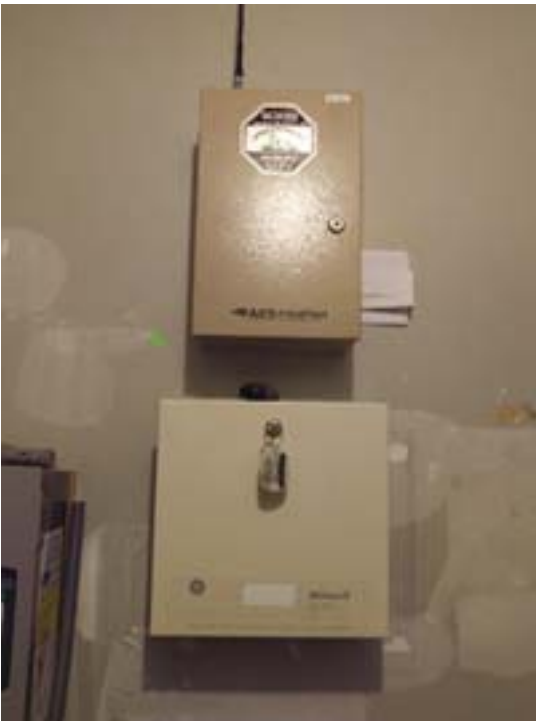
A GE Networkx NX-8V2 residential-grade security alarm panel serves the District Office. The Bayside Learning has a separate GE NX-8E residential-grade security alarm control panel. Alarms are initiated on the systems by motion detectors and door contacts. The building is not equipped with a panic alarm. We recommend providing commercial grade security alarm panels that are integrated with the district-wide network. Keypads are in use to control access to the building. There are no operational security cameras other than an Aiphone video intercom between main entrance and reception desk to provide controlled access. Abandoned non-functional cameras remain in place in some interior areas. We recommend providing digital cameras connected to district servers.

District office security alarm panel

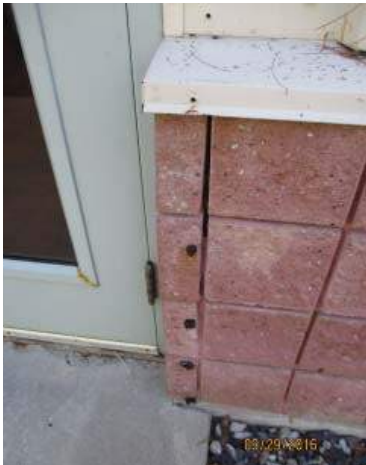
Open masonry joints

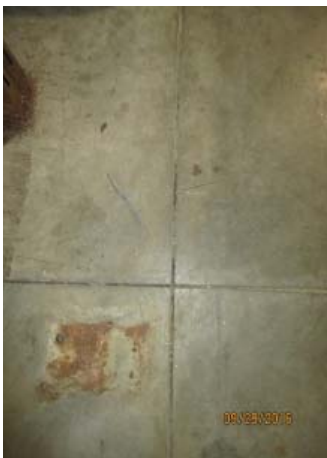
Slab joints

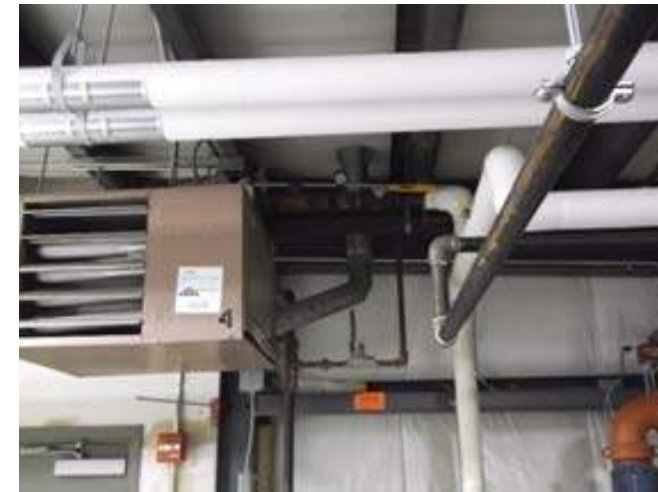
The currently installed mechanical systems are partially vintage and partially three years old. The vintage units are at the end of their useful service life. The gas fired unit heaters are failing and require replacement. The split AHU that serves the administration needs to be replaced with a new gas fired unit and DX cooling system that provides OA ventilation in combination with a small ERU ventilator. Controls may also be upgraded with DDC electronic as systems are replaced.

Vintage Gas Fired Unit Heater

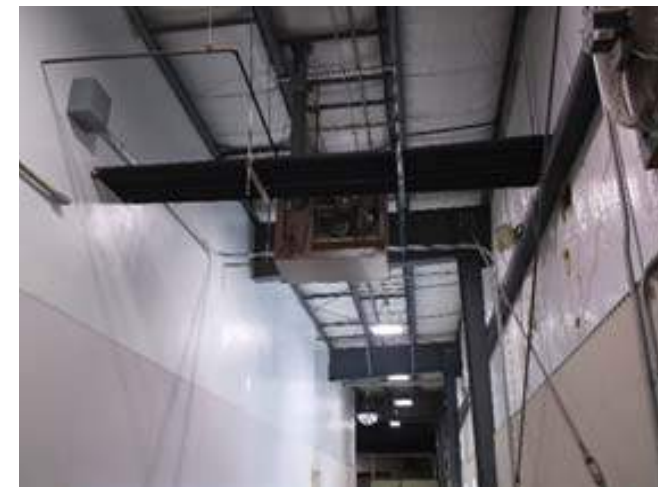
Vintage Gas Fired Unit Heater

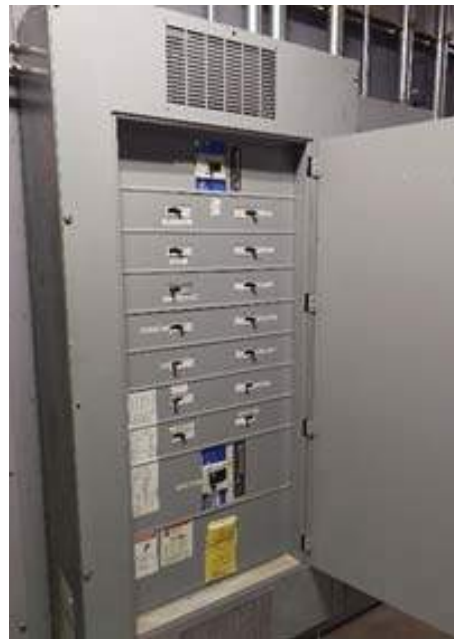
Panel MDP

1998 vintage Cutler Hammer Main Distribution Panelboard (MDP). One circuit breaker is marked "spare" and six others are currently in the off position, but are marked to indicate that they feed utilization equipment such as aeration blowers and chillers. We suspect that some of these circuit breakers are actually unused. As a maintenance item, the MDP circuit breaker identification should be updated to reflect only current equipment.

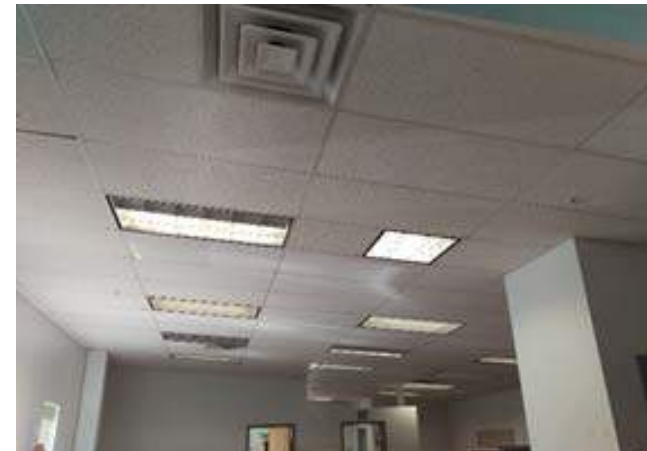
Process Areas have a mix of recessed food service grade lens troffers and Surface and pendant mounted 8' linear vaportight fixtures with T8 fluorescent lamps. Offices are illuminated mostly by recessed fixtures with parabolic lenses and T8 fluorescent lamps, although there are some incandescent downlights in the entrance lobby and T12 lamps were noted in break room. Corridors have surface and pendant mounted 8' linear vaportight fixtures with T8 fluorescent lamps. Toilets, storage and mechanical rooms are illuminated by fluorescent luminaires with T8 lamps. Receiving and warehouse areas have been updated to LED luminaires with integral occupancy sensors.

Parabolic lighting in office area

We recommend updating fluorescent lighting to modern LED luminaires with high-performance optics. Updates for the office area and brake room are recommended for the short term; updates to other areas that utilize T8 fluorescent luminaires are recommended in the long term.

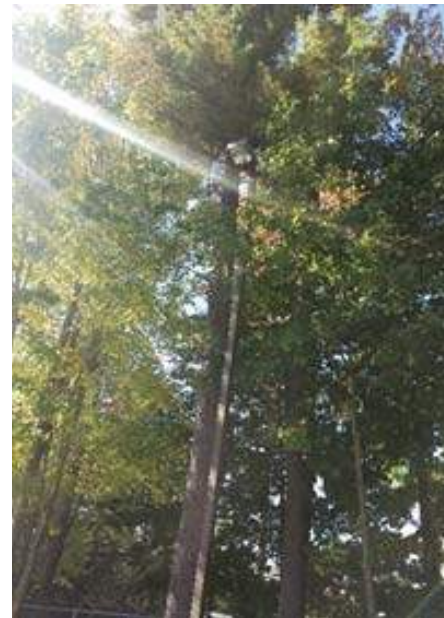
Outdoor areas are illuminated by Shoebox style pole mounted fixtures utilizing High-pressure sodium (HPS) lamps, as well as a mixture of LED and metal halide wall packs. The LED wall packs have been installed to replace old high-intensity discharge fixtures that failed. The existing metal halide and HPS fixtures are at or near the end of their anticipated useful life and should be updated to LED fixtures with full-cutoff optics.

Typical pole light

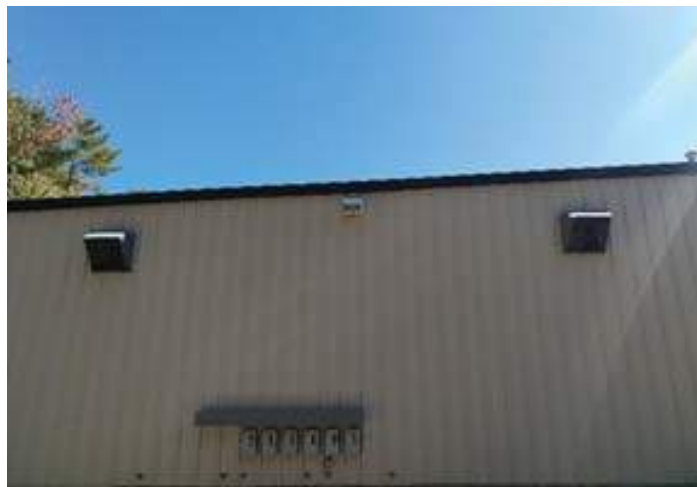
Metal halide wall pack

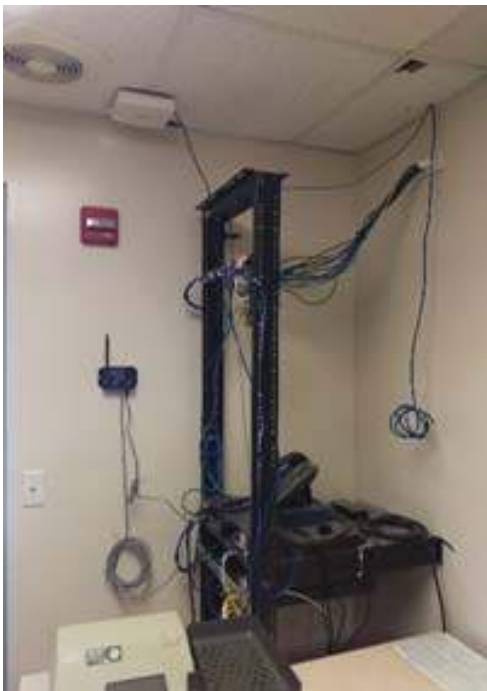
The building is not equipped with fiber optic connectivity from the utility. The Data rack is an open type that is located in a small room that is shared with other program uses. WIFI is available throughout the building. It is recommended that an enclosed cabinet be provided to house the data network equipment.

Data rack

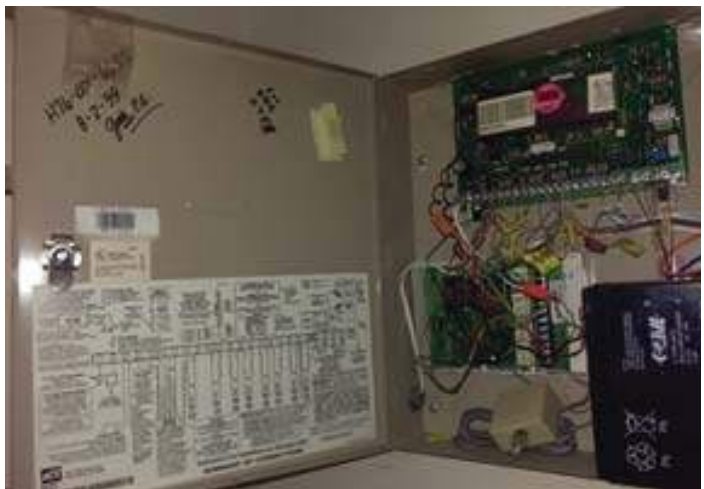
The Intrusion Alarm System has an ADT Residential-grade security alarm control panel that is not capable of being connected to the district-wide security network. The building is not equipped with a panic alarm. We recommend Providing a commercial grade security alarm panel that is integrated with the district-wide network.

Security alarm control panel

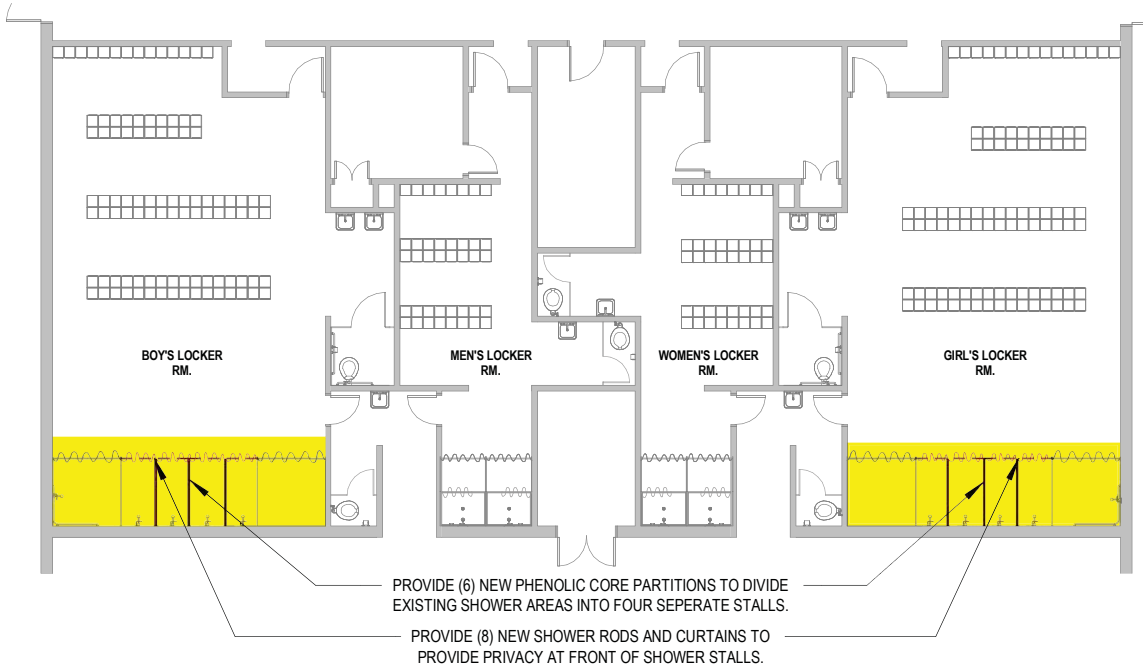
The existing locker room configurations at Reiche Elementary School offer limited privacy in both the showering and changing areas. However, it is clear that the school has taken steps towards providing private shower and changing areas these locker room areas with the installation of partitions dividing what were previously gang shower areas. In each the boy’s and girl’s locker rooms, the gang shower area has been divided into four large stalls. One stall is a dedicated private changing stall with a curtain. Two stalls are meant to be private shower stalls, however they are missing the dividing curtain between them, as well as in the front of them. The remaining stall is meant to be an ADA compliant stall, but is missing some critical components to make that stall fully accessible. The men’s and women’s locker rooms each have two private shower stalls, each with a private changing stall in front. None of these, however, are ADA accessible. All four locker rooms require short and long-term modifications to offer students privacy while showering and changing, and to make them ADA compliant.

Subdivide the existing gang showers into individual private shower compartments using compartment partitions and curtains.

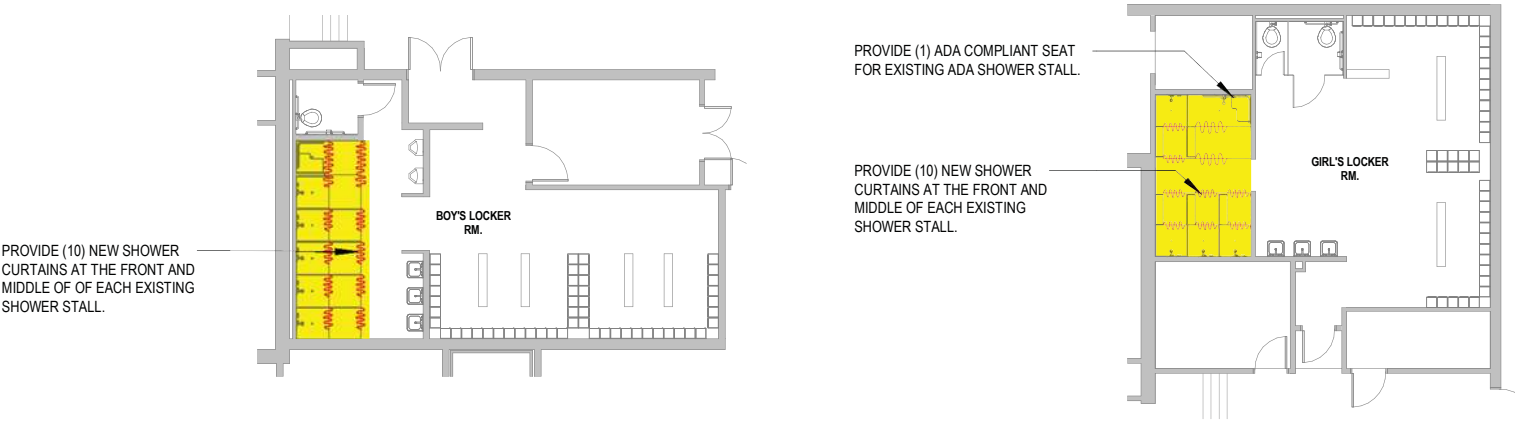
The existing locker room configurations at King Middle School offer limited privacy in both the showering and the changing areas in the boy’s and girl’s locker rooms. Both locker rooms have private showering and changing partitions in front. However, the shower curtains are missing at all partitions in both locker rooms, thereby negating the privacy of these stalls. Each locker room has a shower stall meant to be ADA compliant, though both are missing some critical components to make each stall fully compliant. Adjacent to these shower areas are large, open changing areas with a perimeter of lockers and rows of benches at the center. This configuration lacks dry, private areas in which students can change privately without needing to enter a wet shower area. Both locker rooms require short-term modifications to offer students privacy while showering and changing, and make these locker room areas private and ADA compliant.

Install curtains at the existing individual showers and changing compartments.

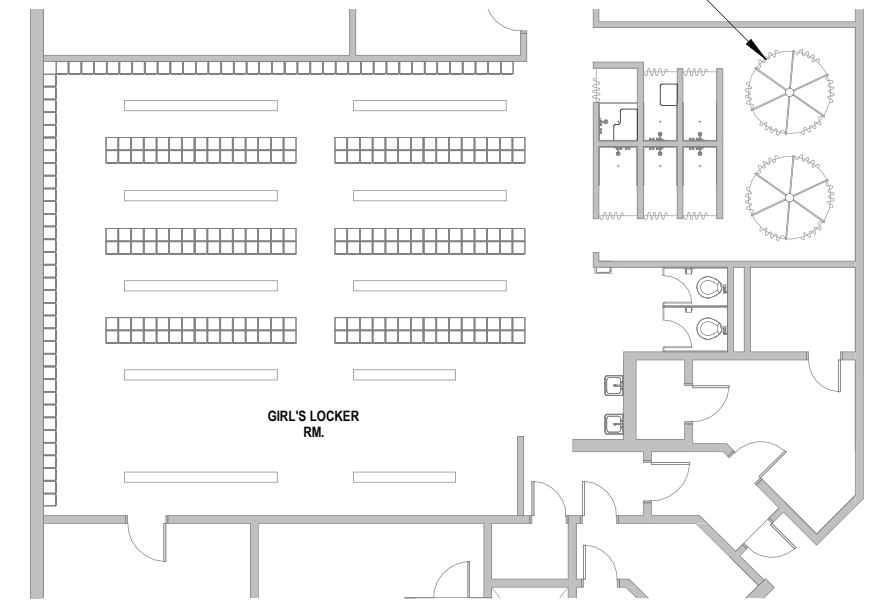
THE SCHOOL HAS ALREADY TAKEN STEPS TOWARDS HELPING MAKE THE GIRL'S LOCKER ROOM MORE PRIVATE. NO TEMPORARY ACTION NEEDED.

PROVIDE (6) TEMPORARY SHOWER PARTITIONS W/ DOORS BETWEEN EXISTING SHOWER FIXTURES IN GANG SHOWER AREAS. PROVIDE (6) NEW SHOWER RODS AND DIVIDING CURTAINS MOUNTED AT THE CENTER OF EACH STALL CREATING A SHOWER STALL WITH SEPERATE CHANGING AREA IN FRONT.
